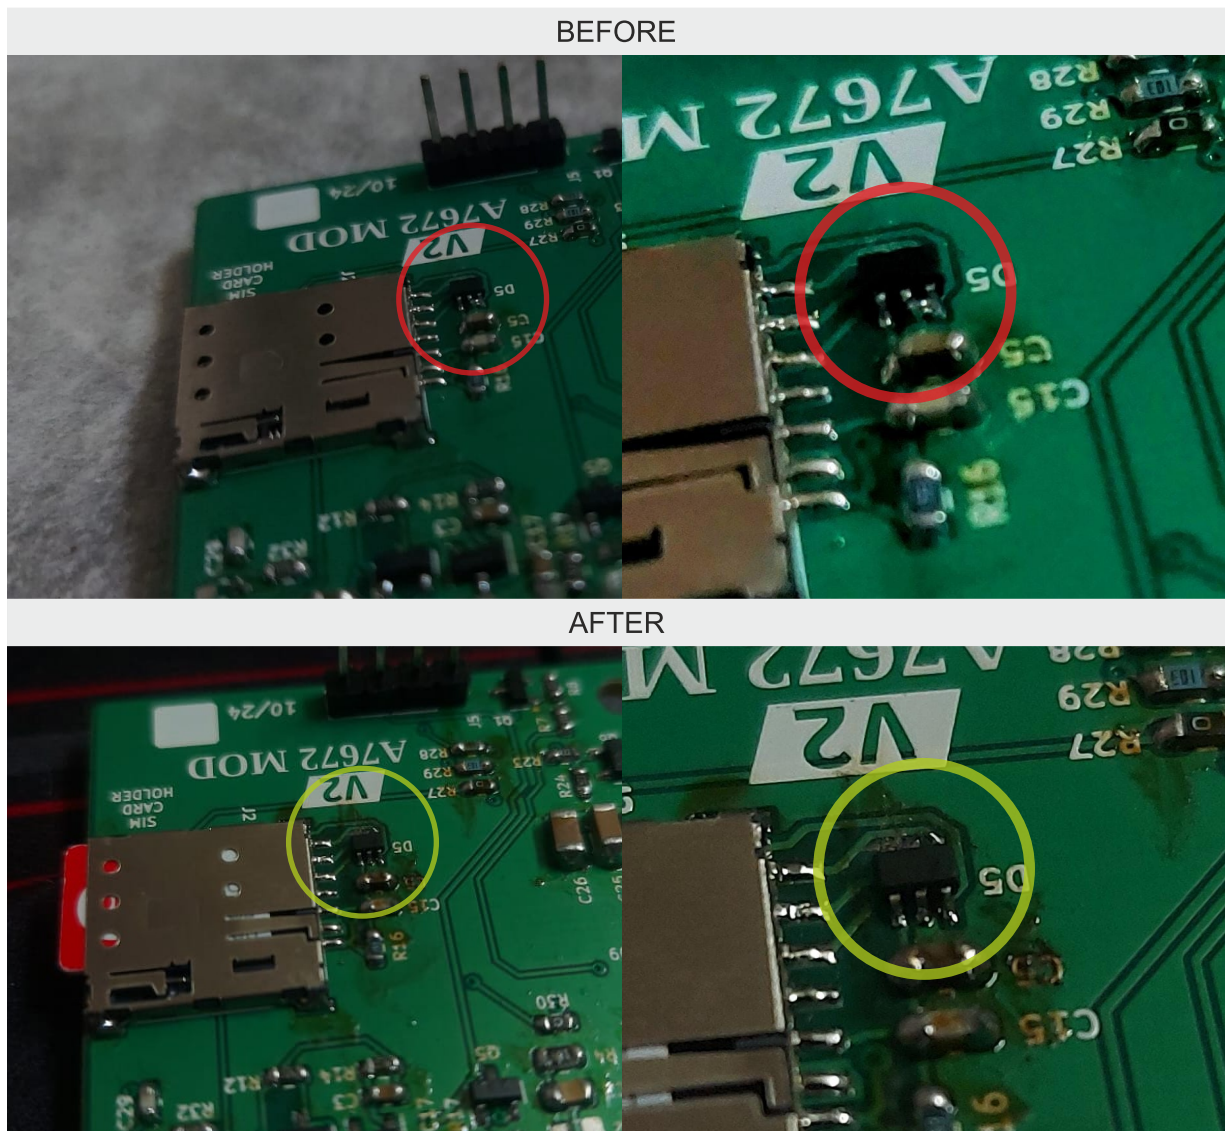
I tried multiple codes and uploaded them to different microcontrollers, but nothing worked. Then, I began inspecting hardware's each component using my soldering station's magnifying glass and discovered that two pads of the transient **voltage suppression (TVS)** diode (**ESDA6V1-5SC6**)—specifically, **IO2** and **GND** - were soldered together, causing the SIM error. Here are the attached images showing the issue before and after the fix.
