On-site investigation and analysis of flaking damage leading to rail break

Hiroyuki Matsuda^{a,*}, Yukio Satoh^b, Yoshikazu Kanematsu^b, Kengo Iwafuchi^b

In order to know the relationship between the occurrence of flaking leading to the rail breakage and wear of the rail, on-site investigations and analysis of the broken rail were carried out. As a result, it was found out that the occurrence rate of the flaking damage was high at gauge corner side of high rail in moderate curves with radius from 800 m to 1800 m. It was also found that the rail wear in the section where lubrication was applied was about a half of that in the section without lubrication. Moreover, it was found that flaking damage was generated on the running surface or in the close vicinity of the surface of rail head under the condition of repeated loading of shear and tangential forces caused by the rolling contact with wheels. It could be assumed that the balance between the wear and the accumulation of micro-strain or fatigue was a key to occur the flaking damage.

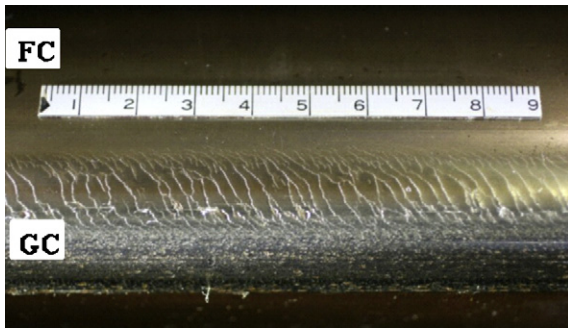
Fig. 1. Headcheck.

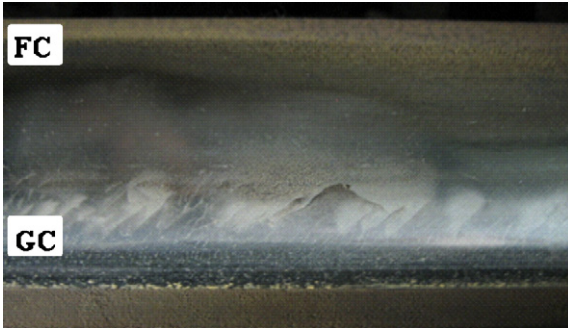
Fig. 2. Gauge corner cracking.

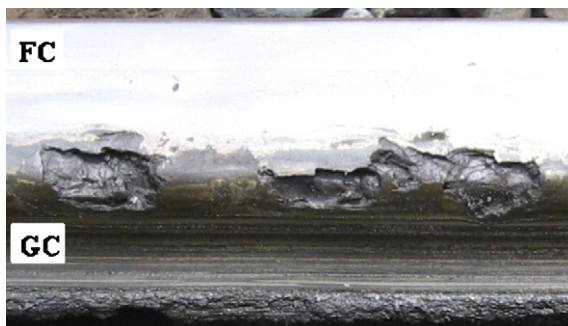
Fig. 3. Flaking.

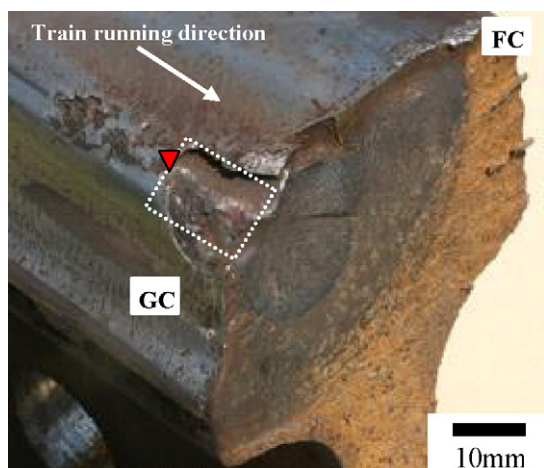
Fig. 6. Appearance of the flaking damage.

Fig. 6 shows the appearance of the rail in question. Delaminations were observed on GC side at the position with the smallest radius of curvature of rail head. Headcheck occurred on the running surface between the delamination and the rail center. Lubrication oil adhered uniformly on the surface of side wear and the rolling contact band on the running surface.

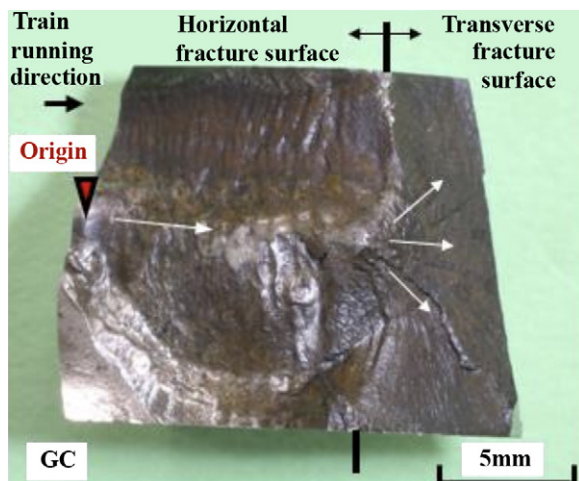
The fracture surface around the origin of the crack is shown in Fig. 7. This was the area surrounded with a rectangle box in Fig. 6 observed from an upper point obliquely downward. Though details of the fractographic pattern on the fracture surface were lost by repeated contacts between surfaces of the crack, it was possible to estimate the fracture type and the propagation path by visual observation of the remaining macroscopic fractographic characteristics. The propagation path of the crack was estimated through the visual observation. A point on GC side of rail shown with red arrow in Fig. 7 could be regarded as the origin of the crack. At the point, the radius of curvature was smallest in the geometrical shape of 60 kg rail. In the initial stage, cracks occurred and propagated toward the train

Fig. 7. Fracture surface around the origin of crack.

running direction keeping their fracture surfaces almost parallel to the running surface and the side surface of rail. The cracks branched in the succeeding stage. The crack parallel to the side surface propagated continuously in the subsurface of GC and resulted in the delaminations. On the other hand, the crack parallel to the running surface propagated and branched downwardly to the bottom forming the transverse crack that was the cause of the rail break.

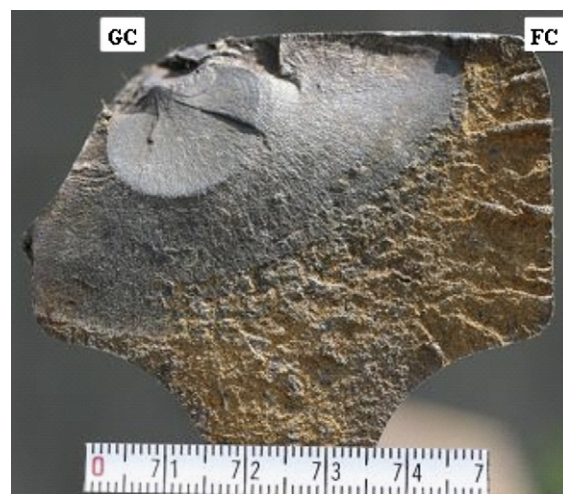
Fig. 8. Fracture surface of branched transverse crack.

Fig. 8 shows the transverse fracture surface. The brown-black area was regarded as a fatigue fracture surface. On the oval area with relatively smooth surface near GC, beach-mark that was a typical pattern of the fatigue fracture surface could be identified. Based on the evidence, it was considered that the fatigue crack propagated moderately in this area. The area that was surrounding the oval fatigue fracture surface seemed less smooth than the inner oval area. It meant that the propagation rate gradually increased with the growth of the fatigue crack. The crack propagated rapidly through the brown area that was surrounding the brown-black area giving a very rough fracture surface. Taking the surface patterns described above into consideration, after the branching from the horizontal crack, the transverse crack propagated very slowly as a fatigue crack at the first stage, then it extended continuously increasing the propagation rate gradually, finally the crack propagated rapidly to the bottom as a brittle crack breaking the rail.

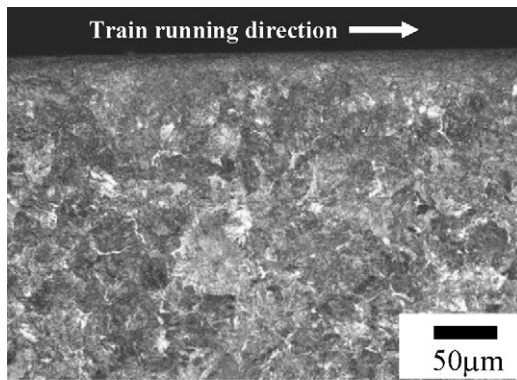
(1) 15mm to FC side from the rail center

The direction of the plastic flow was opposite from the train direction at the observation points on GC side. On the other hand, the direction of the flow was same to the train direction at the points on FC side. In Fig. 13, examples of the observation of the plastic flow in the metallographic structure of the rail center, the position of the origin of the flaking (17 mm to GC side from the rail center), and a position near FC side (15 mm to FC side from the rail center) were given.

Fig. 13. Metallographic structure of plastic flow.

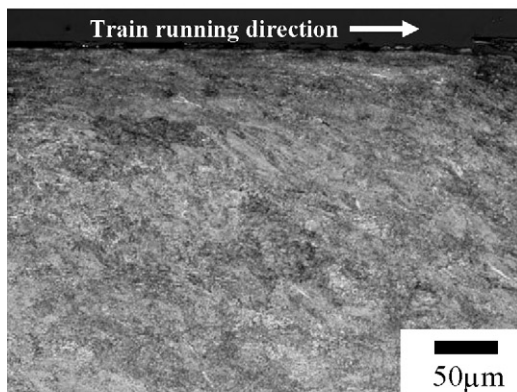
(3) 17mm to GC side from the rail center

Comparison of the plastic flow directions at the observation points from GC side to FC side showed the inversion of the flow direction that was generally observed in the rail used at tangent track. As mentioned above, the depth of the plastic flow layer increased gradually from the rail center toward both of FC and GC sides. Large value of the depth of the flow layer meant that the tangential force acting on the point in question was large. Taking the depth of the flow layer into account, it was possible to think that the condition for the generation of the flaking damage crack could be prepared by the repeated rolling contact of wheel at GC side.
