DOCKING PROGRESS REPORT – Day 10	
Ship Name	GAS NURI ARIZONA
Type of Docking	INTERMEDIATE SURVEY V
Location	Semarang
Main Contractor	PT . YWTS
Date	20 July 2018

PHOTO REPORT

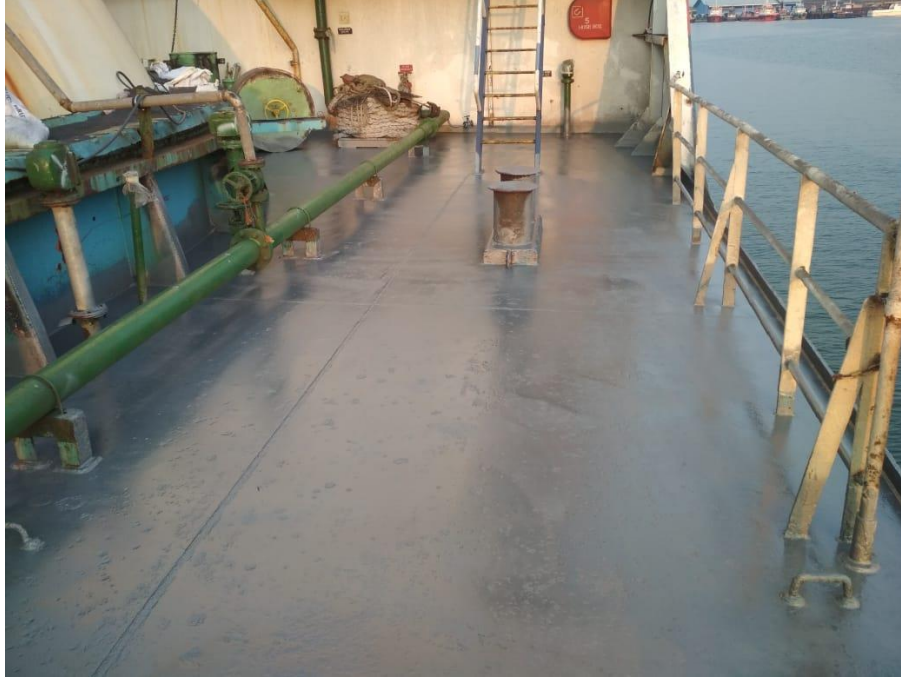
Main deck after application first layer anti corrosive paint

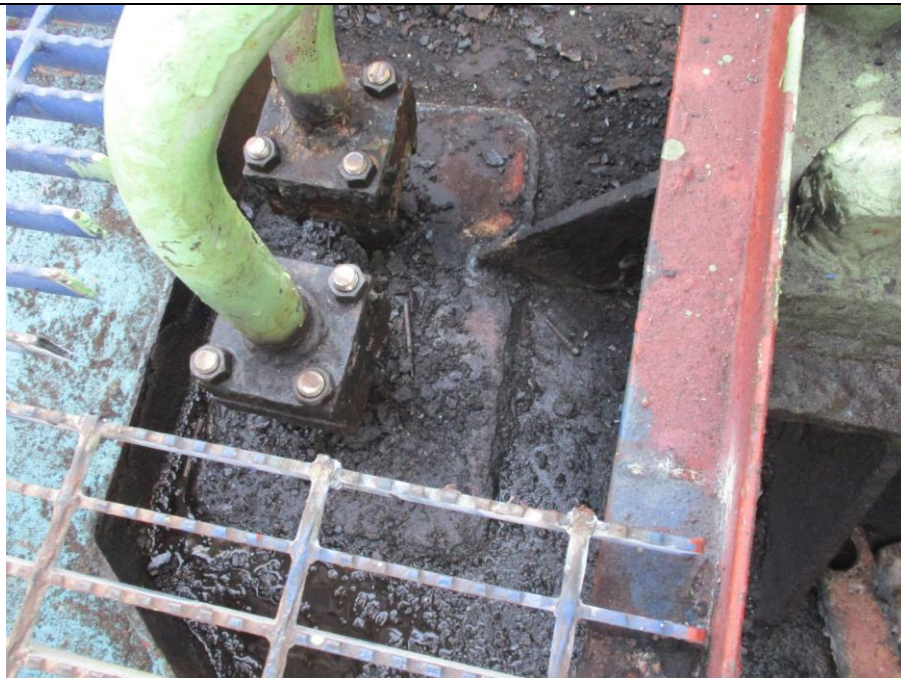
Windlass hydraulic pipe has been renewed

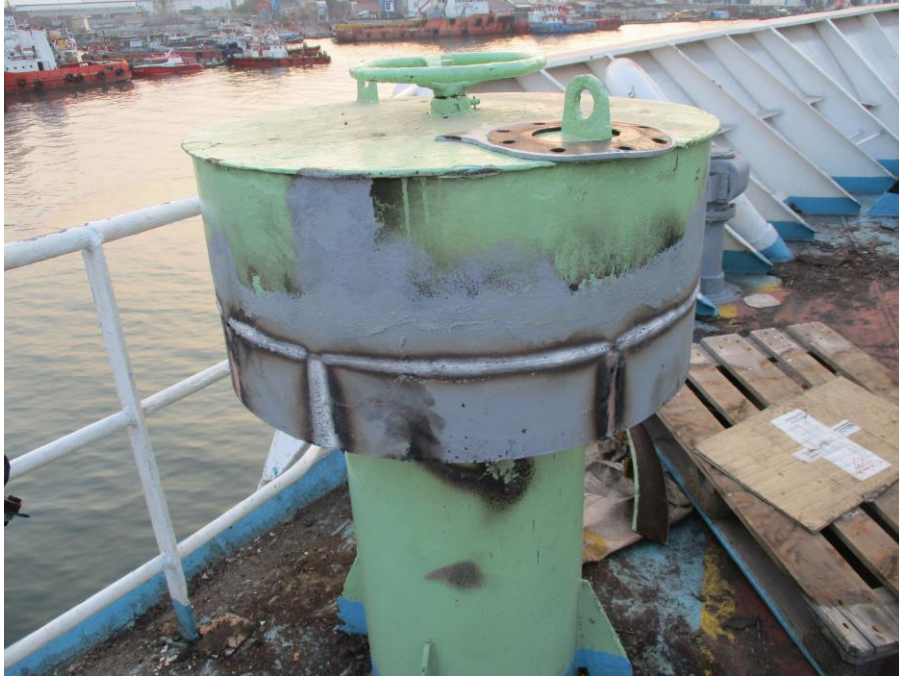
Forecastle blower fan has been reinstalled after repair

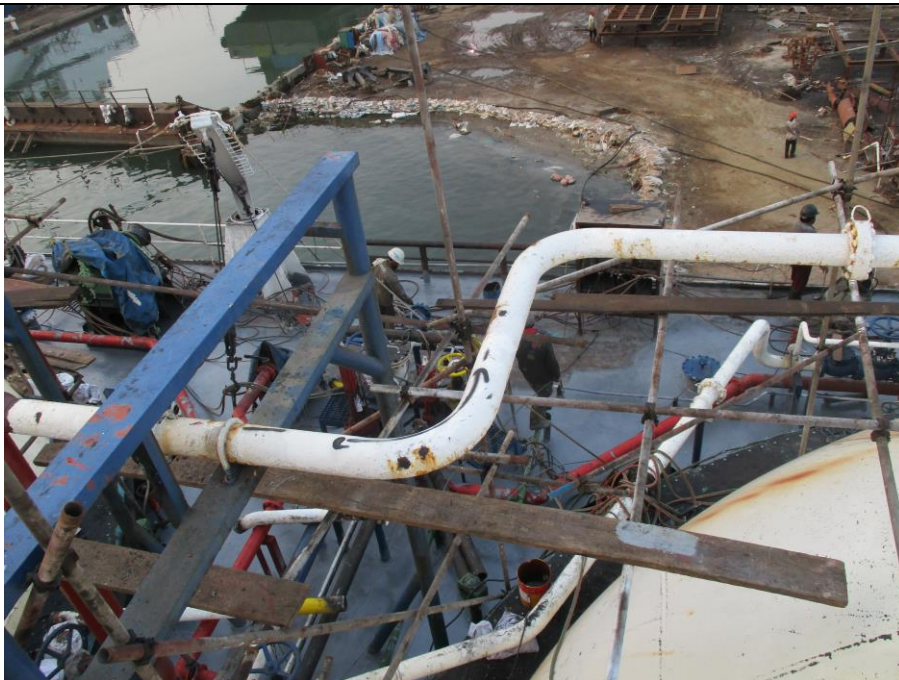
Installation staging to dismantle cargo pipe

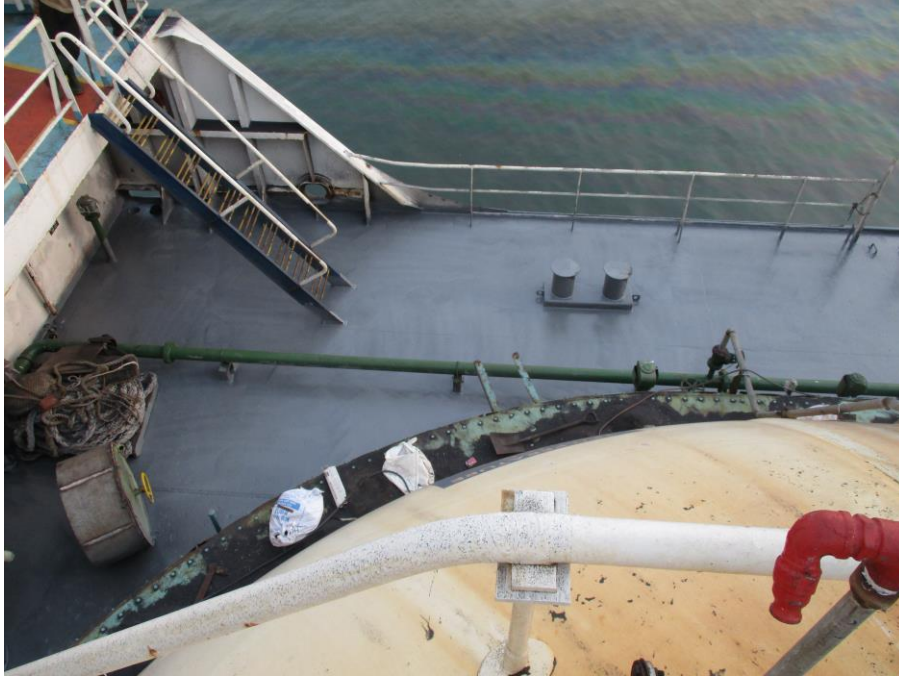
Main deck after application first layer anti corrosive paint

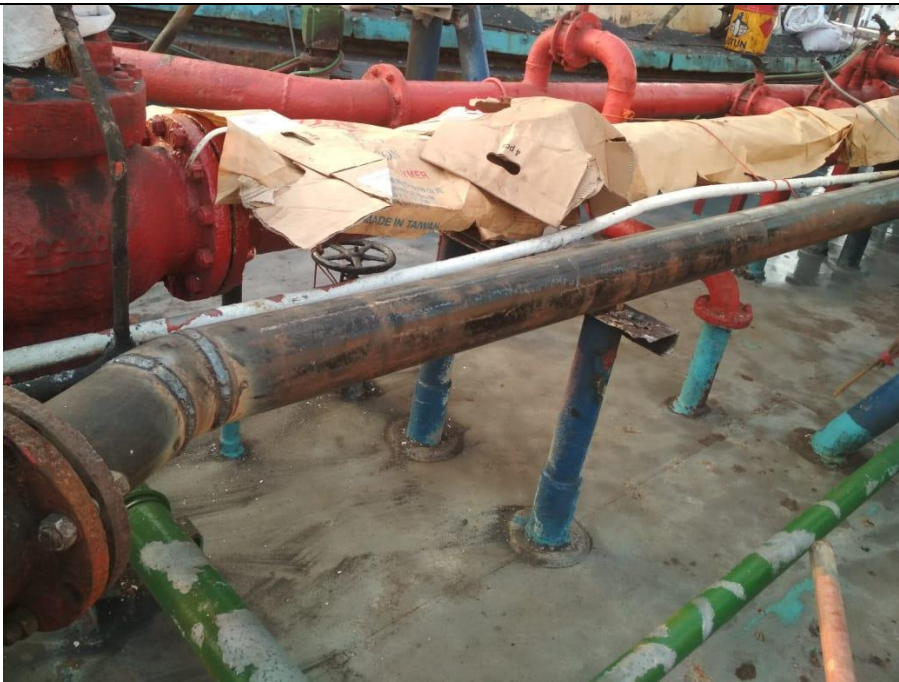
Bunker pipe line has been renewed

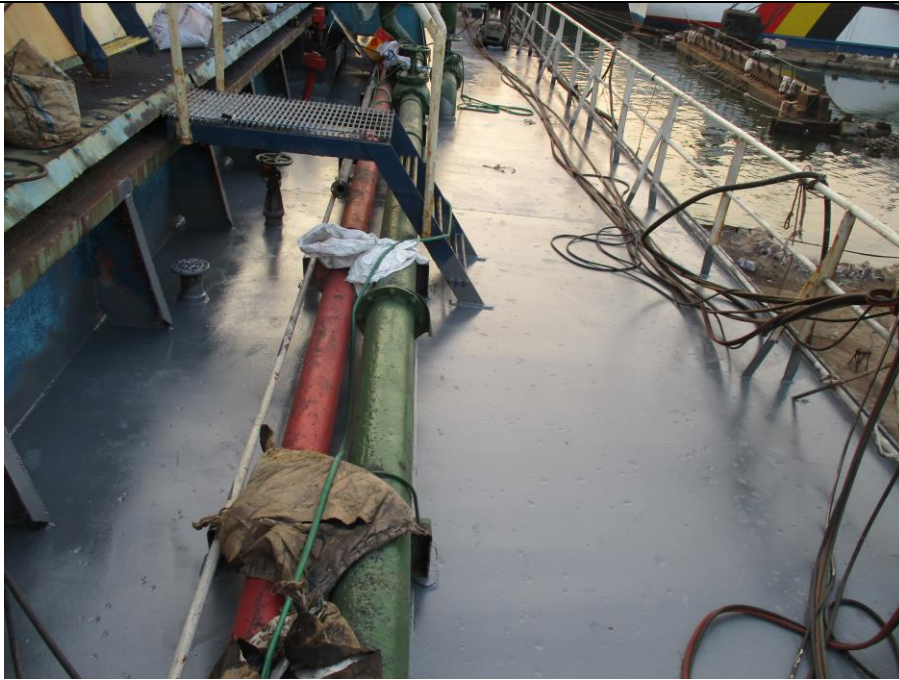
Main deck after application first layer anti corrosive paint

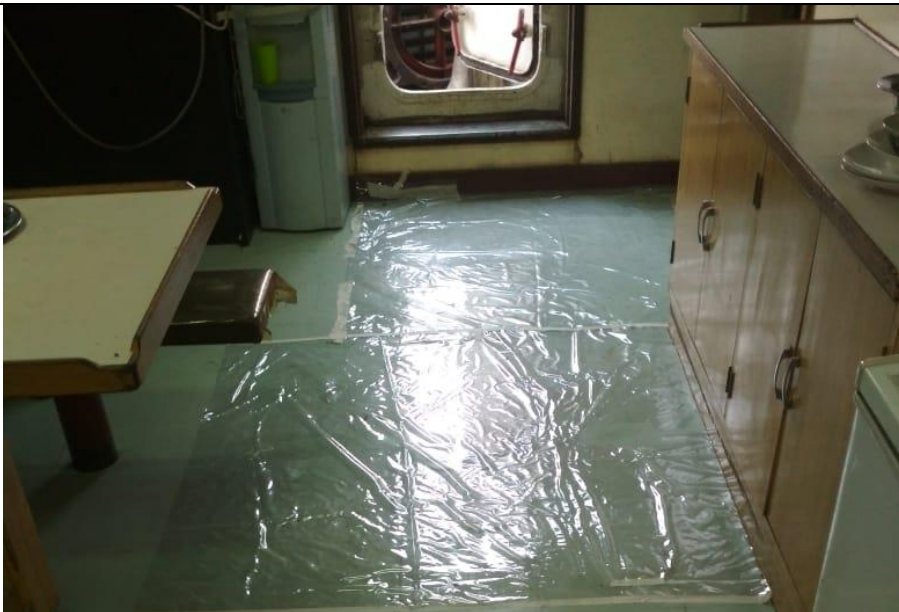
In progress renew vinyl floor in mess room
