# Quality Report of Yacht Sanding

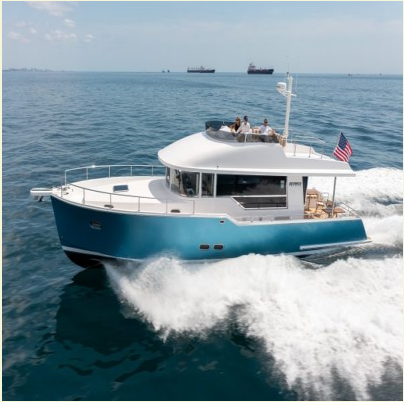
ID: 1 roughness: 2.47 readyToPaint: false

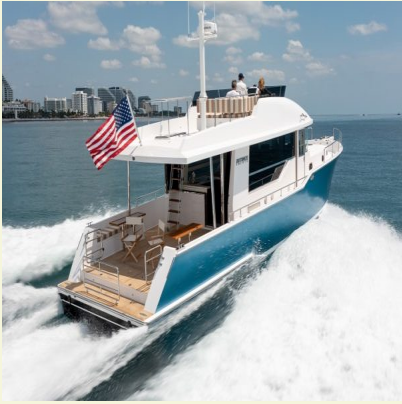
ID: 2  
roughness: 2.76  
readyToPaint: true

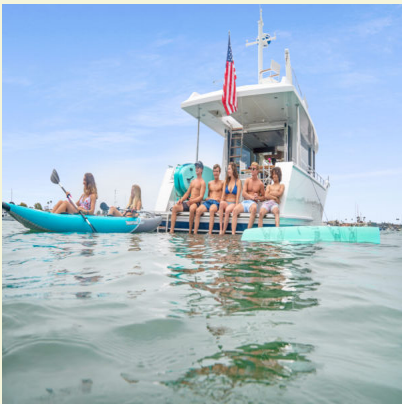
ID: 3  
roughness: 2.68  
readyToPaint: true

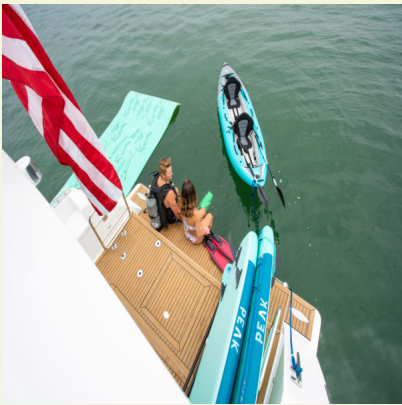
ID: 4  
roughness: 2.2  
readyToPaint: false

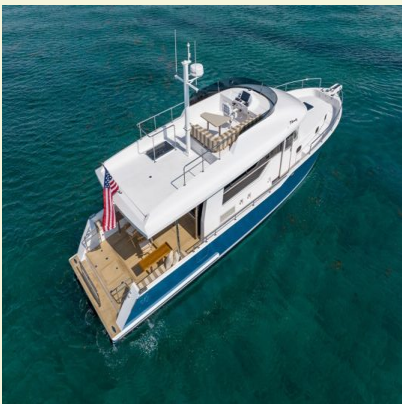
ID: 5  
roughness: 2.39  
readyToPaint: false
