PCB V5 ADC Problems

Matthew Collins

July 3, 2014

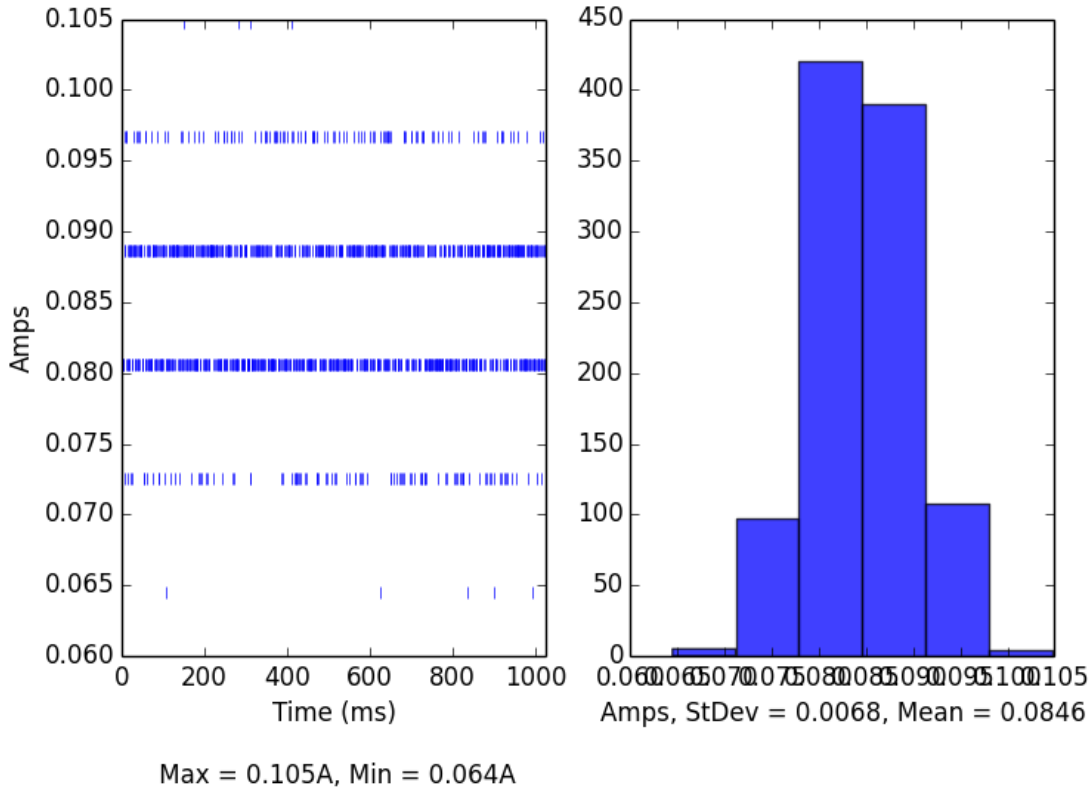
The issue at hand is that there is a floating offset present in the measured current value from the chip. At zero current, the measured current should be zero; however, this is not the case. When the ADC is read using the read ADC function (found in ADC.c) and the CurrentSensorPlotter.py python function that plots and average the current values, at zero current a value of about .05 to .08A is obtained. This can be seen in Figure 1. Additionally, it can also be seen that there is a wide variability for the ADC readings.

Figure 1: ADC Reading at Zero Current

It should be noted that for a while the measured current falls within an 8mA range, i.e. if the first reading gives a value of .085A, the next measurements for a while will have a minimum and maximum value that falls within 8mA. This is not an issue for the resolution of the current sensor is 8mA/ADC count, thus this falls within the expected range.

The error seen on the ADC was not due to any board or code issue. The problem lays within the chip itself. The chip being used has a typical offset voltage of plus or minus 11mV, as seen in Figure 2.

This voltage offset for the chip when it is at zero current explains the values that have been experimentally found. With the .8mV/ADC resolution of the dsPIC, a voltage of 11mV corresponds to 13.75 ADC counts. When the calculation is taken further with the 100mV/A current slope of the chip, the typical offset range of the chip will fall between -.11A to .11A. This new found discovery provides evidence that although the reading in Figure 1 is not around 0A as anticipated, it proves that the readings are in fact correct as all the readings fall within the voltage offset range.

One solution is to have the ADC do some number of reads upon initialization within zero current to set the average offset which will be used as a baseline to compare the current values. Due to the wide range that the offset can have, this solution will not entirely eliminate the error, but it will reduce it.

Since the current can also "float" within that range, it may change and alter the current readings as the average value calculated at initialization no longer fits. To combat this, after prolonged inactivity, the current average can be recalculated to make sure it represents the values being read at that time and provides a more reliable and accurate current measurement with which to use for the internal calculations.

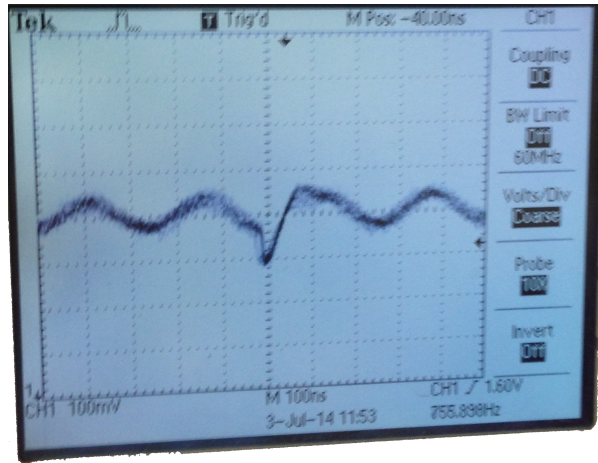
Figure 3: Oscilloscope Reading of Current Sensor Voltage Output at Zero Current

A reading from the oscilloscope of the output voltage from the current sensor at zero current can be seen in Figure 3. The voltage seems to oscillate within in a range of 100mV or so. This value falls within the current limits due to the quiescent voltage offset.
