Campaign 4

Problems & Resolutions

UF Stan Mayfield Biorefinery Pilot Plant

Prepared by Joe Sagues, Director of Operations

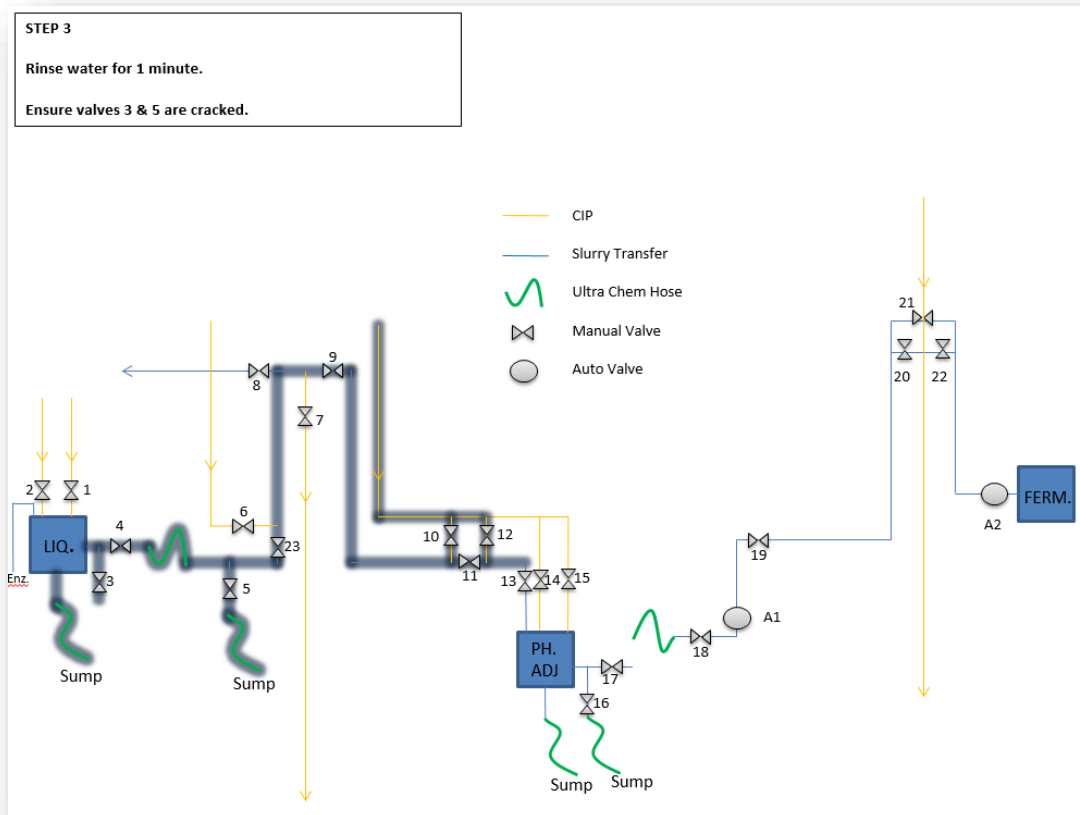
During Campaign 4, contamination was evident in the fermentation. It was most likely due to a residual pocket of slurry from Campaign 3. The pocket was in the middle of the transfer line between the liquefaction and pH adjustment tanks.

A new, much more comprehensive CIP/SIP procedure. Transfer lines, including tough pockets and dead ends, will now be cleaned and sterilized. Our new Quick Procedures (QPs) supplement our SOPs to enable a quick and proper CIP/SIP once a campaign is over.

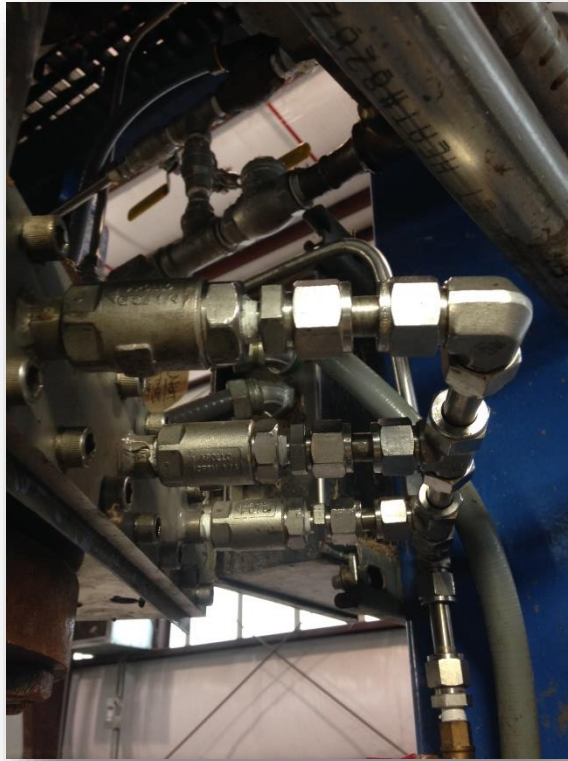
During Campaign 4, the bottom knife gate valve started leaking pressure near the end of its required run time. This was due to biomass clogging the insertion space. Our three-port blow-out was not working well enough.

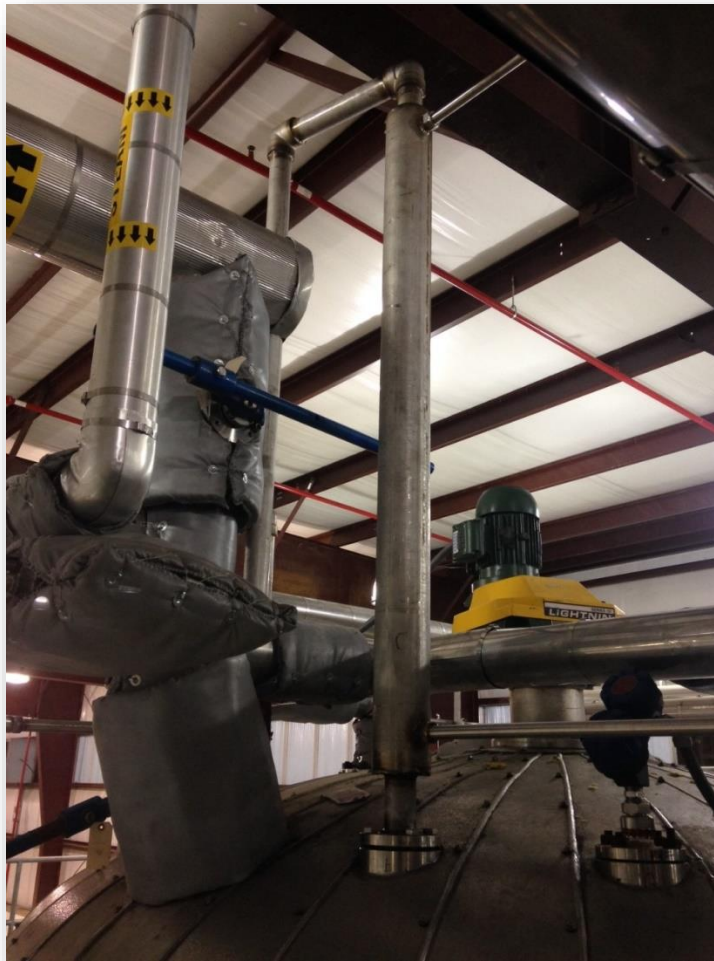
During all previous Campaigns, sparging and air injection into the head space likely blew some ethanol out the vent of the fermentor.

A shell and tube condensing tower for the fermentor was fabricated at our own workshop.
