Campaign 2

Problems & Resolutions

UF Stan Mayfield Biorefinery Pilot Plant

Prepared by Joe Sagues, Director of Operations

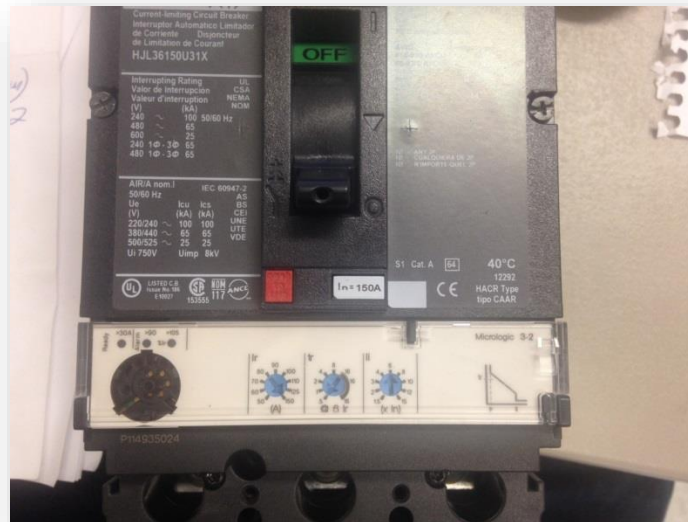
Prior to Campaign 2, the air compressor breakers in the MCC were tripping frequently. It caused disturbance in pre-Campaign preparation. The breakers were 150A non-adjustable instantaneous with a thermo-magnetic trigger. The operating amperage for the compressors is around 100 A, but on startup there is an in-rush up to 300-400 A. This high in-rush was just barely over the allowable limit of the breaker. Sometimes it would trip, sometimes it would not.

Initially, we bought new 250A breakers to solve the problem, but we then realized the wiring was rated for a maximum amperage under 250A. Our next best option was to replace the original breakers with 150A adjustable instantaneous breakers.

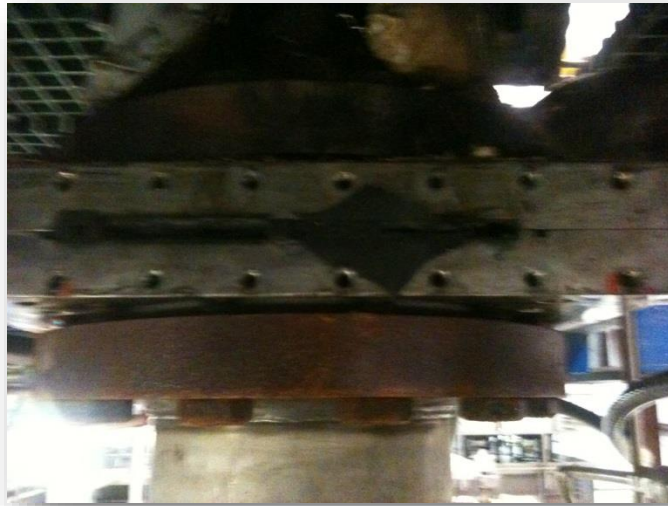
Prior to Campaign 2, the gasket for back plate on the bottom knife gate blew out during operation. The reason for the blow out was because an operator changed the material without notifying an engineer/supervisor. The material which was used was not rated for such high temperatures.

Not resolved. The replacement AFLAS gasket melted and clogged up the knife gate insertion spaces.

A replacement gasket material made of AFLAS was bought and installed. This material was specified by the valve company. The operator was instructed to never install something without first letting a supervisor know.

A new gasket material made of high temp/high pressure silicone was bought and installed. This material worked, but it was thick and spongy which made it difficult to install.
