Campaign 7

Problems & Resolutions

UF Stan Mayfield Biorefinery Pilot Plant

Campaign Date: December 2014

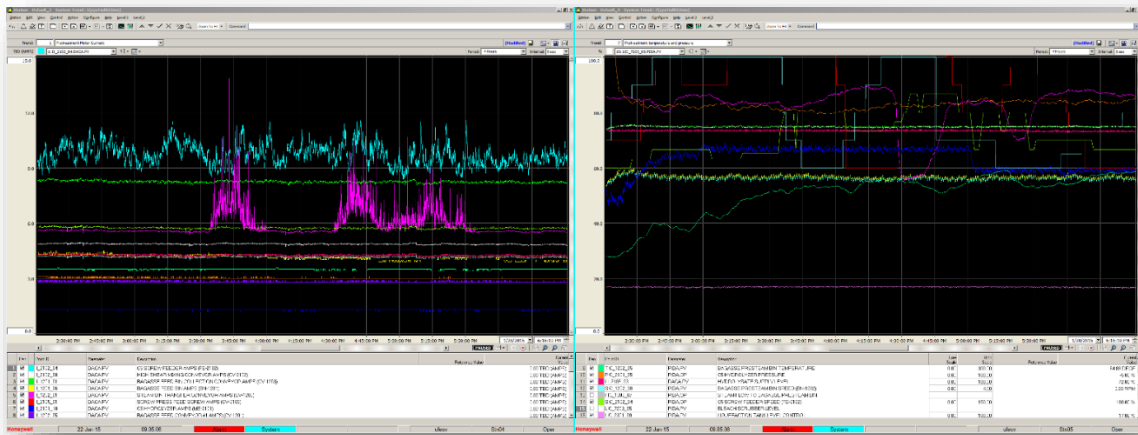
After close evaluation of trends, it was discovered that on some occasions of clogging, the pre-steam bin level suddenly dropped immediately prior to clogging. This led to the conclusion that level fluctuations in the pre-steam bin might cause biomass flow rate surging. The image below shows two trend screens which show amperages (left) and levels (right) at the same times. The pink spikes on the left correspond to the transfer conveyor amperage, and the pink line on the right corresponds to the pre-steam bin level. As can be seen, there is now level drop prior to the first instance of amperage spiking, but there is a significant level drop prior to the second instance of amperage spiking. It was decided that modifying the agitation in the pre-steam bin might prevent these sudden changes in level.

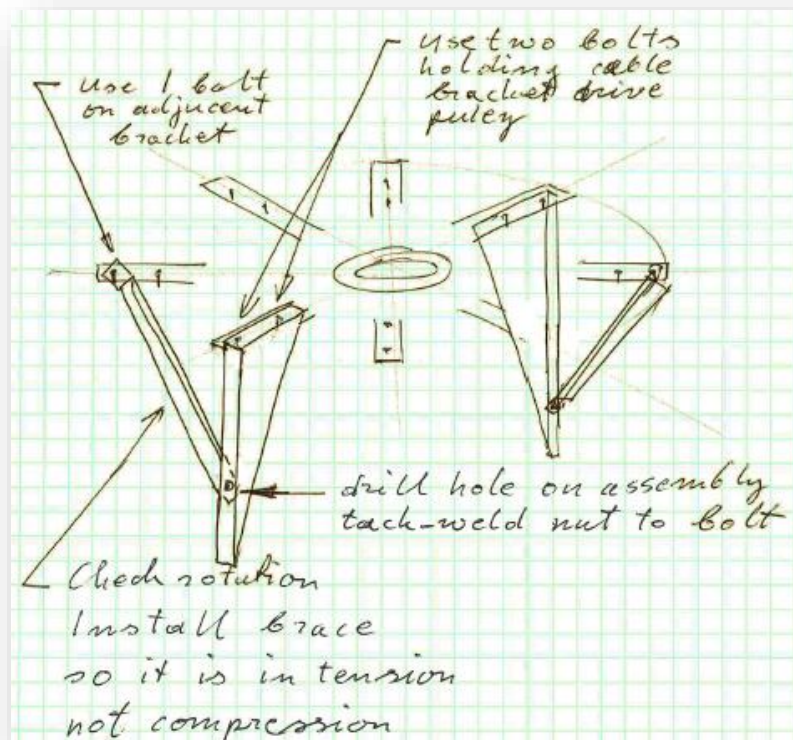
The original agitator consisted of two arms, see drawing below. After Campaign 7, it was decided to modify the agitator by installing a paddle between each arm. A live action camera was then installed to watch the inside of the bin during operation. If the paddle doesn't solve the problem, the camera will help us identify the problem during Campaign 8.

Original agitator.

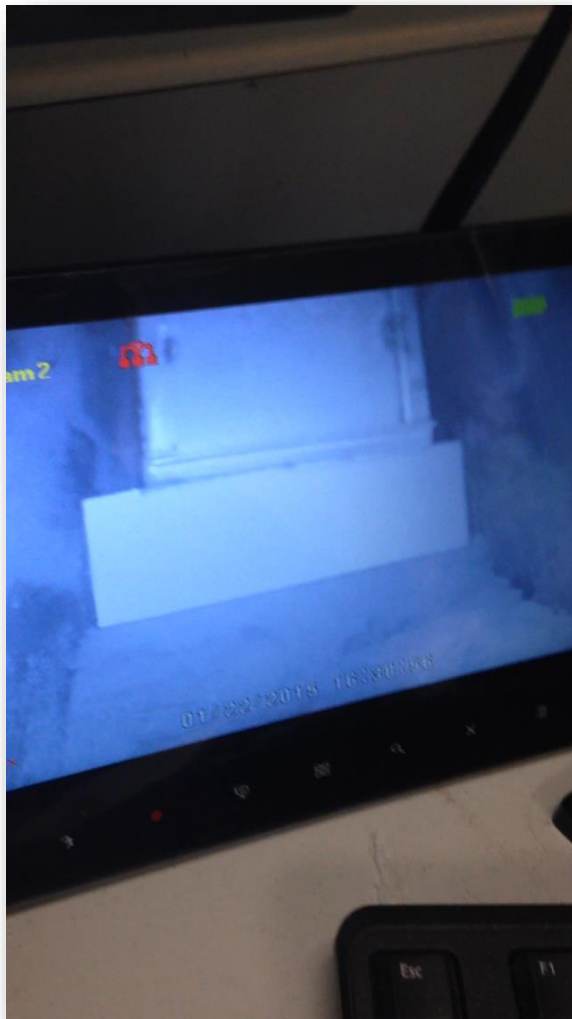
An image of the modified agitator taken from the live action camera.

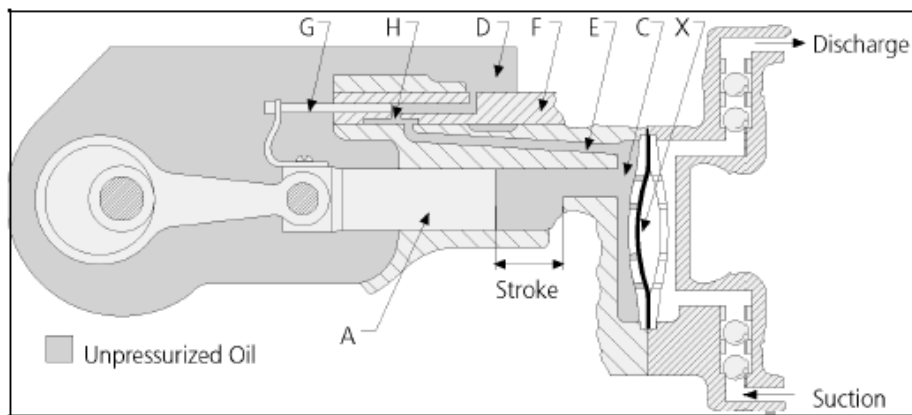
Figure 1. Pump Operation With By-Pass Port Open

The phosphoric acid addition pump for the pretreatment system stopped working. The oil appeared to be mixed with water, which led us to believe that the diaphragm ruptured. However, upon inspection, the diaphragm was found to be fine, but the plunger arm was missing. The plunger arm (part G) is needed to prevent oil from discharging through the bypass port while the diaphragm is pressurizing. It's essential for proper operation.

- New BBD seals (made on 12/10/2014 – 6-to-8-week lead time (Danielle should confirm the lead time)).
- Rebuild kit for our acid pump.
- New bearings and oil seal for reversing conveyor motor adapter kit (bought from Dennis from Miller Bearings)
- Vibco BVS 250 vibrator (190 was returned).
- A bunch of spare fittings to have in the plant.
