Campaign 8

Operations Summary

Stan Mayfield Biorefinery Cellulosic Research and Demonstration Plant

Prepared by Joe Sagues, Director of Operations
04/15/2015

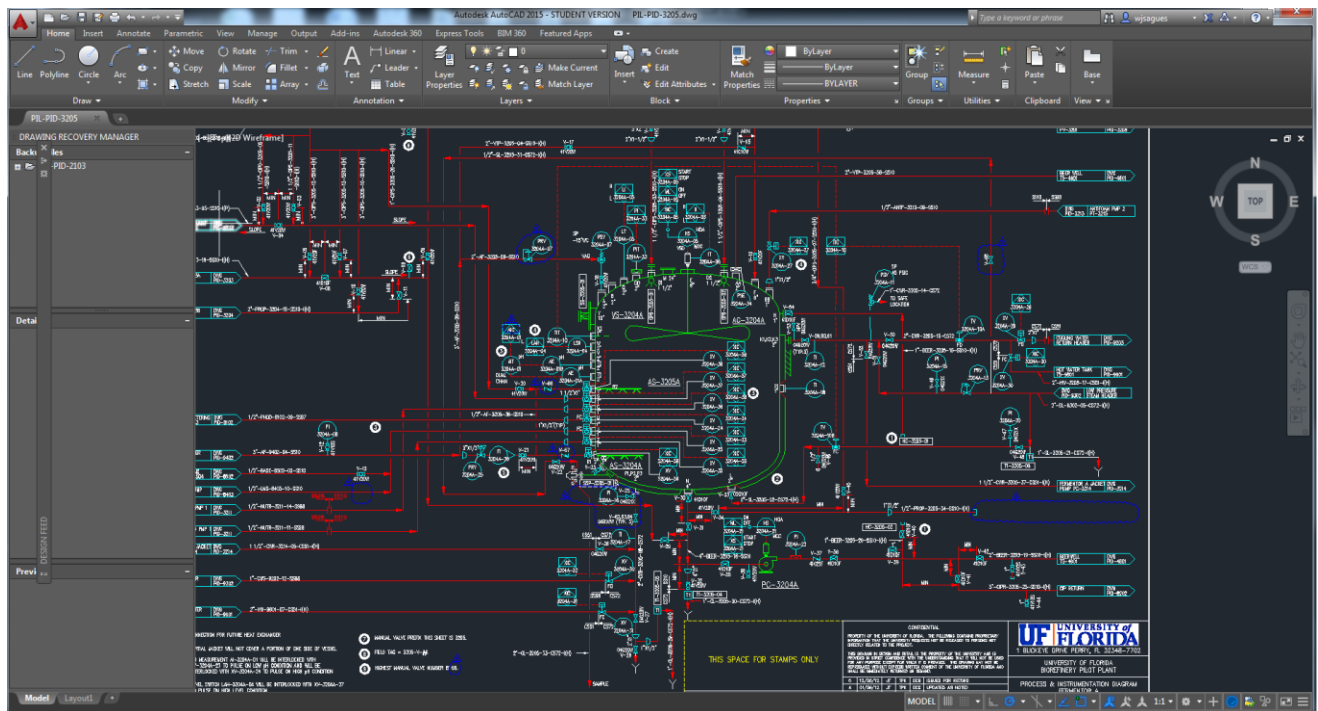
1. Inaccurate Piping and Instrumentation Diagrams (PIDs)
 - Problem:
 - There are many misrepresented process components in the PIDs supplied to us by the process design engineering firm. The major discrepancies are original valves and steam traps, as well as the modifications to the process which were done after the plant was fully constructed.
 - Resolution:
 - We have been asking the process design engineering firm for copies of the original autocad files for over a year. We finally received the files, so we are now modifying them to reflect the actual piping and instrumentation in the field. The screenshot below shows work being done by a process engineer at the biorefinery.

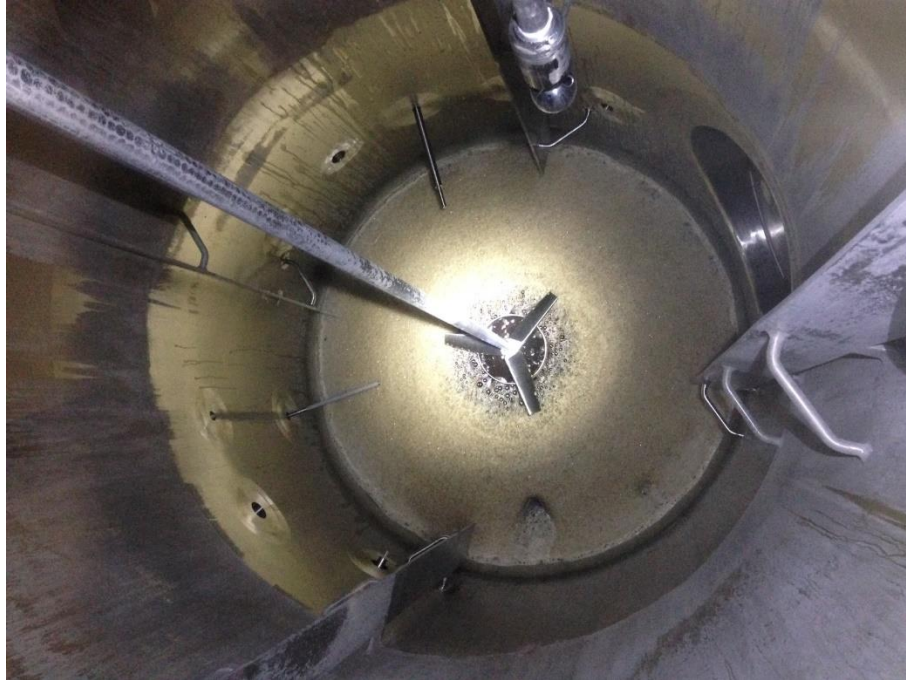
- Status:
 - Resolved. See the “Campaign 12 Operations Summary” for current status.
- 5. Propagator 3 slurry fermentation
 - Problem:
 - No growth, and the reason was likely due to the inoculation method used. Once the 40 gallon seed in each propagator 2 was ready, we transferred it into an empty propagator 3 and then added slurry on top of it at a slow rate. The image below is of the 40 gallons before slurry was added. There was no nutrient addition, mixing or pH adjustment for an extended length of time (about an hour), and this likely led to the cells dying out.

- Another possibility for no growth was the higher toxicity of the 190C slurry.
 - Resolution:
 - Add slurry to the propagator 3’s prior to transfer, such that at time of inoculation there is pH control and agitation.

- This plan ended up not working either, as is evident in the subsequent operations summaries.
 - Reduce harshness of pretreatment by reducing the temperature from 190 to 185C.

- This plan ended up not working either, as is evident in the subsequent operations summaries.
 - Status:
 - Not resolved. More information in subsequent campaigns.

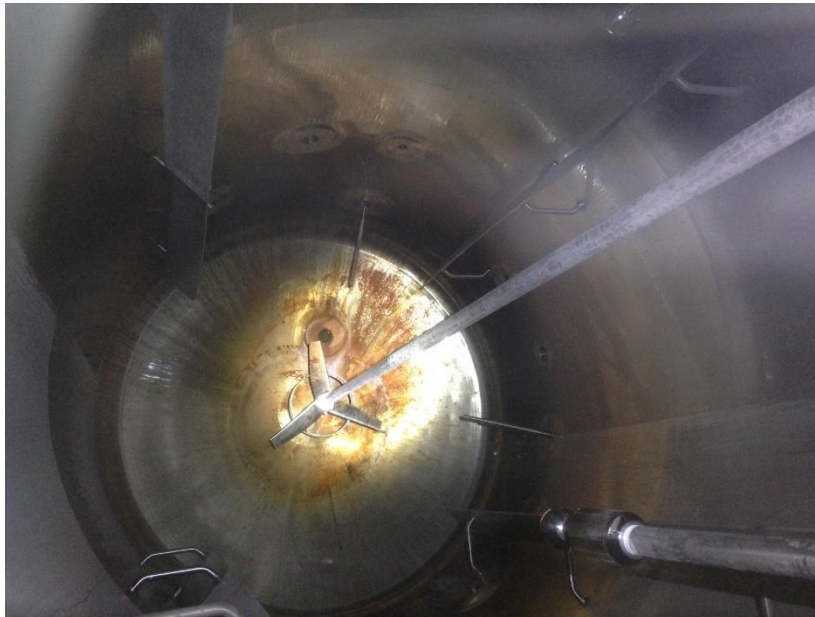
8. Propagator 3A steam pipe corrosion

- During SIP of propagator 3A, old stagnant corrosion from the steam supply line caked itself onto the bottom surface of the tank (see image). This tank had not been sterilized for many months, therefore the steam line had not been used for many months. The corrosion would not have been an issue if there was a steam trap and drain installed in the steam line.

- Install a steam trap in the line or regularly clear the line out.

- A steam trap has not been installed but we are routinely clearing the line.
