# **Campaign 9**

## **Operations Summary**

### **Stan Mayfield Biorefinery Cellulosic Research and Demonstration Plant**

Prepared by Joe Sagues, Director of Operations  
04/15/2015

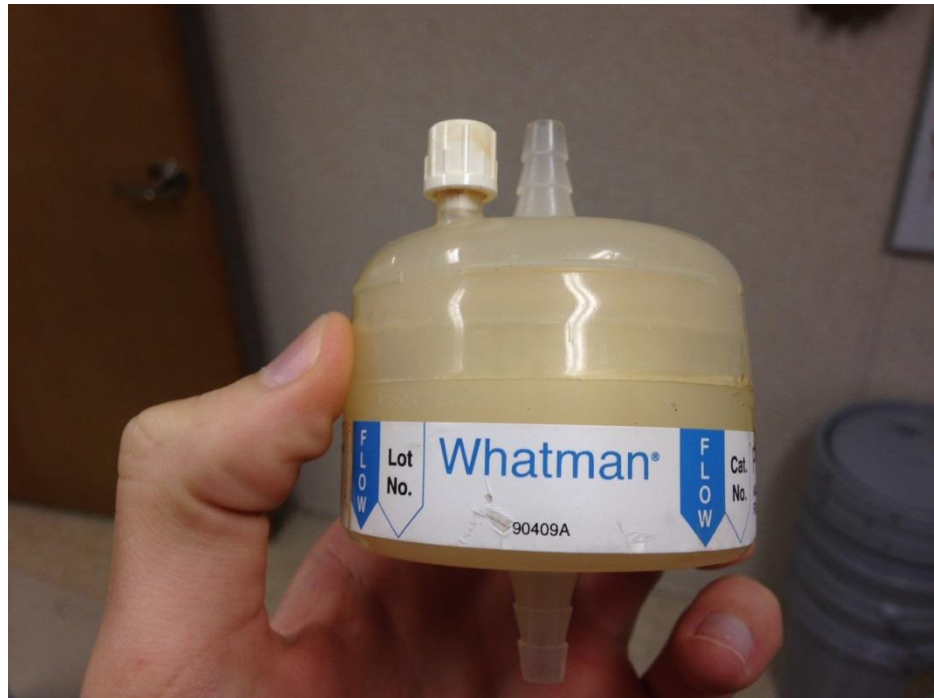
4. Sterile filters for venting

- i. We had purchased several small, reusable sterile filters to see if they could be used for our propagation tanks. The idea was that we could use these instead of the bleach scrubber pump during the initial propagation stages of a campaign, and therefore overnight personnel would not be needed. Unfortunately, the moisture in the vented air slowly clogged the filters to the point where they vented too slowly.

- b. Resolution:
          - i. A resolution is not possible with the current filters, however, operations changed in subsequent campaigns such that night shift personnel is needed during the propagation stages.
