Campaign 12

Operations Summary

Stan Mayfield Biorefinery Cellulosic Research and Demonstration Plant

Prepared by Joe Sagues, Director of Operations
04/15/2015

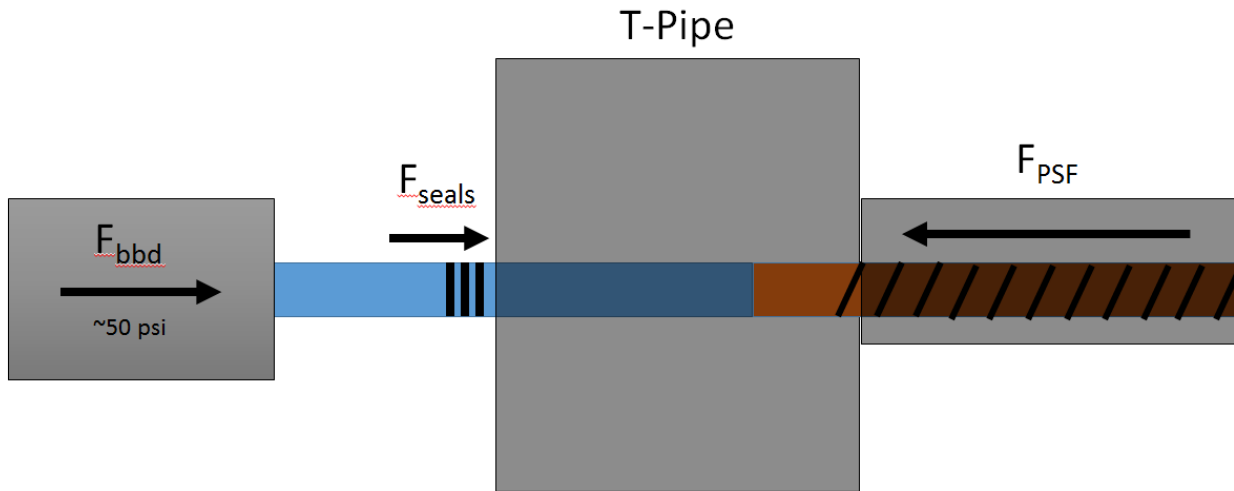
- ii. The plug screw wears over time due to the friction force from the plug created by the blow back dampner, but we considered a couple other possible forces which might have contributed to the rapid wear of the plug screw. For one, the seals around the blow back dampner shaft seem to expand when really hot which gives a friction force against the shaft. The blow back dampner shaft is

quick to respond when the system is cool, but it is very slow when the system is hot and the seals have expanded. This friction force from the seals on the shaft might add to the total force the plug screw is experiencing. See the free-body diagram below. The second possible contribution to wear is the effect vibrations from the mechanical vibrator have on the screw. The plug screw surely feels the vibrations because all surrounding metal does, and maybe these vibrations in the plug cause the biomass to act like a sander power tool on the flights.

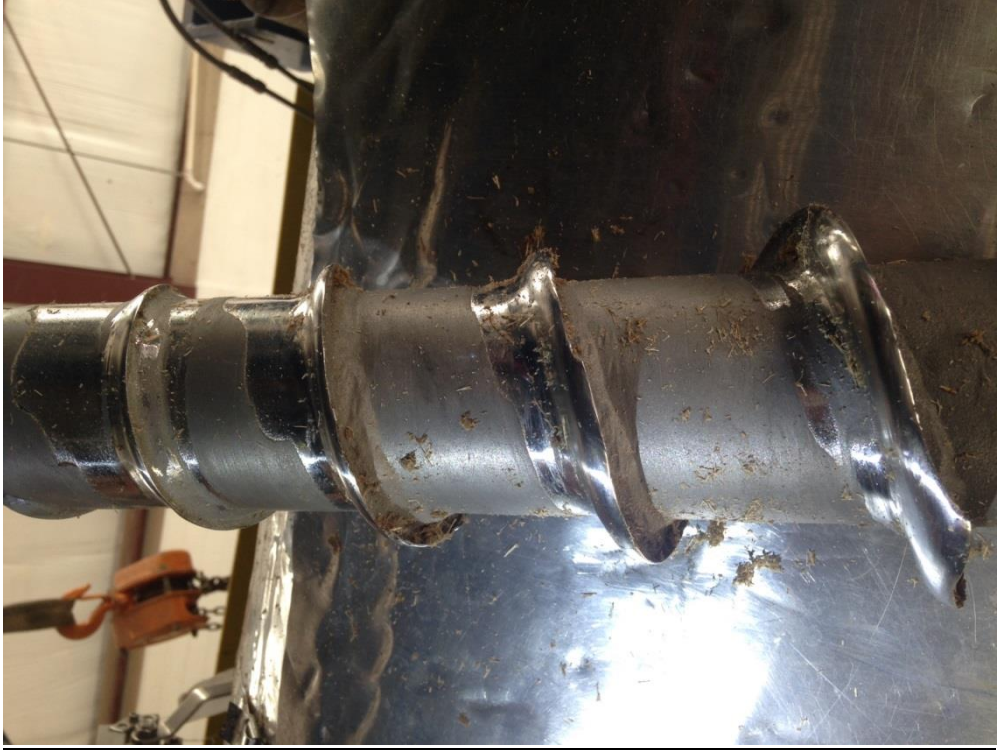
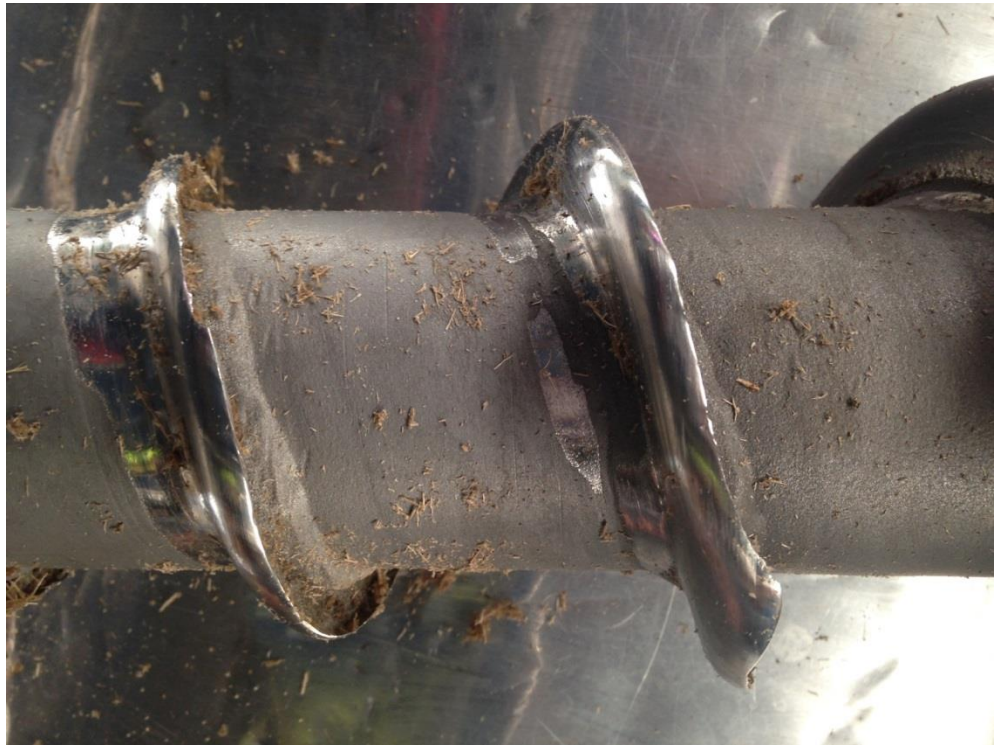
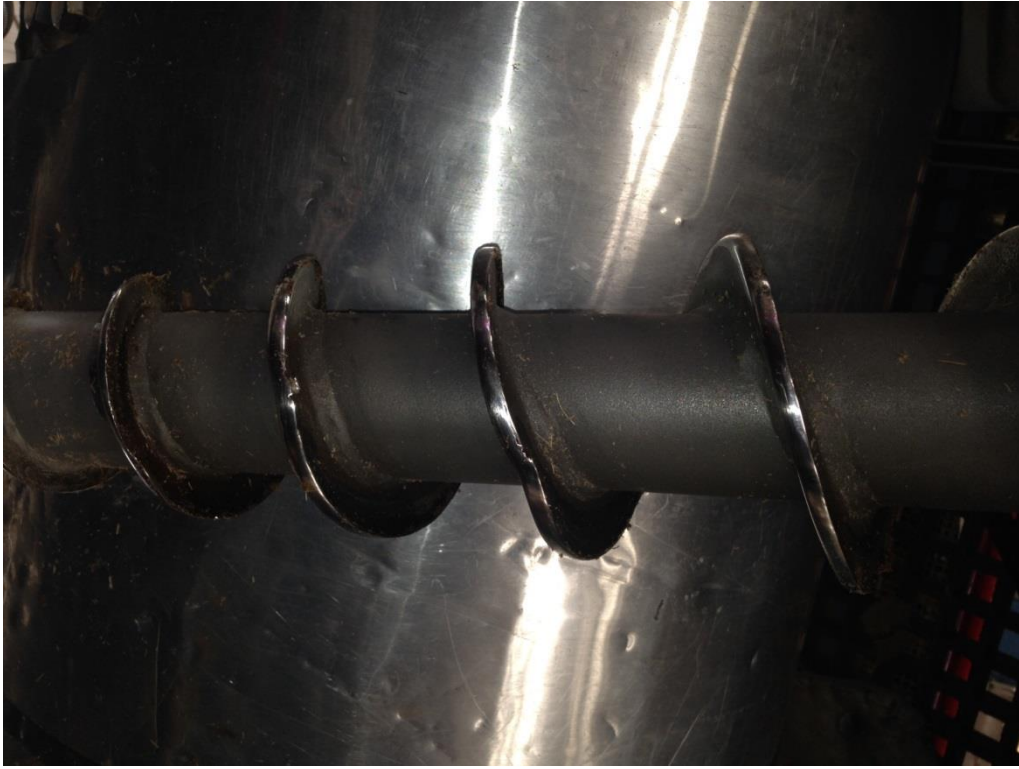
1. Pretreatment chute clogging and worn plug screw
 - a. Problem:
 - i. The chute clogging has been a reoccurring problem for several months, but we believe we finally know the reason. We had to run the speed of the plug screw at a much higher speed than usual during this campaign, indicating that the flights had worn. See past operation summaries for further detail into what the implications of a clogged chute are.

- b. Resolution:
 - i. The plug screw is worn out again. See pictures below. We had put about 1000 hours on the screw since we got it resurfaced. The worn flights likely do not move the biomass uniformly which causes the biomass to back up and clog the chute. We had originally thought that if the clogging was from a worn plug screw, it would be evident from the amps, but apparently it was not. We had been hesitant to remove the screw because we were worried of damaging equipment in the process, but the operators are much more comfortable doing so after this diagnosis. We will be watching this screw closely, and we have already set the wheels in motion to have a brand new screw fabricated. We will install the new screw as soon as it arrives because it will allow us to run at a higher biomass flow rate again. In the meantime, we will continue running the worn screw, but we are going to keep the dampner pressure low and limit the hours ran.

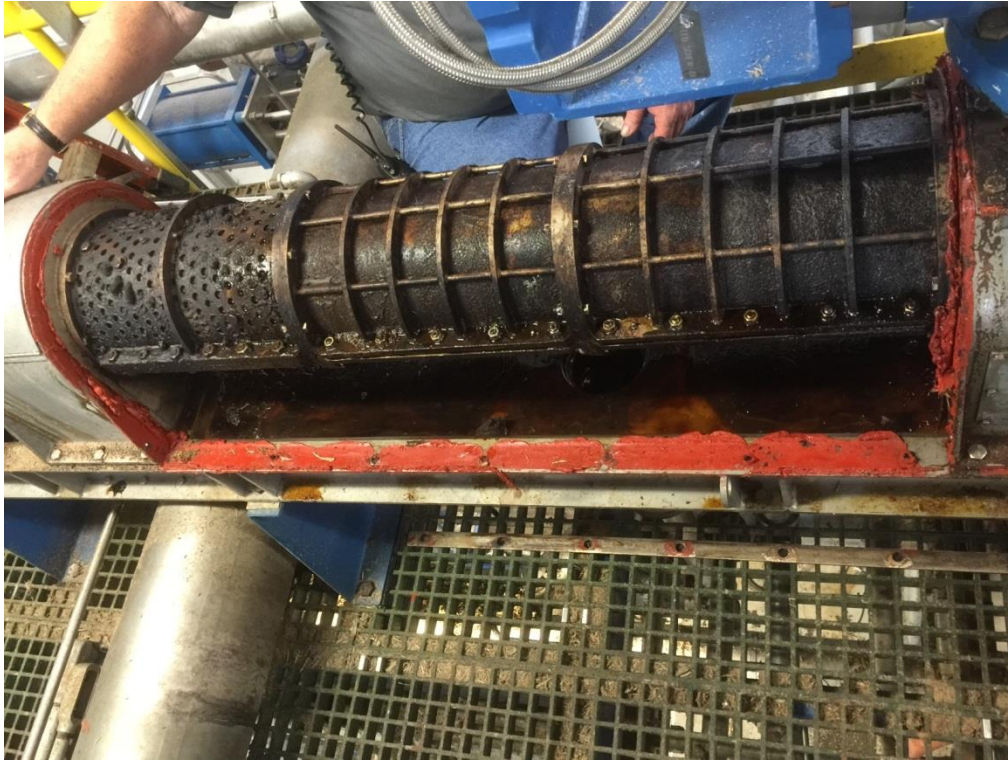
- c. Status:
 - i. In progress.
- 2. Squeezing hydrolysate
 - a. Problem:
 - i. We disposed of our stock 190C hydrolysate after the failure in campaign 11, so we needed to squeeze a fresh batch while running at the new pretreatment temperature (185C). Unfortunately, squeezing with the metso screw press was incredibly slow, and it seemed like we were overworking the mechanical screw press and screw press feed screw in the process. We initially thought the reason for the slow squeezing was due to fouling/clogging of the screw press screen (see picture below). However, after cleaning the screen with a pressure washer, the squeezing rate was still slow. The likely reason for the slow squeezing was the high dry-weight of the cake, approximately 37-40%, and the fact that the severity of the pretreatment was lower than when at 190C.

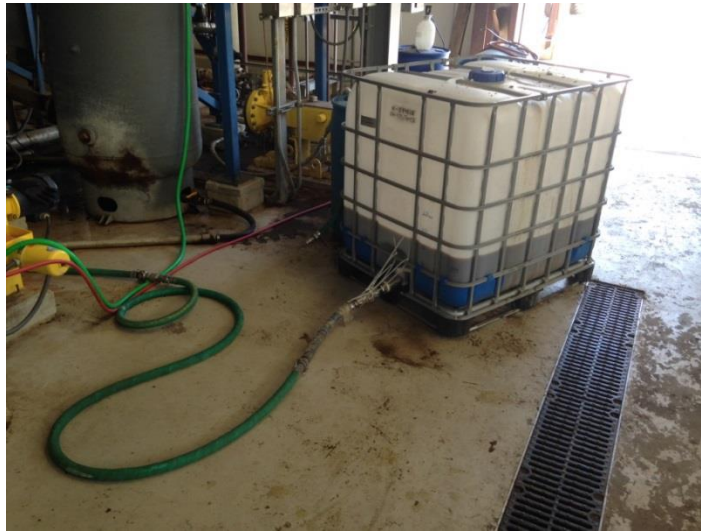
- i. The week prior campaign 12, we squeezed approximately 180 gallons of 185C hydrolysate (using the small screw press on the floor) and collected it in a large plastic tote. The hydrolysate was tested in preparation for the campaign, and the results were a success. Unfortunately, on the first day of the campaign, immediately before we started preparing the propagator 2 with hydrolysate, the drain valve on the hydrolysate tote broke and the entire contents drained to floor.

- i. In order to stay on schedule, we had to squeeze another 150 gallons of hydrolysate as quickly as possible. We started pretreatment and started squeezing using the small screw press method described in problem 2. We also rigged up a new drain and secured it to ensure we would not lose it all again. See picture below.

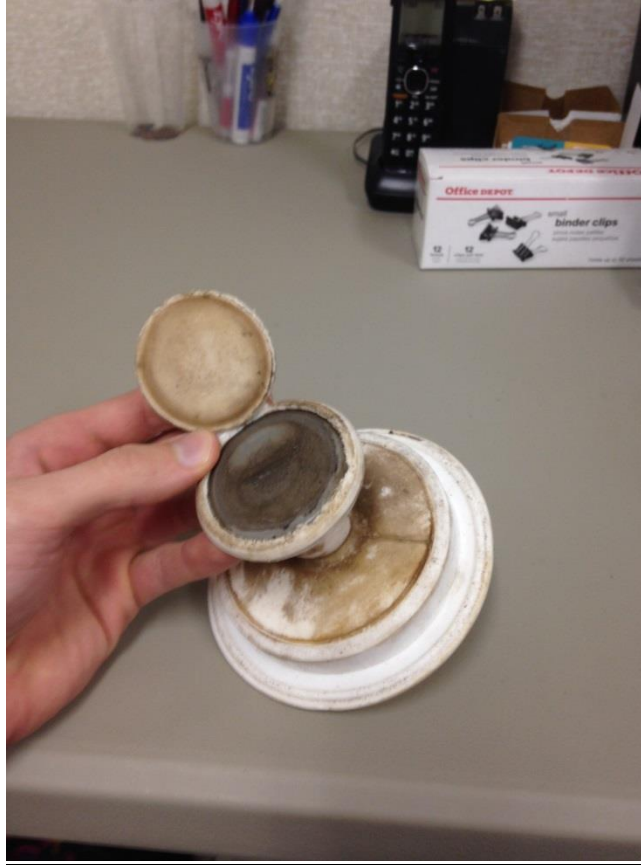
- i. The sterile sample port diaphragm for the propagator 2B broke while performing SIP on the tank. See picture below.

- b. Resolution:
 - i. We had recently added steps in all relevant SOPs to open the SSP while performing SIP on process vessels since we wanted to be over-cautious with contamination prevention, but the steps must now be removed.
 - c. Status:
 - i. Not yet removed from all SOPs, but the team understands the change and ensures that it doesn't happen.
8. Debris in biomass
- a. Problem:
 - i. The bagasse load delivered to the biorefinery on 03/30/2015 (batch 10029) was full of debris. The debris included pieces of wood, plastic, metal, and fabric. Our feed system clogged up twice before we realized how much debris was in the pile.
 - b. Resolution:
 - i. We had to sort through all 13 tons to ensure there was no more debris.
 - c. Status:
 - i. Resolved

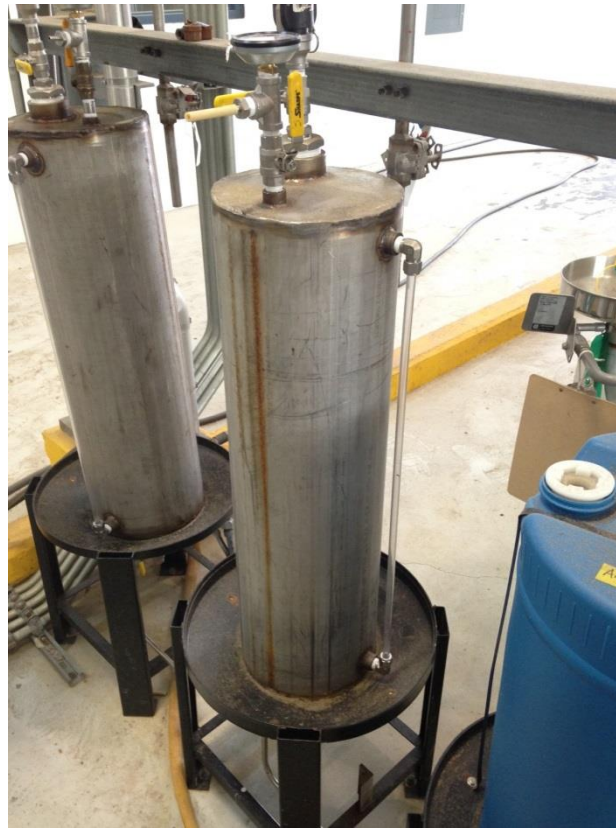
- i. This was the first campaign using the new stainless steel nutrient totes which were fabricated with level indicators so we could accurately add nutrients to the fermentors. See picture below.
- ii. The sight level indicators are polycarbonate and are rated for high pressure and temp, and we pressure and leak tested the totes prior to the campaign, but we still experienced leaking while pumping the nutrients into fermentor C. We heated up the totes with steam prior to filling them with nutrients, and we believe that during this process the plastic deformed and then reformed with a weaker seal.
- iii. We also noticed a small leak in the trace metals line underneath the metal walk-way about $\frac{3}{4}$ of the way into the fermentation. Ismael said it was not enough to make a difference though.

- i. We took the nutrient level indicators out and applied some high temperature silicone at the top and bottom connections.
