Campaign 6

Problems & Resolutions

UF Stan Mayfield Biorefinery Pilot Plant

Prepared by Joe Sagues, Director of Operations

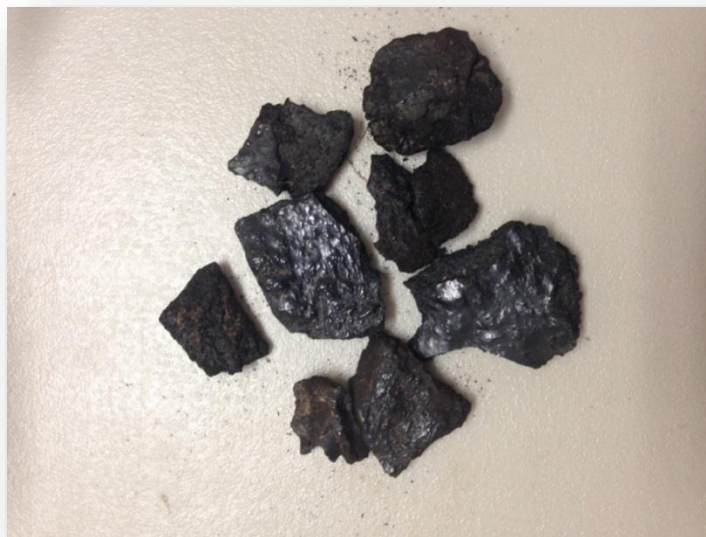
Prior to Campaign 6, after a run to squeeze hydrolysate, when shutting down metso, we cleared the plug screw like usual, but pieces of black charred biomass came out of the biomass dump chute (see picture below). These pieces might have been lodged in the biomass inlet port to the pretreatment system (immediately downstream of the plug screw), disallowing the dampner to close fully. The lodged biomass may have been the reason for the pressure loss we had been experiencing on startup during test trials leading up to the start of Campaign 6. We originally thought steam was leaking past the knife gates (biomass exit port from the pretreatment system), but there was no evidence, visually or from pressure trends, to indicate such.

Another area of biochar accumulation was discovered in the cylindrical chute between the hydrolyzer discharge screw and the top knife gate valve. Upon disassembly, it was found that a vast majority of the chute volume was taken up with solid biochar. It appeared like it had been accumulating for a while. We are concerned about what the hydrolyzer screw looks like. It is probably covered thick in biochar.

Ensure the biomass inlet port to the pretreatment system is always clear of biochar by confirming that the blow back dampner shuts fully upon system shut down.

A new section has been added to the “Preventative Maintenance” procedure to routinely clean the cylindrical chute between the hydrolyzer discharge screw and the top knife gate.

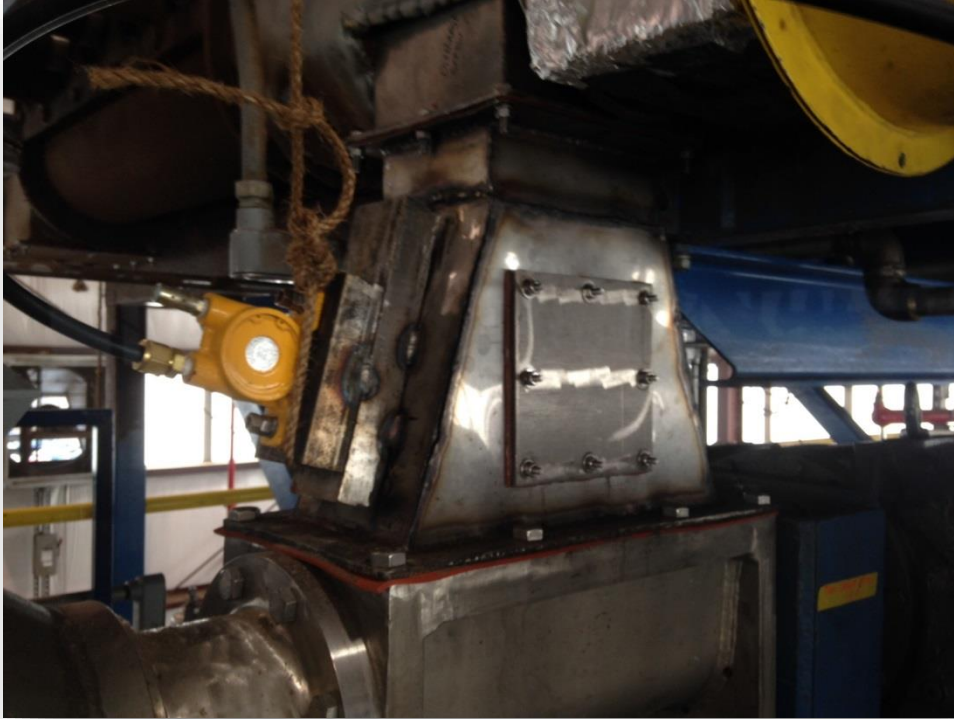
4. We installed a vibrator (Global Manufacturing US19). The vibrator was installed incorrectly, but it worked well, until it cracked the chute. The chute metal thickness was only 1/16", and the vibrator was probably a little too powerful.

5. After Campaign 6 and before Campaign 6.5, we fabricated a new chute out 1/4" 304 SS, and we installed the vibrator correctly. The US19 vibrator has a substantially lesser effect on vibrating the chute. We ran the vibrator at 80 psi (max) throughout the whole Campaign 6.5 and had several instances of almost clogging and once instance of actual clogging (at the very end of the campaign).
6. A technical rep from Vibco Co. stopped by the plant and let us trial two vibrators. We'll see how they work on 2014-11-19 when properly installed on a 1/16" chute.

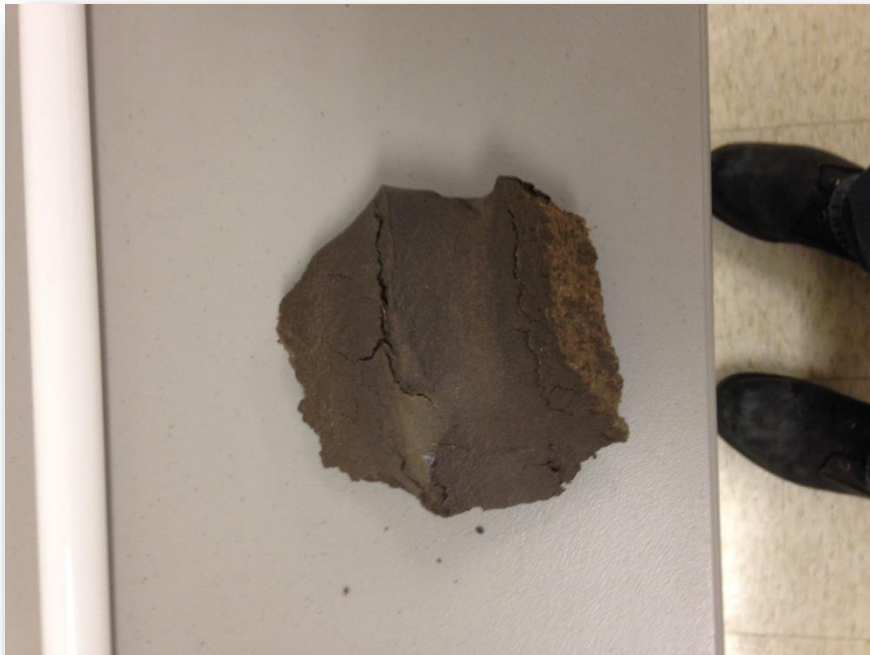
During Campaign 6.5 it was discovered that the collection conveyor screw paddle developed a large lump of biomass. This may have contributed to some clogging and inconsistent feed. Upon examining a small sample of the large lump, it appears to be composed of fine biomass dust.

Chip off the lump.
