# Campaign 5

## Problems & Resolutions

UF Stan Mayfield Biorefinery Pilot Plant

**Campaign Date: October 2014**

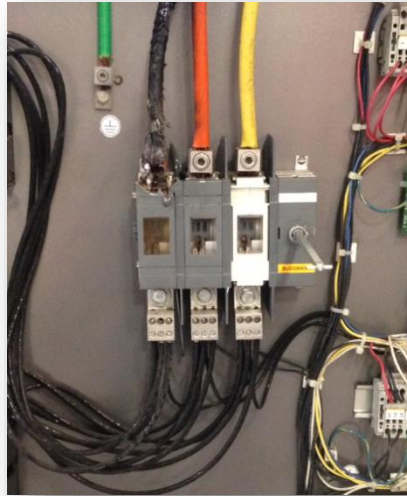
After liquefaction was complete, one leg of the 3-phase power wires burnt up which caused the power transmission box to melt.

Had to replace all 3 wires plus ground back to the local disconnect on the wall. Total cost of wire was about ~\$400. Had to replace the power distribution box for a total cost of ~\$1,300. The original was non-fused, and I bought another non-fused, but I should have bought fused. Must routinely check amperage draw on incoming wires, tightness of all lugs/connections, and continuity on all fuses. Need to order more replacement fuses.

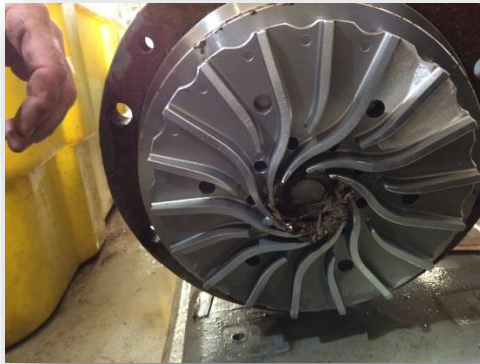
The beerwell was about 75% full, with most of the contents being post fermentation 15% vanasse. It could not pump at all.

We probably need a new pump. I can't imagine this pump head was designed for high solids slurry. Our portable diaphragm pump was handling it well though.
