# HSS Inspection Report

Report Number: SIS2522576      Inspection Date/Time: 01 Sep 2025 21:40  
02 Sep 2025 04:59  
Workplace: PPT3,PPT2  
Inspectors: AUSTIN CHUE, SR OPS EXEC, YOD, PSA  
MUHAMMAD JAMALULLAIL BIN MAHADI, SR OPS EXEC, YOD, PSA

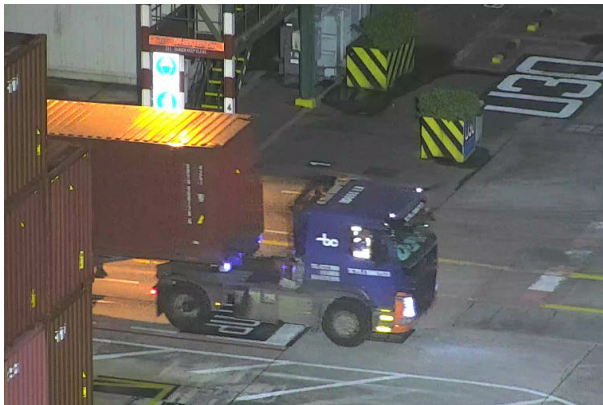
Description / Immediate Action	Follow Up / Remarks
It was observed that XE 5500E failed to stop at stop line before exiting RTG block U30 after mounting.	SOP not complied / NISR issued separately.

Caption : XE 5500E

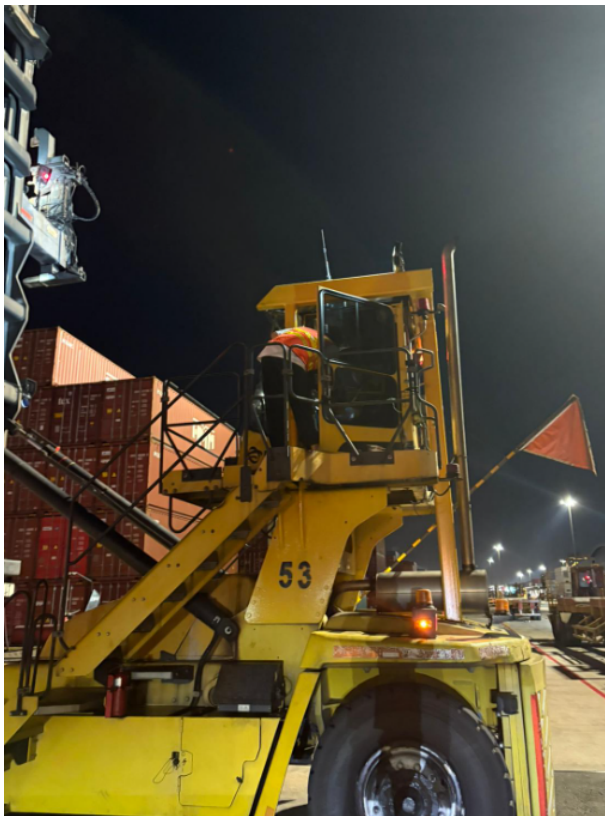
<p>Team conducted CCTV inspection at hyster block U31.</p> <p>Team observed that FM053 operator was on stationary position with spreader closed to 20-footer and hoist to 3 high.</p> <p>Team commended FM053 operator for complying to SOP and to continue practicing good safety habits at all times.</p> <p>Team also reminded the FM053 operator to report any hazard immediately to his superiors and /or control centre.</p>	<p>SOP complied / SBR awarded.</p>
--	------------------------------------

Caption : FM 053 on standby

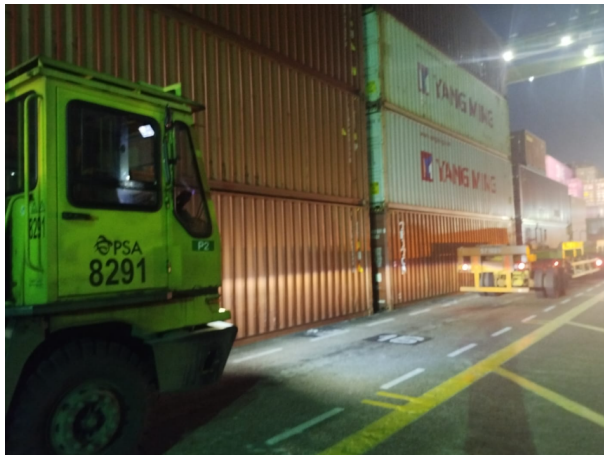
<p>Team conducted CCTV inspection at RTG blk W27.</p> <p>Team observed PPM8291 was doing mounting job at W27.</p> <p>Team observed PPM8291 was parking 40ft slot away from front PM chassis while waiting for his turn for mounting.</p> <p>Team commended the PPM8291 driver for complying to SOPs and to continue practicing them.</p> <p>Team also encouraged the PM8291 driver to report any hazard immediately to his superiors and /or control centre.</p>	SOP complied / SBR awarded.
--	-----------------------------

Caption : PPM 8291 40ft safety distance with front PM

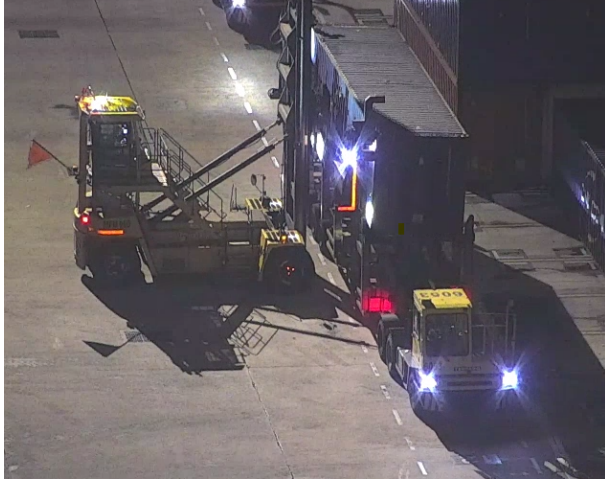
Description / Immediate Action	Follow Up / Remarks
<p>Team conducted CCTV inspection at hyster block K11.</p> <p>Team observed FM060 operator adhered to SOP by following 3-step mounting rule for all mounting PMs.</p> <p>Team commended the FM060 operator for complying to SOPs and to continue practicing good safety habits at all times.</p> <p>Team also reminded the FM060 operator to report any hazard immediately to his superiors and /or control centre.</p>	SOP complied / SBR awarded.

Caption : FM 060 mounting ops
