HSS Inspection Report

Report Number: SIS2523265 Inspection Date/Time: 08 Sep 2025 23:00
09 Sep 2025 00:00
Workplace: PPT2
Inspectors: ABDUL HAKIM BIN YUSOF, SR OPS EXEC, YOD, PSA
AUSTIN CHUE, SR OPS EXEC, YOD, PSA

YARD - K11 - HYSTER OPS

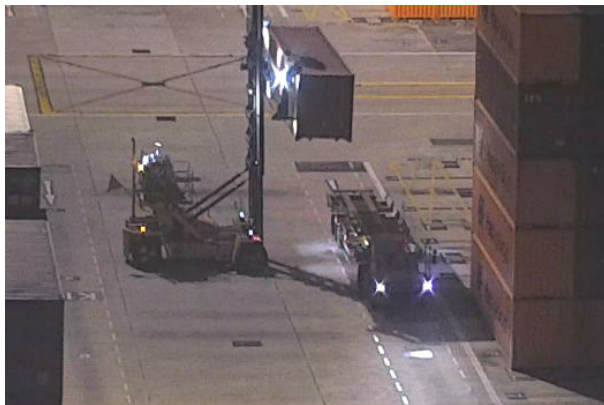
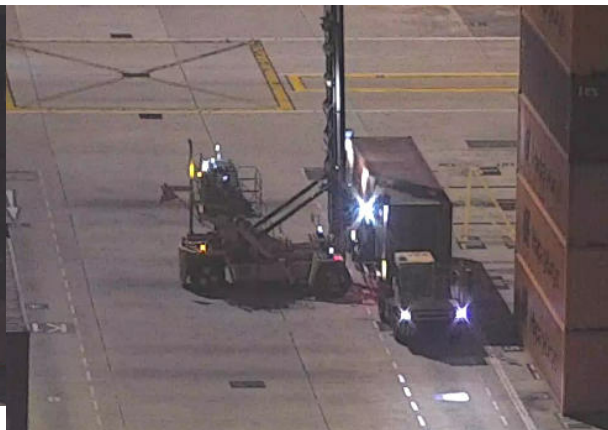
Description / Immediate Action	Follow Up / Remarks
It was observed that FM039 operator complied with SOP when mounting for PMs at yard block K11. FM operator followed 3-step mounting rules for all PMs. FM operator was commended for complying to SOPs and reminded to continue practicing them. FM operator was also reminded to report any hazard immediately to his superiors and / or control centre.	SOP complied / SBR awarded

Caption : FM039 Mounting Operations

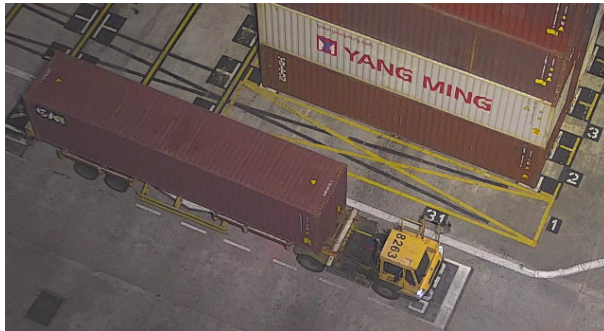
Description / Immediate Action	Follow Up / Remarks
<p>It was observed that PM8263 after mounting operations at block K11, stopped before the STOPLINE of the chassis lane, checked for oncoming traffic, before moving off.</p> <p>PM driver was commended for complying to SOPs and reminded to continue to practice safe driving habits.</p> <p>PM driver was also reminded to report any hazards immediately to control centre.</p>	SOP complied / SBR awarded

Caption : PM8263 stopped at the STOP LINE, checked for clear traffic before moving off

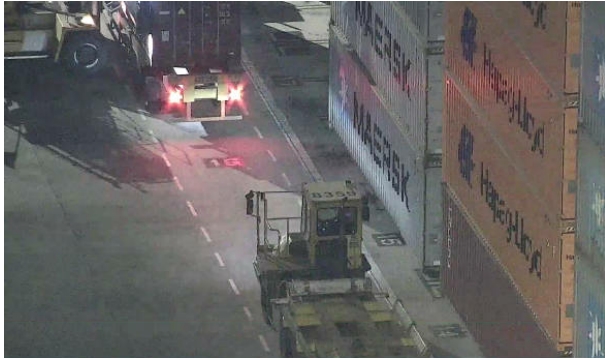
Description / Immediate Action	Follow Up / Remarks
<p>It was observed that PM8359 waiting at block L11, maintained a 40ft distance from the front chassis.</p> <p>PM driver was commended for complying to SOPs and reminded to continue practicing them.</p> <p>PM driver was reminded to report any hazard immediately to his superiors and / or control centre.</p>	SOP complied / SBR awarded

Caption : PM8359 maintained a 40ft distance from the front chassis

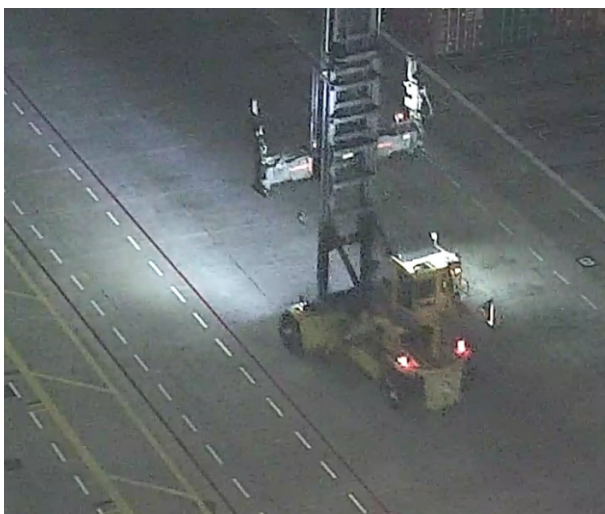
Description / Immediate Action	Follow Up / Remarks
<p>It was observed that FM056 operator adhered to SOP when on gantry from one location to another. It had its spreader closed to 20ft and raised to 3 high.</p> <p>FM operator was commended for complying to SOPs and reminded to continue practicing them.</p> <p>FM operator was also reminded to report any hazards immediately to his superiors and/or control centre.</p>	<p>SOP complied / SBR awarded</p>

Caption : FM056 on gantry, with spreader at 20ft and 3 high
