HSS Inspection Report

Report Number: SIS2523524 Inspection Date/Time: 11 Sep 2025 11:00
11 Sep 2025 12:00
Workplace: PPT2,PPT3,PPT1
Inspectors: MERVIN HO, SR OPS EXEC, YOD, PSA
JACINTA NISHANTHI D/O DHARMARAJ, OPS EXEC, YOD, PSA

YARD - W09 - PM/HAULIER/IGH OPS

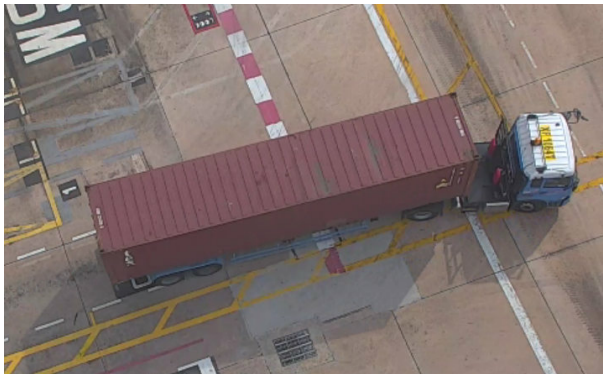
✗	SWP COMPLIANCE - DRIVING WITHIN CHASSIS LANE/SAFE DISTANCE FROM FRONT PM/REVERSE WITHOUT GUIDANCE/PROPER POSITION WITHIN SLOT FOR MOUNTING/OFFLOADING
---	---

Description / Immediate Action	Follow Up / Remarks
Following a rise in incidents where PM/IGH/Hauliers did not adhere to the SOP, the team carried out a safety inspection at the RTG yard. The inspection revealed that drivers neglected to stop at the designated stop line before exiting the block.	NISR issued

Caption : XF1064T failed to stop at stop line before exiting RTG block W09.

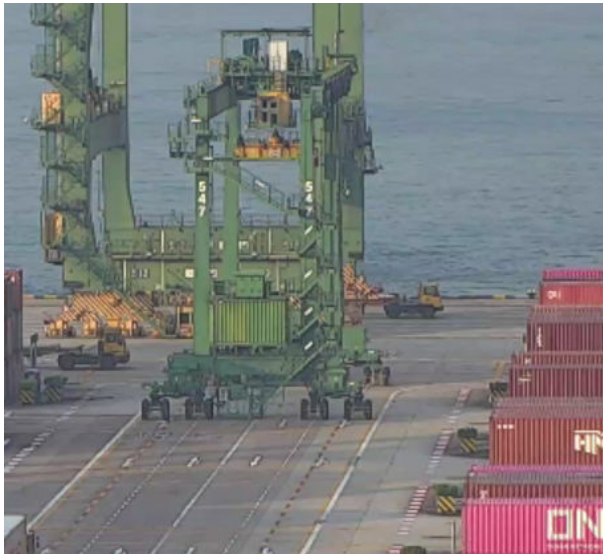
Description / Immediate Action	Follow Up / Remarks
Team then conducted inspection at RTG yard blocks to ensure that RTG operators ensure traffic clearance and no obstruction at the gantry path before proceed out from the RTGs block.	SBR awarded

Caption : RTG547 ensure traffic clearance during gantry operation

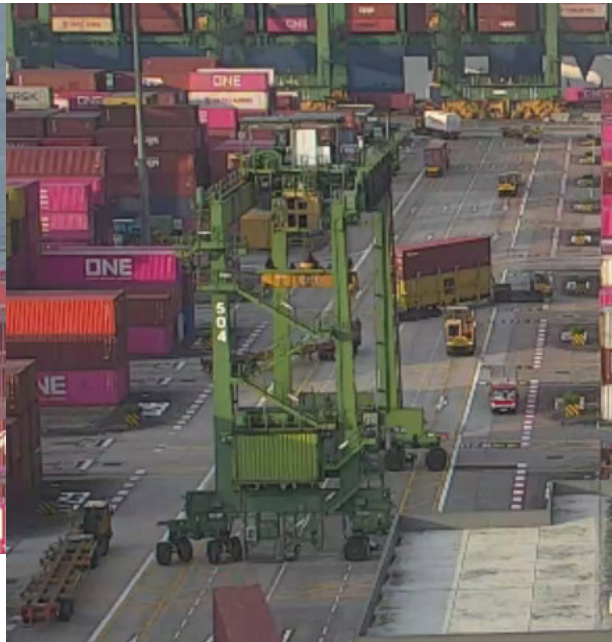
Caption : RTG504 ensure traffic clearance during gantry operation

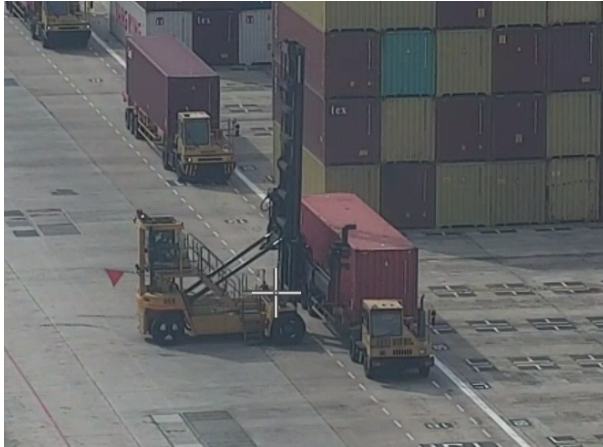
Description / Immediate Action	Follow Up / Remarks
The team then observed FM065 and FM053 to be performing offloading/mounting operations at T31/T09. FMOs were observed to have performed 3 step hoisting of the spreader while offloading/mounting. After offloading/mounting the container from the PM chassis, FMOs were observed to have reversed to a safe distance before giving the instruction to 'PMGO'. They commended on their compliance to the SWP and reminded not to perform any self recovery on their FM and to inform control or the SR team should they encounter any issues. They acknowledged the reminders and assured the team that they will continue to do so.	SBR awarded

Caption : FM65 performing offloading operations at T31

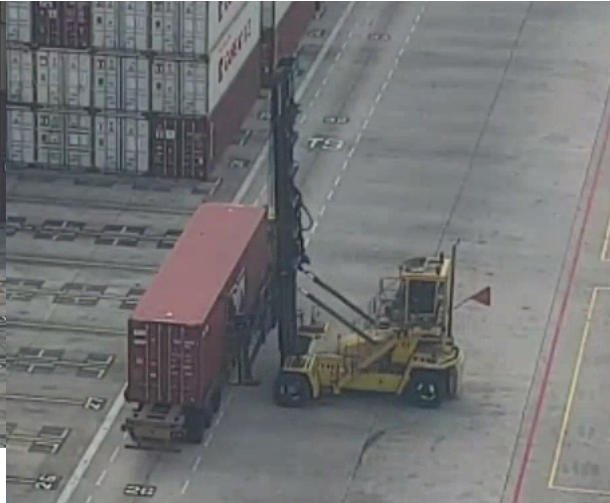
Caption : FM53 performing offloading operations at T09

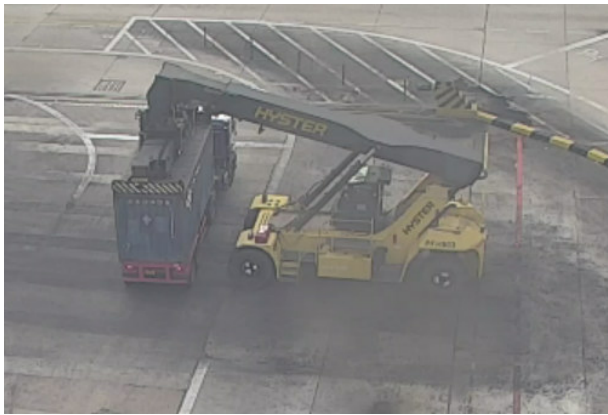
Description / Immediate Action	Follow Up / Remarks
<p>Lastly, The team then turned their attention to J13 where RS operations was ongoing. The team observed that RSO803 had followed ensure that his surroundings were clear while performing the shuffling and complied with the 3 step hoisting procedure of the spreader while lifting the container. In addition, RSO803 retracted the boom all the way and lower the container to the ground in compliance with the SWP. RSO803 was also reminded to monitor his Linear Load Moment Indicator and stop work immediately if the indicator is in the yellow region. RSO803 acknowledged the reminders and ensured he will continue to work safe for both himself and safety of others.</p>	<p>SBR awarded</p>

Caption : RS803 performing offloading at J13.
