Customer: Birla Carbon

Location: Centerville, LA

## TEAM Tank Consultants API-653 Inspection Report

Tank Number: 6

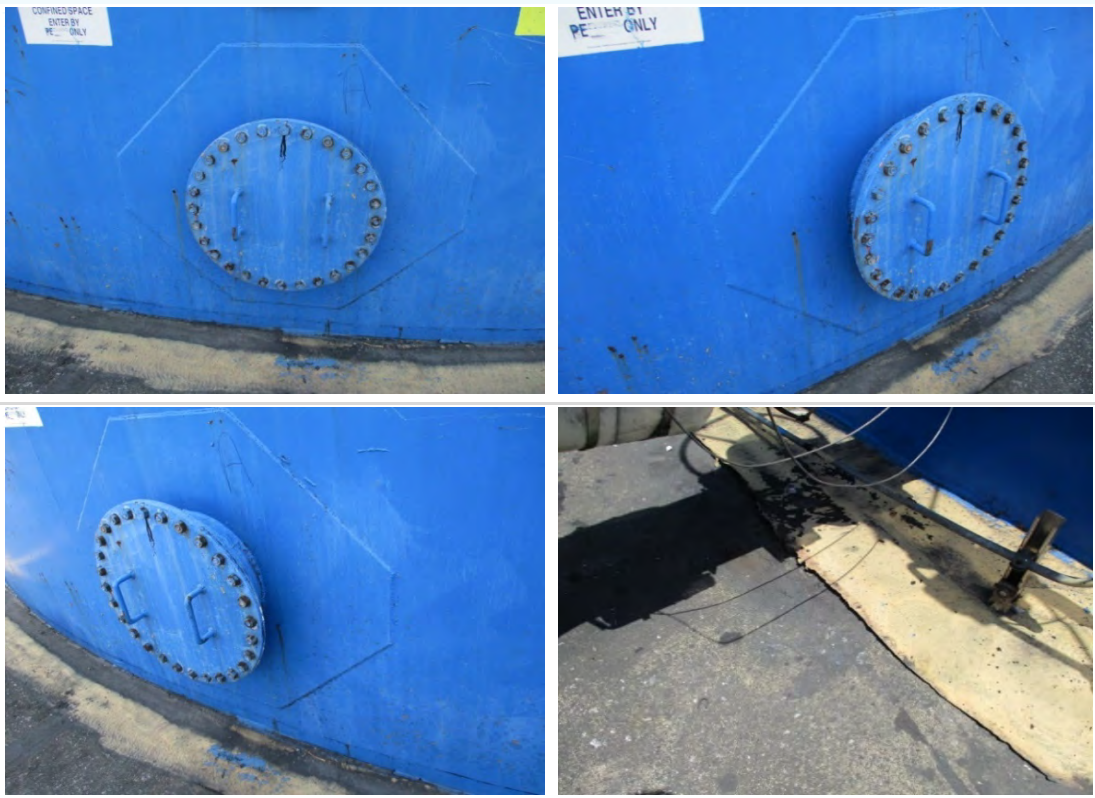
Foundation and Bottom Extension	
Foundation Type	Concrete Ringwall
Anchor Details	Not Applicable
Foundation Failure Conditions	Acceptable
Other/Details	
Conditions Around Tank	See Comment(s)
	Vegetation _____ Deterioration Of Dike Wall <b>See FO-15</b>
	Debris _____
Other/Details	
ID: FO-15	<p>The tank rests on a concrete ringwall within a concrete containment. The concrete containment had been installed flush with the top surface of the concrete ringwall. All concrete containment seams, cracks and the bottom extension have been sealed with an epoxy-like material. Several areas of the epoxy had deteriorated.</p> <p>Consideration should be given to repairing the sealant.</p>

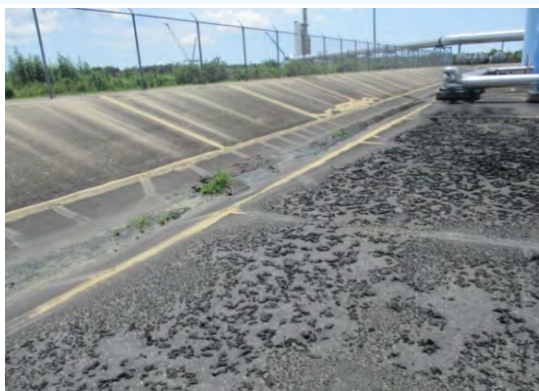
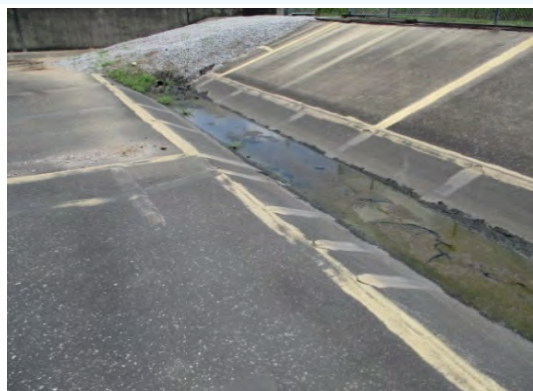
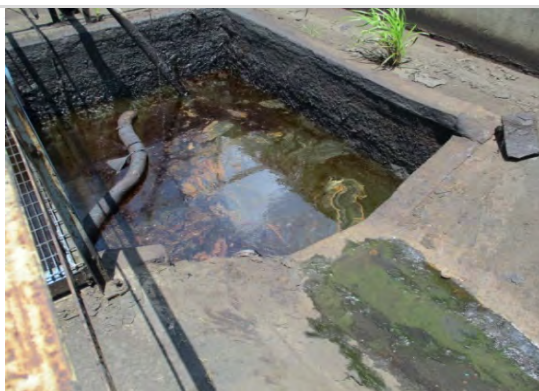
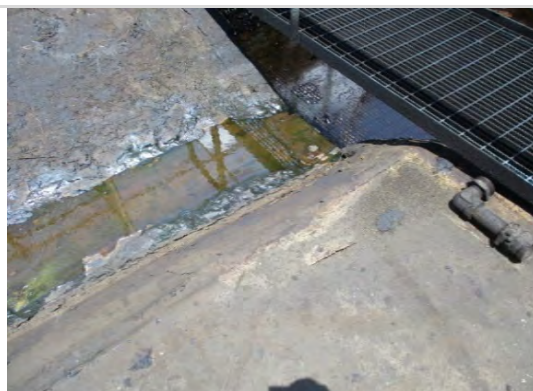
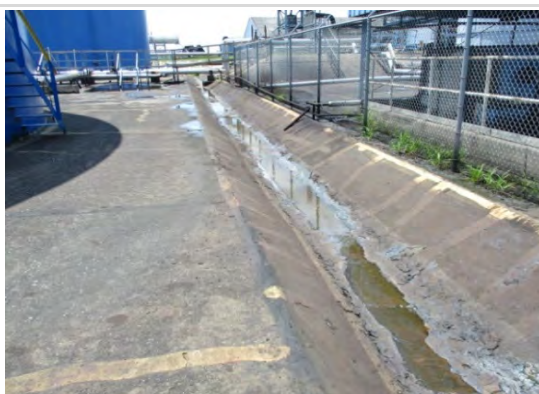
ID: FO-31

The concrete containment drain was retaining mud, vegetation, debris and water. The sump located at the end of the drain was full of water, product and debris.

The containment drain and sump should be cleaned to ensure proper operation.

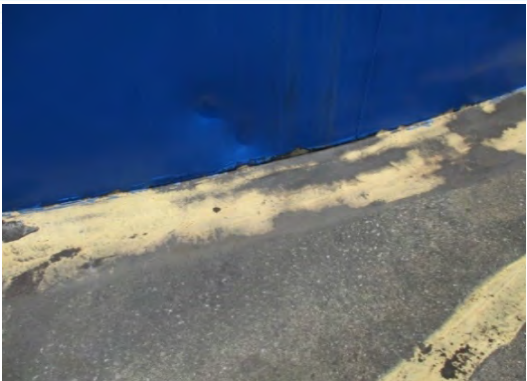
<b>Shell Distortion and Buckling</b>	<b>See Comment(s)</b>	
	Major Buckle _____	Distortion <b>See ES-48</b>
	Minor Buckle _____	Distortion Around Piping _____
	Flat Spot _____	
<b>Other/Details</b>		
ID: ES-48	<p>The shell had two mechanical distortions in Ring 1. The mechanical distortions were located at 85.35 and 85.75 feet counter-clockwise from East Shell Manway A. The mechanical distortion located at 85.35 was 2.50 inches in width x 3.00 inches in height x 1.25 inches inward depth, centerline elevation above the cornerweld was 7.00 inches. The mechanical distortion located at 85.75 was 5.00 inches in width x 11 inches in height x 1.50 inches inward depth, centerline elevation above the cornerweld was 15.00 inches.</p>	
	<p>The dents should continue to be closely monitored during routine inspections of the tank. The dents should be further inspected and evaluated when the tank is next out of service.</p>

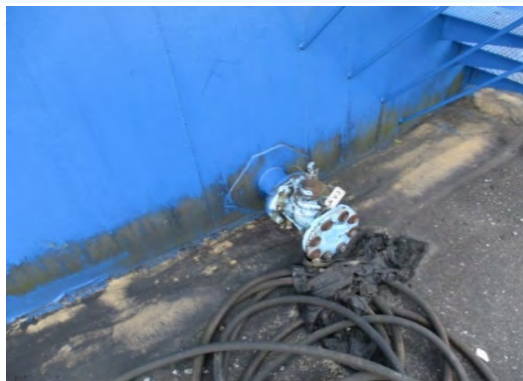
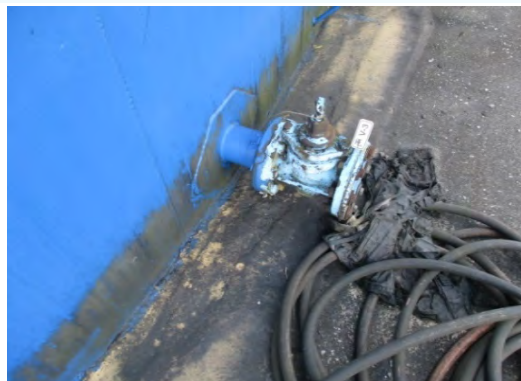
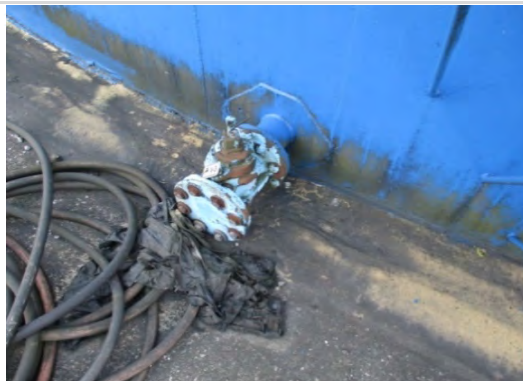
ID: ES-23 The weld spacing between the repad of Shell Nozzle F and the cornerweld did not meet API standards.

Because the nominal thickness of the shell plate in Ring 1 is ½-inch or less, no corrective action is required.

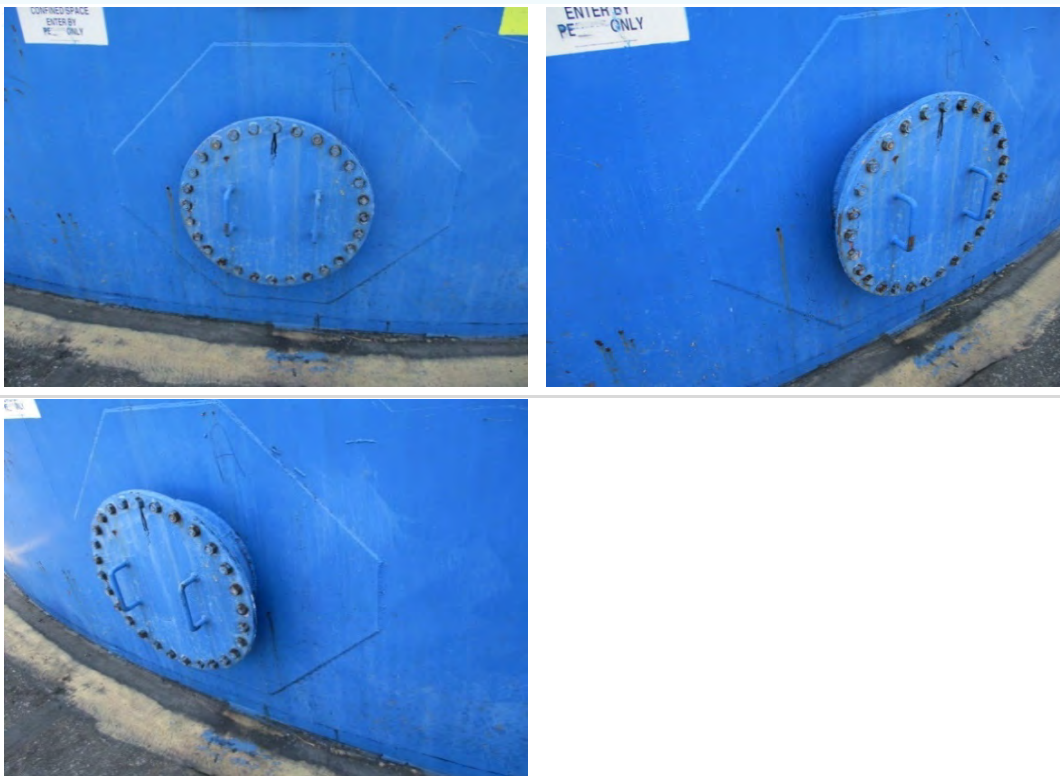
ID: ES-51 Shell Manway A flange bolting hardware had lack of thread engagement.

Consideration should be given to adjusting or replacing the bolting hardware.

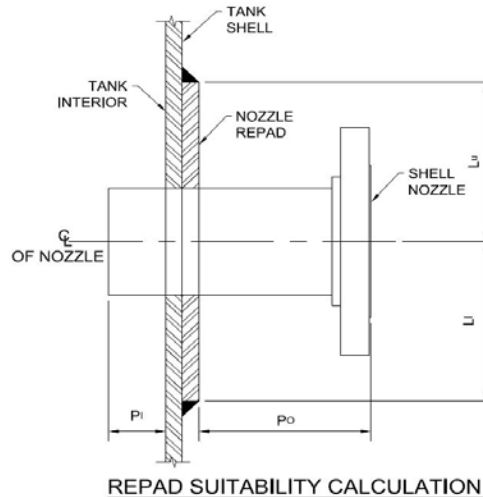
Shell Nozzle F had a repad with a plate thickness less than the nominal thickness of Shell Ring 1. Shell Nozzle F also had a nominal thickness less than extra-heavy piping. The nozzle was evaluated and found to be acceptable at this time.

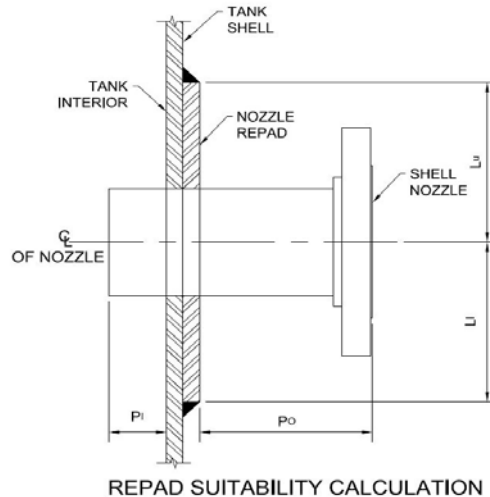
Shell Nozzle I had a nominal thickness less than extra-heavy piping. The nozzle was evaluated and found to be acceptable at this time.

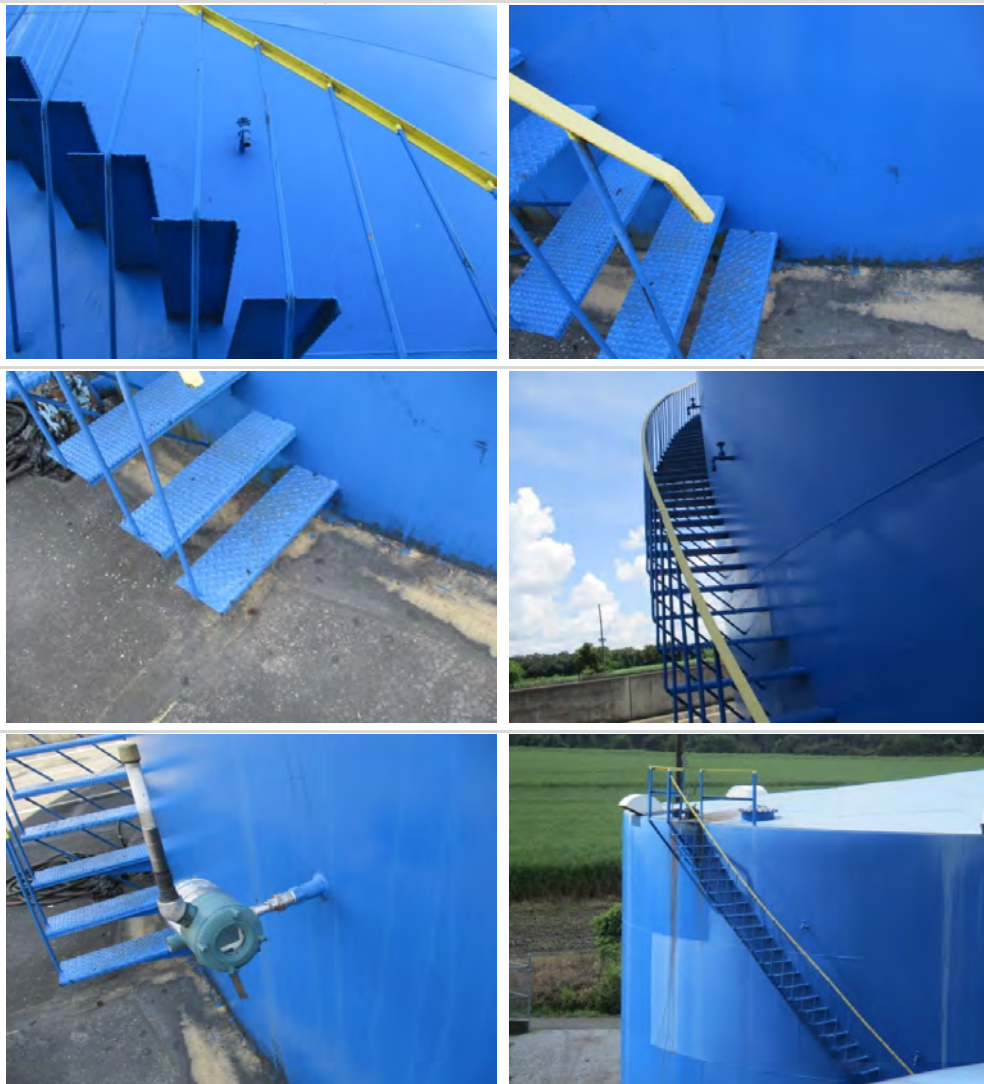
Other/Details	<p>ID: AS-18 The spiral stairway, platform and roof handrail had isolated areas of minor coating failure with thinning, staining, and there were areas that were not coated. There was surface corrosion in the areas of coating failure.</p> <p>No repair is required. The tank owner may elect to clean and paint any uncoated areas and areas of coating failure, especially those with corrosion.</p> <div>         </div>

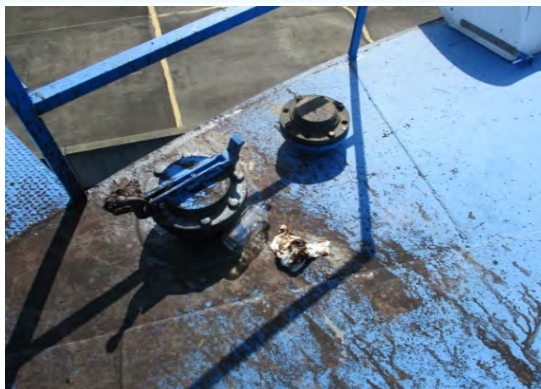
The cover of Roof Nozzle D was missing four bolts.

The missing bolts should be replaced.

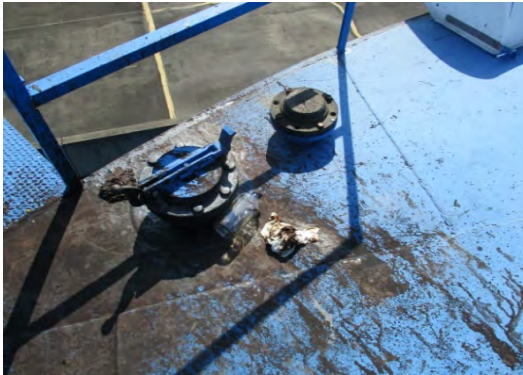
ID: ER-24 Roof Nozzle C and the roof plate around the roof nozzle had dried product. The product had also stained the nearby spiral stairway and platform.

Consideration should be given to cleaning the area.

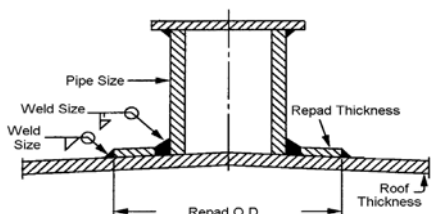
*The tank did not have a dedicated roof hitch. Roof Nozzle A was evaluated and found to be acceptable for use as a scaffold hitch based upon calculations. No repair is required. The tank owner may elect to install a dedicated roof hitch.*
