**RE: 272 Broadway  
Hamilton Twp., OH 45039  
Inspection #: 001-092010-0252**

File Number: **001-092010-0252**  
Address of Inspection: **272 Broadway**

**272 Broadway Street**

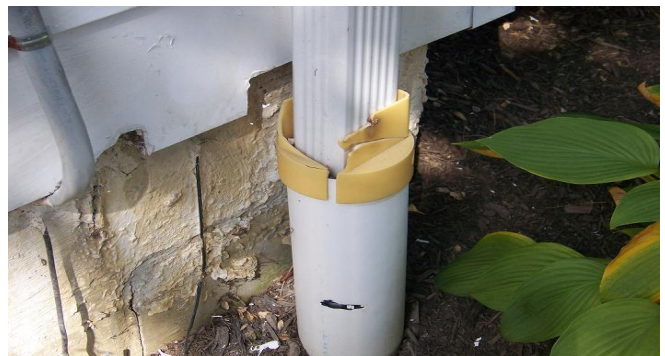
NOTE: The left PVC downspout drain pipe is cracked and needs to be replaced.

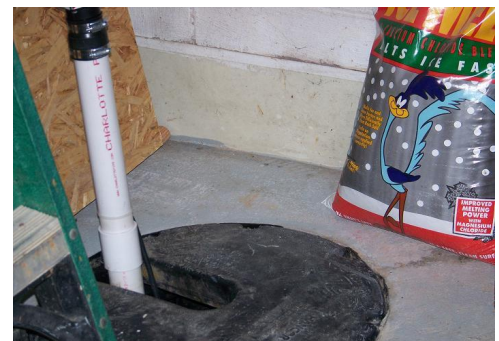
There was a sump pump located in the basement. The sump crock was in good condition. The sump pump was functional.

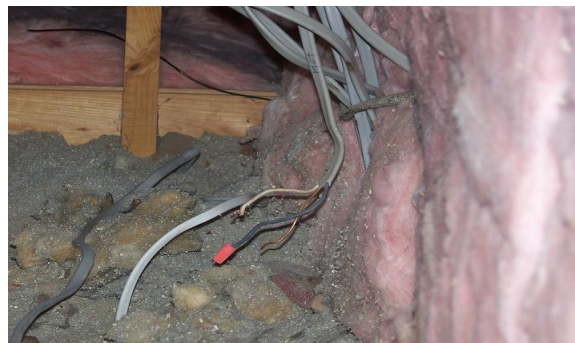
NOTE: The attic has an electric wire that needs to be installed into a junction box.

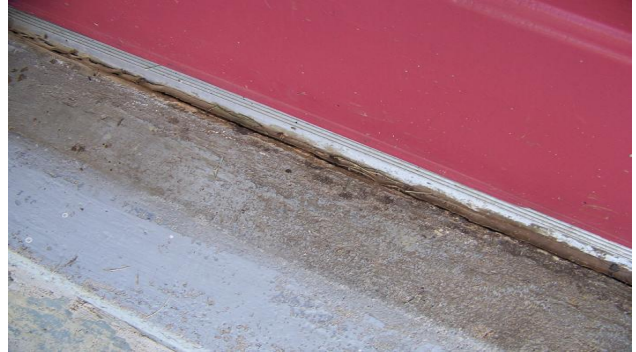
NOTE: The living room threshold needs to be sealed.

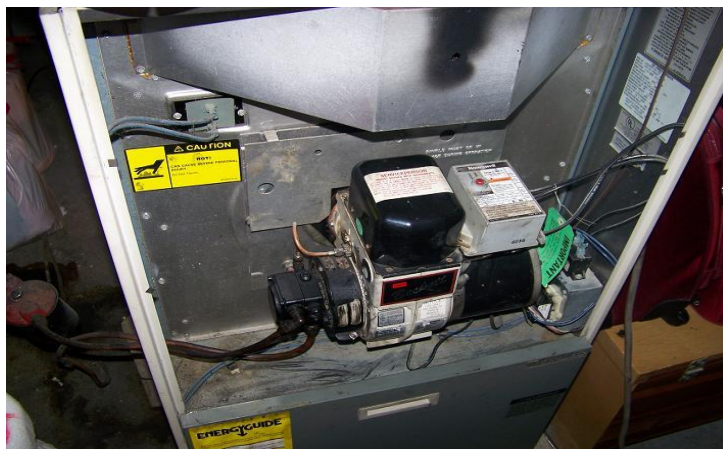
The home was heated by a UNI Cell fuel oil forced air furnace. The unit was located in the basement of the home and has an approximate input heating capacity of 119,000 BTUH. Information on the unit indicated that it was manufactured approximately 15+ years ago.

The heating system was functional at the time of the inspection but should be cleaned and serviced.
