Analysis report document

1. Problem description

There's a customer reporting issues with serial transmissions on UART1 when the Omega's network is restarted.

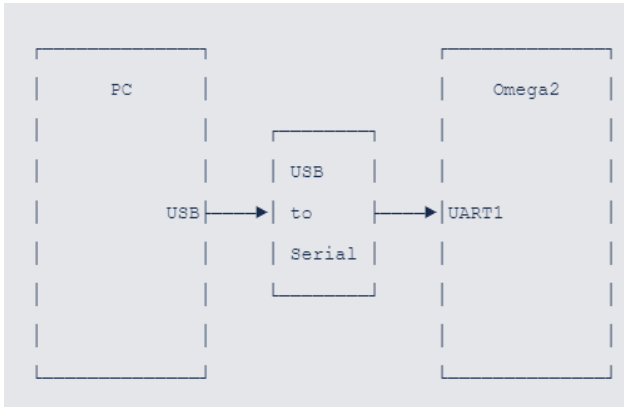
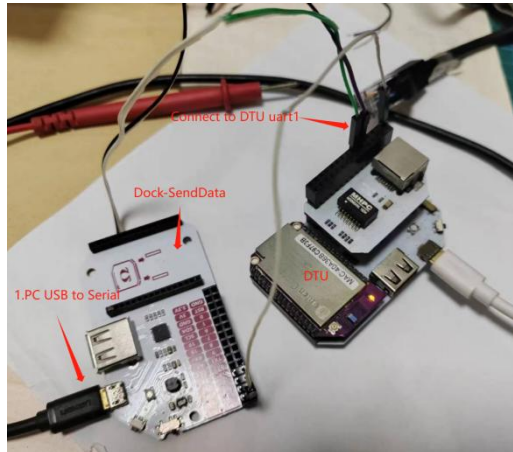
Here i used two expansion dock (USB to Serial) to build the testing environment.

Dock-SendData: Send data to DTU(Omega2).

DTU :receive data from Dock-SendData.
