ATtiny1614/1616/1617

Silicon Errata and Data Sheet Clarifications

The ATtiny1614/1616/1617 devices you have received conform functionally to the current device data sheet (www.microchip.com/DS40002204), except for the anomalies described in this document. The errata described in this document will likely be addressed in future revisions of the ATtiny1614/1616/1617 devices.

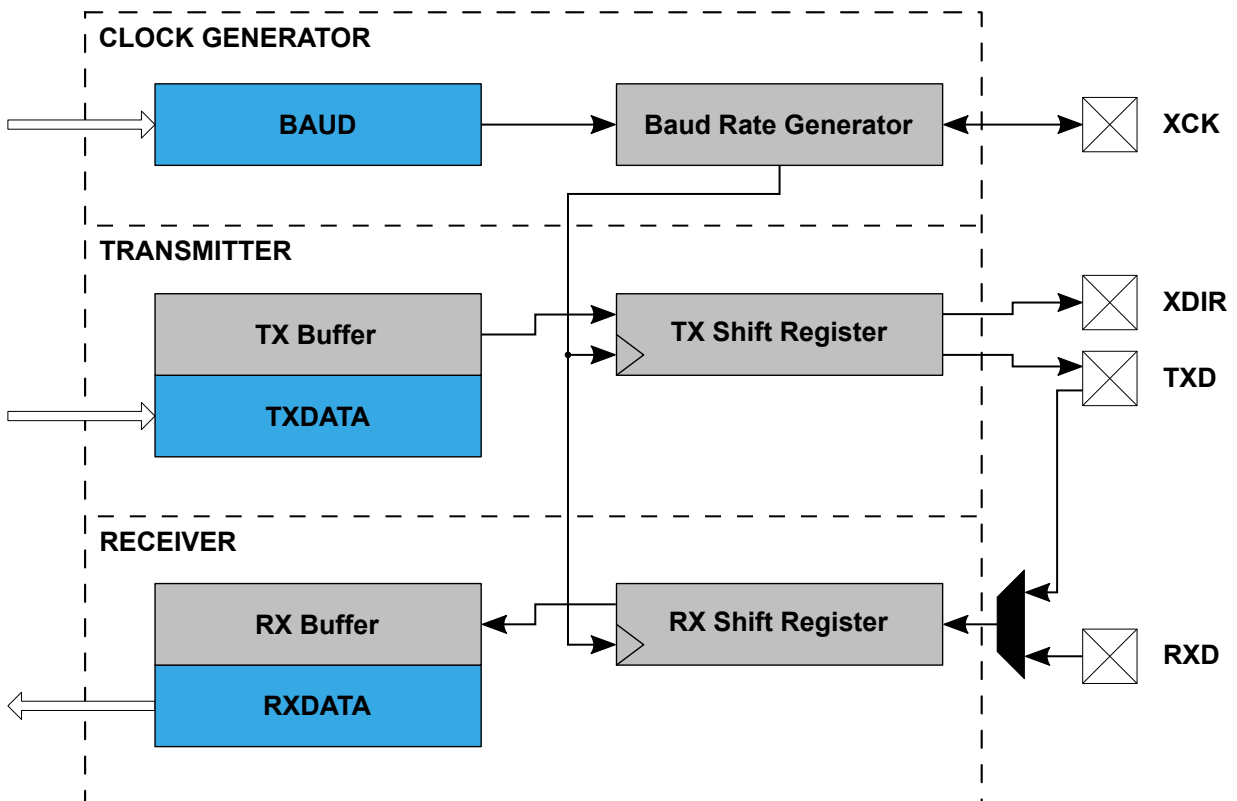
Figure 3-1. Block Diagram

The block diagram is missing that USART TX is double-buffered from Figure 25-1 in the data sheet. The figure below shows the added **TX Buffer**.

The following text is changed in the *Overview* section:

The transmitter consists of a **two-level** write buffer.

The following text is changed in the *Data Transmission* section:

The data transmission is initiated by loading the **Transmit Data (USARTn.TXDATAL and USARTn.TXDATAH)** registers with the data to be sent. The data in the **Transmit Data registers are moved to the TX Buffer** once emptied and then to the Shift register once it is empty and ready to send a new frame.
