**Oxford Flying Club
Aviation Hazard or Incident Report (HIR)**

Tracking # (assigned by Safety Officer): HIR-2020-003

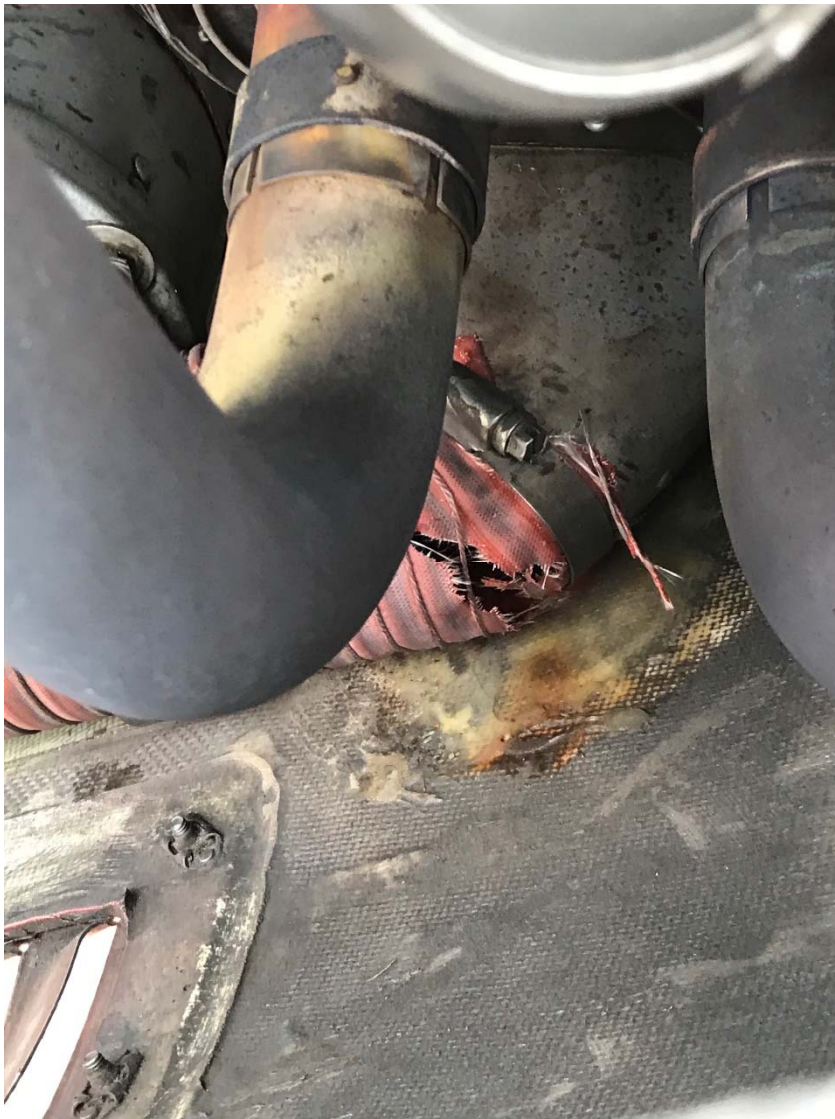
En-route during cruise, the monitor alerted us of possible high CO levels with it reading somewhere between 13-17. I initially thought that it was possibly an error with the detector seeing that N8261H had an annual inspection completed the week prior. Vents were opened upon the first indication and heat was turned off. Once we landed at 4B8, during taxi the monitor spiked up to higher levels of about 20-26. During climb out the levels were the same but then started to reduce as we leveled into cruise flight. (Somewhere between 13-17 again). At that moment I was still convinced that it had to be an error in the monitor. Upon arriving back at KOXC, my instructor prompted me to take off the cowling to inspect. That is when we found the cockpit heater hose had a tear (see Page 2).

- 1) Aircraft Grounded (3/10/2020)
- 2) Temporary Hose repair made and new hose ordered. (3/10/2020)
- 3) Aircraft returned to service. (3/10/2020)
- 4) Temporary hose removed and new hose installed. (Date not available)
- 5) Aircraft returned to service.
