**Oxford Flying Club  
Aviation Hazard or Incident Report (HIR)**

Tracking # (assigned by Safety Officer): HIR-2019-001A  
Probability (assigned by Safety Officer): 3- Unlikely  
Severity (assigned by Safety Officer): 3- Major  
Resulting Risk Code (assigned by Safety Officer): 2- (See below)

## Oxford Flying Club HIR

Attachment to report dated April 3, 2019

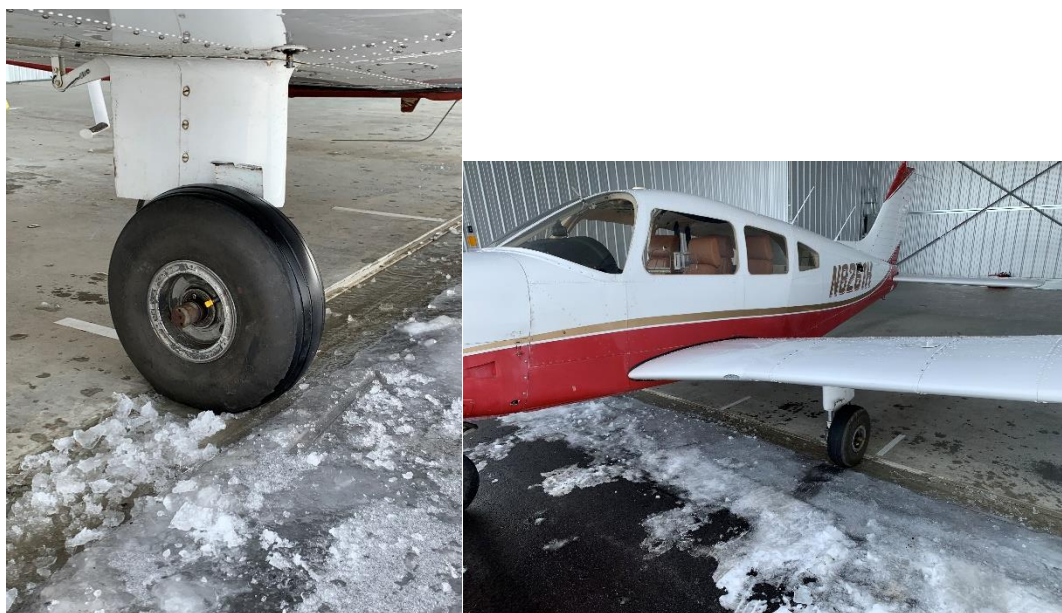
While I was alone backing the aircraft into the hangar with the tow bar after the completion of the AIC, the aircraft came to a rest prematurely as the main wheel became stuck in a depression formed by the lip of the concrete hangar floor and a thick band of ice running parallel to the hangar. See the two photos below.

The club should adopt a policy requiring the operator's hands remain connected to the tow bar anytime it is connected to the airplane regardless of whether flight is intended.

The club should adopt a policy addressing whether an aircraft may be moved if hazards such as ice in front of the hangar and ice falling from the hangar roof exist and pose a risk of injury to a person or damage to club aircraft.

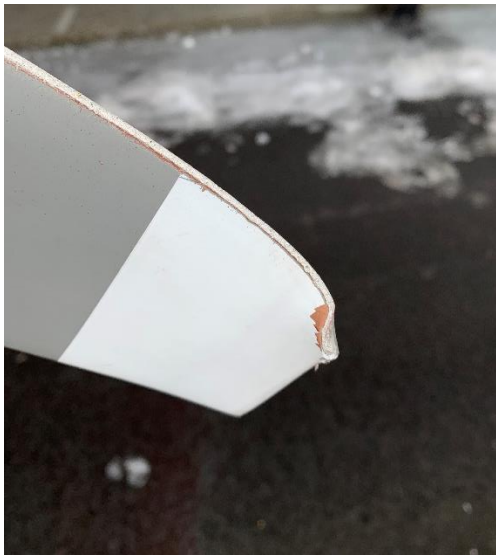
Upon starting the engine, it ran normally. As I gently added power to get the aircraft over the ice hump, the nose started to lower slightly and then I heard a loud clang. With the engine still running normally, I pulled the mixture to the cut-off position simultaneously realizing that the propeller had struck the tow bar. The engine shut down normally.

My inspection revealed that the tow bar had been thrown about 5 feet to the side of the aircraft landing on the apron. The tow bar did not strike anything after it was thrown. One end of the propeller had about a one-inch square curl caused by the strike. See photo below.
