### STM32F405/407xx and STM32F415/417xx device errata

This document applies to the part numbers of STM32F405/407xx and STM32F415/417xx devices and the device variants as stated in this page.

It gives a summary and a description of the device errata, with respect to the device datasheet and reference manual RM0090.

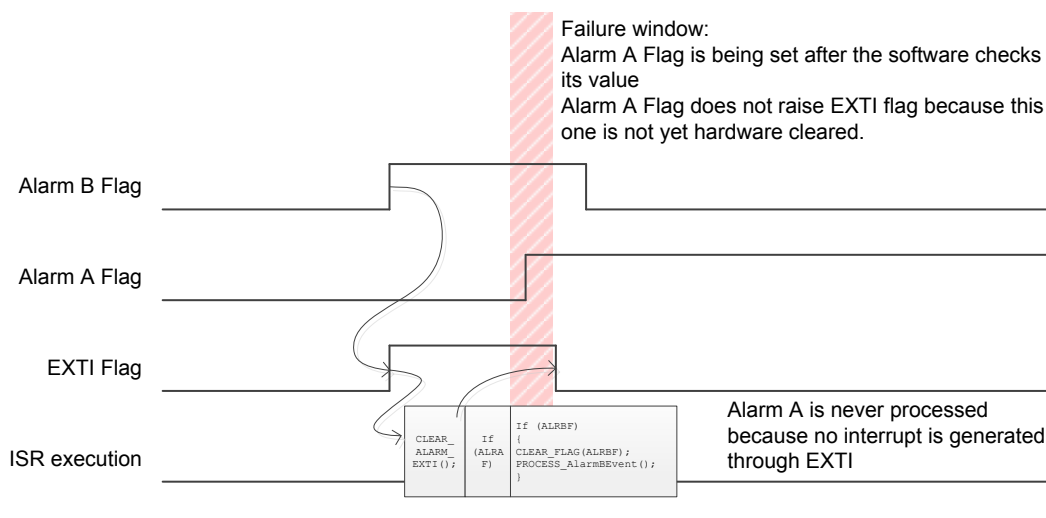
图1. 屏蔽的RTC中断

以下代码示例和图示说明了故障机制：Alarm A事件在发生时被丢失（未能生成中断），即在检查Alarm A事件标志后但在硬件有效清除EXTI中断标志之前。EXTI中断标志的有效清除相对于软件清除指令被延迟。

#### 变通方法

在中断服务程序中，应用三个连续的事件标志检查 - 源一、源二和源一再次，如以下代码示例所示：
