ELEVATOR INSPECTION REPORT

Project Name: ECOWORLD

Place: BANGALORE

Date of Inspection: 08/11/2024

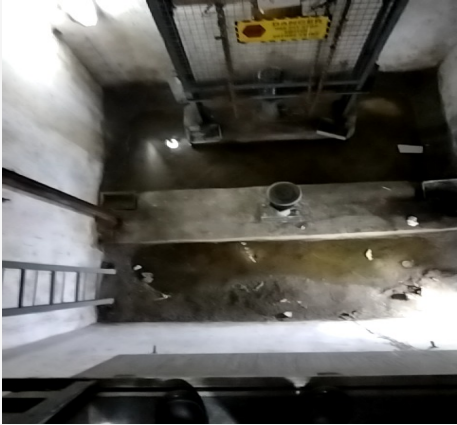
S.No.	DESCRIPTION	SL 1	SL 2	OBSERVATION
1	PIT IDENTIFICATION	Y	Y	Complied
No Image Captured				
2	PIT CONDITION	N	N	Y - Complied, N - Not Complied

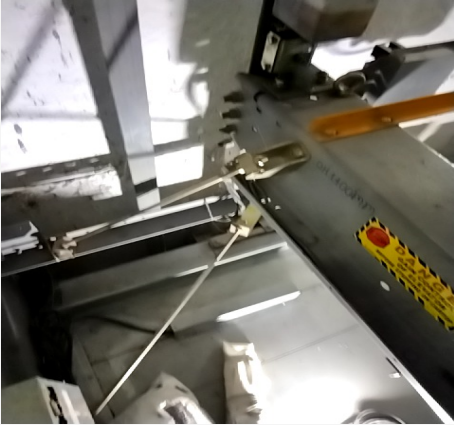
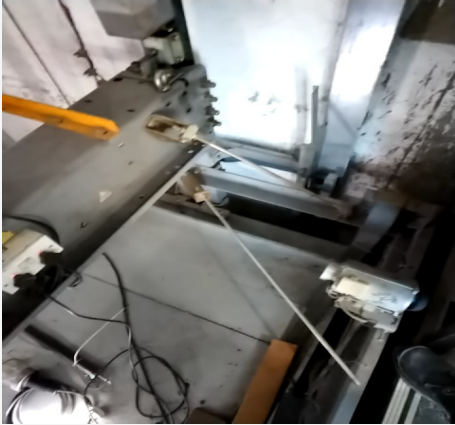
S.No.	DESCRIPTION	SL 1	SL 2	OBSERVATION
6	3 PIN SOCKET	Y	Y	Complied
No Image Captured				
7	BALUSTRADE OF CAR TOP	N	N	Y - Complied, N - Not Complied

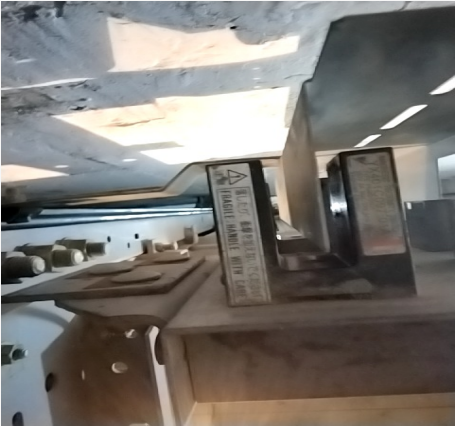
</div> <div>SL 2</div>

S.No.	DESCRIPTION	SL 1	SL 2	OBSERVATION
12	UP FINAL LIMIT SWITCH CONDITION /OPERATION	Y	Y	Complied
No Image Captured				
13	INDUCTOR SW. & CAM ALIGNMENT/CONDITION	Y	N	Y - Complied, N - Not Complied
<div>

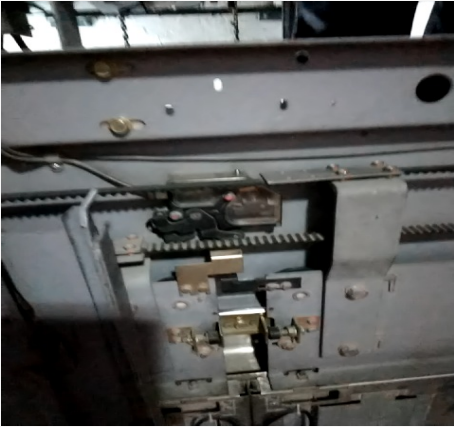
S.No.	DESCRIPTION	SL 1	SL 2	OBSERVATION
22	CONDITION OF CAR DOOR OPERATOR	Y	Y	Complied
No Image Captured				
23	CAR DOOR CONTACT(SWITCH) OPERATION	N	N	Y - Complied, N - Not Complied

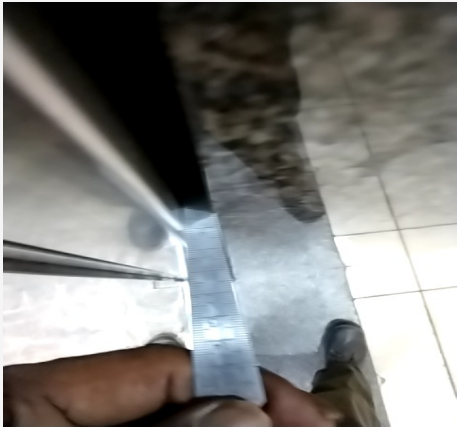
</div> <div>SL 1</div>

S.No.	DESCRIPTION	SL 1	SL 2	OBSERVATION
2	ACCESSIBILITY OF UNLOCKING DEVICE	Y	Y	Complied
No Image Captured				
3	DOOR PANEL TO DOOR PANEL /JAMB GAP	N	Y	Y - Complied, N - Not Complied
<div>
