# **PUBLIC SAFETY AT LOW-HEAD DAMS**

*By Kenneth R. Wright, P.E.,<sup>1</sup> T. Andrew Earles, Ph.D., P.E.,<sup>2</sup>  
and Jonathan M. Kelly, P.E.<sup>3</sup>*

## **Abstract**

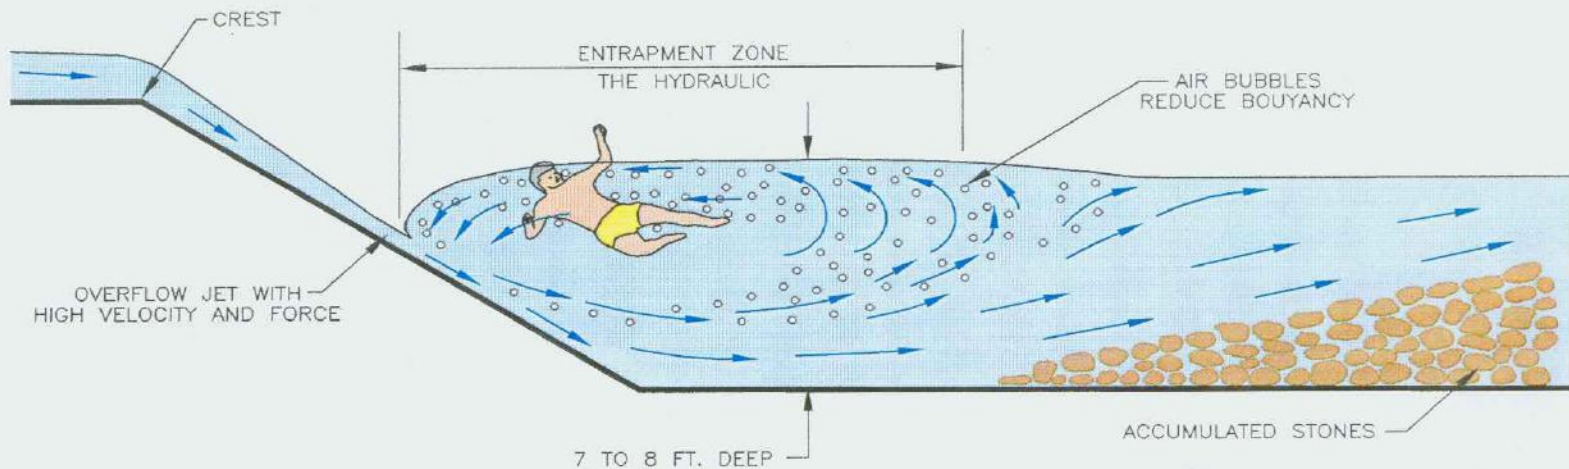
Figure 1  
GCS at Salt River,  
Tempe, Arizona

As a result of a highway project and improvements to the channel of the Salt River through Tempe, Arizona, GCSs in a series were under construction in the 1991–1993 period to control bed erosion. One GCS, No. 5, immediately downstream of the McClintock Bridge, was built of compacted soil cement 378 feet with a height of 5 feet, with a stilling pool 64 feet long and 4 feet deep, as illustrated in Figure 1.

At the likely location where the two canoes passed over the GCS, the vertical hydraulic drop on March 25, 1993 was only 4 feet. The velocity of flow at the crest was about 9 fps, with a depth of 1.4 feet. Where the overflow jet met the downstream water surface, it had an estimated velocity of 17 fps, plunging into the stilling basin to create a submerged hydraulic jump. Kinetic energy in the submerged jet was maintained until the jet rose to the surface downstream of the crest where a boil was formed. Some of the jet flowed downstream and some flowed upstream, back towards the GCS face and the plunging jet. Based on photographs and video records, the water flow character downstream of the GCS appeared somewhat smooth and tranquil, but bubbles rising to the surface and some debris bobbing in the water at the downstream face of the GCS told another story; this was a drowning machine.

- (1) Overflow jet produces large submerging force on victim.
- (2) Air bubbles reduce buoyancy of victim.
- (3) Reverse flow in upstream direction carries debris and victims back into overflow jet.
- (4) Water too deep for standing.

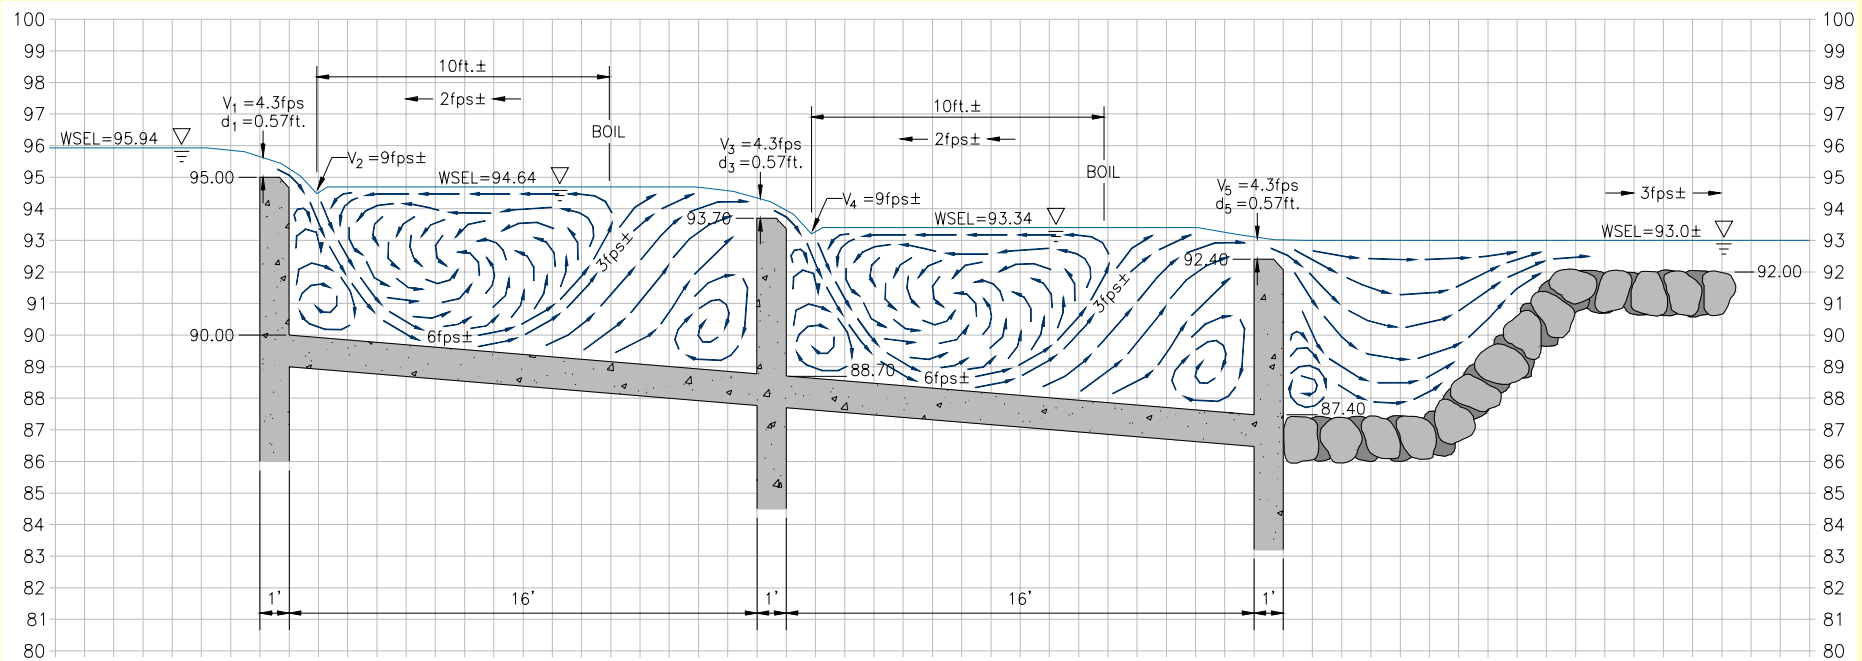
# Figure 2 – Swackhammer Dam on Catherine Creek Near Union, Oregon

The tragic drowning of a mother and daughter near Union, Oregon on June 30, 1996 was caused by one or more reverse rollers, where the hydraulic drop from one set of weirs to another was only 1.3 feet. It was here on Catherine Creek that the old Swackhammer Dam was replaced with a modern drop structure to facilitate fish passage, as shown in Figure 2. The U.S. Bureau of Fisheries and the State of Oregon designed the structure; both neglected to consider hazards created by submerged hydraulic jump reverse rollers to the general public.

The total hydraulic drop across the new structure was only 2.9 feet at 160 cfs, the vertical drop being distributed over three concrete weirs in series. The flow velocity at each weir crest was 4.3 fps, while the jet velocity impinging on the lower water surface was 9 fps. Water depth in the pools was 5.6 feet, and the reverse roller was about 10 feet long. A relatively slow reverse current of 2.0 fps provided the hydraulic trap for the two victims.

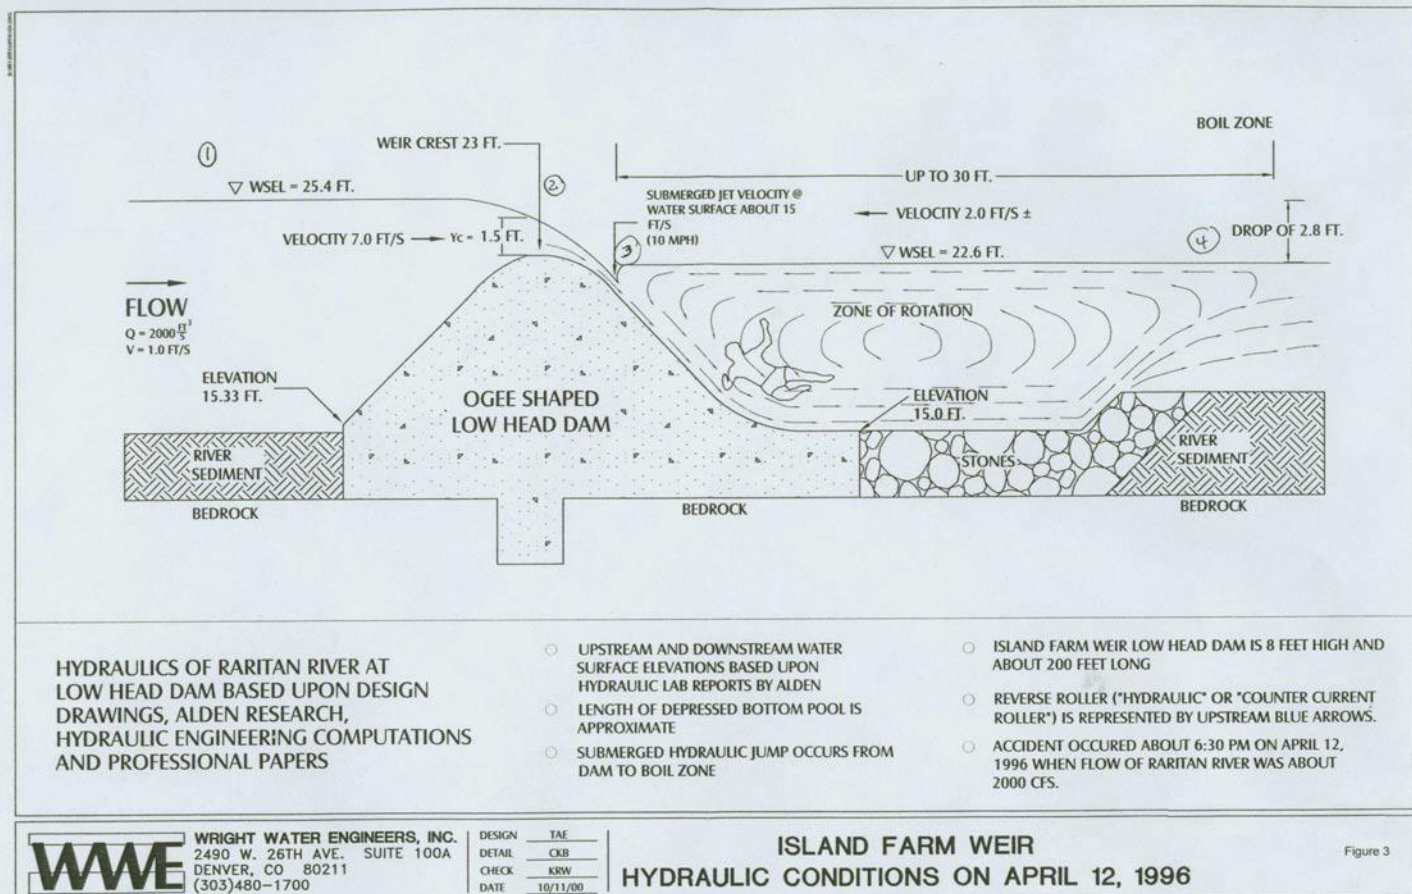
# Figure 3 – Island Farm Weir Hydraulic Conditions on April 12, 1996

Even though the dam was 8 feet high, the hydraulic drop across the dam, from upstream to downstream, was only 2.8 feet, due to the stilling basin depth and the high tailwater conditions. At the crest of the dam, the velocity was 7 fps, with a depth of 1.55 feet. Meanwhile, where the overflow jet met the downstream pool, the velocity had increased to over 13 fps, with a Froude number of 2.8.

Figure 3 illustrates the dam and hydraulic characteristics at the time of the drowning and shows the length of the reverse roller at 30 feet, with an upstream velocity toward the dam of only a modest 2.0 fps; yet the current was able to trap the victim causing his expiration and the injury of two companions.

The Island Farm Weir was finally retrofitted in 1998 after four drownings in only three years following its construction. The successful retrofit consisted of merely flattening the downstream face of the dam by providing a series of steps to dissipate energy and to eliminate the opportunity for a reverse roller to form below the dam structure.

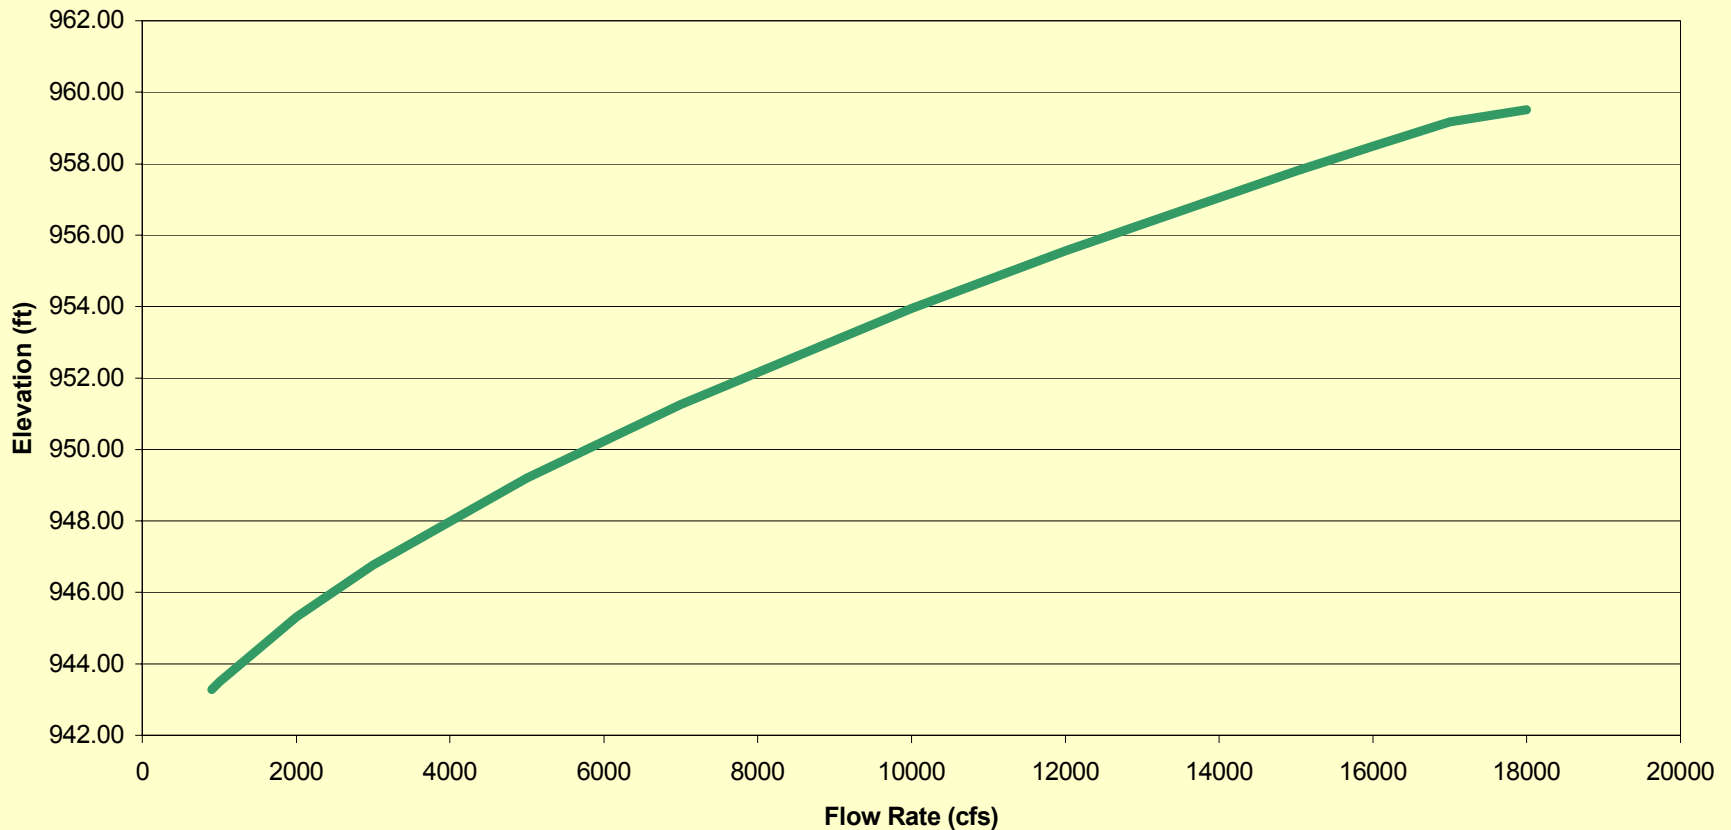
# Figure 4 – Tailwater Elevation Rating Curve for Highland Dam

At the time of the incident, the depth of the flow over the crest was 0.97 feet at a velocity of 4.0 fps. The tailwater elevation was 7.9 feet below the dam crest with a vertical upstream-downstream water surface drop of 8.9 feet and a jet velocity of 24.2 fps where the jet plunged into the downstream pool (Froude number of 9.0). The jet surfaced approximately 40 feet

downstream of the dam at a boil, where the remaining kinetic energy in the jet caused a small water surface rise with bubbles, with a portion of the jet flowing upstream at a relatively high velocity of 6.5 fps. The tailwater rating curve and the submerged hydraulic jump characteristics are presented in Figures 4 and 5.

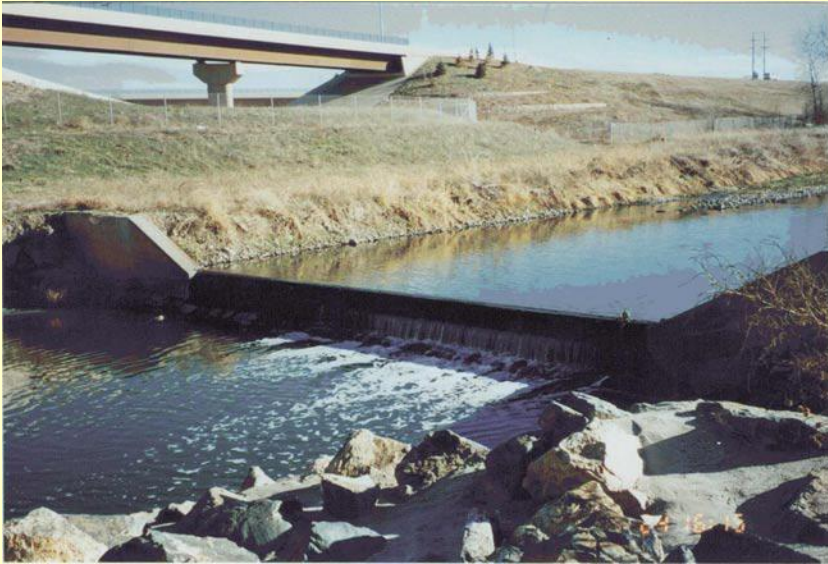
Wall A

The Colorado Department of Transportation (CDOT) constructed three low-head GCS structures in series in Clear Creek under Interstate 25 during 1991 and 1992. On June 30, 1996, a man and wife floated down Clear Creek in Adams County, along with another couple; upon encountering the first GCS, their raft capsized, and the first couple was tragically drowned. The second couple survived. The stream flow was about 700 cfs at the time of the incident. The GCS structure is shown in Figure 6.

In May 1992 prior to the accident, the director of the local county Parks and Recreation Department wrote to CDOT informing them of the hazardous nature of the GCS design and construction. By June 1998, the three GCS structures were retrofitted by creating a 1:10 sloping, grouted, riprap surface downstream of each crest. This created enough of a horizontal flow vector, hydraulic roughness, and shallow enough flow depth immediately below each structure so that reverse rollers no longer form.

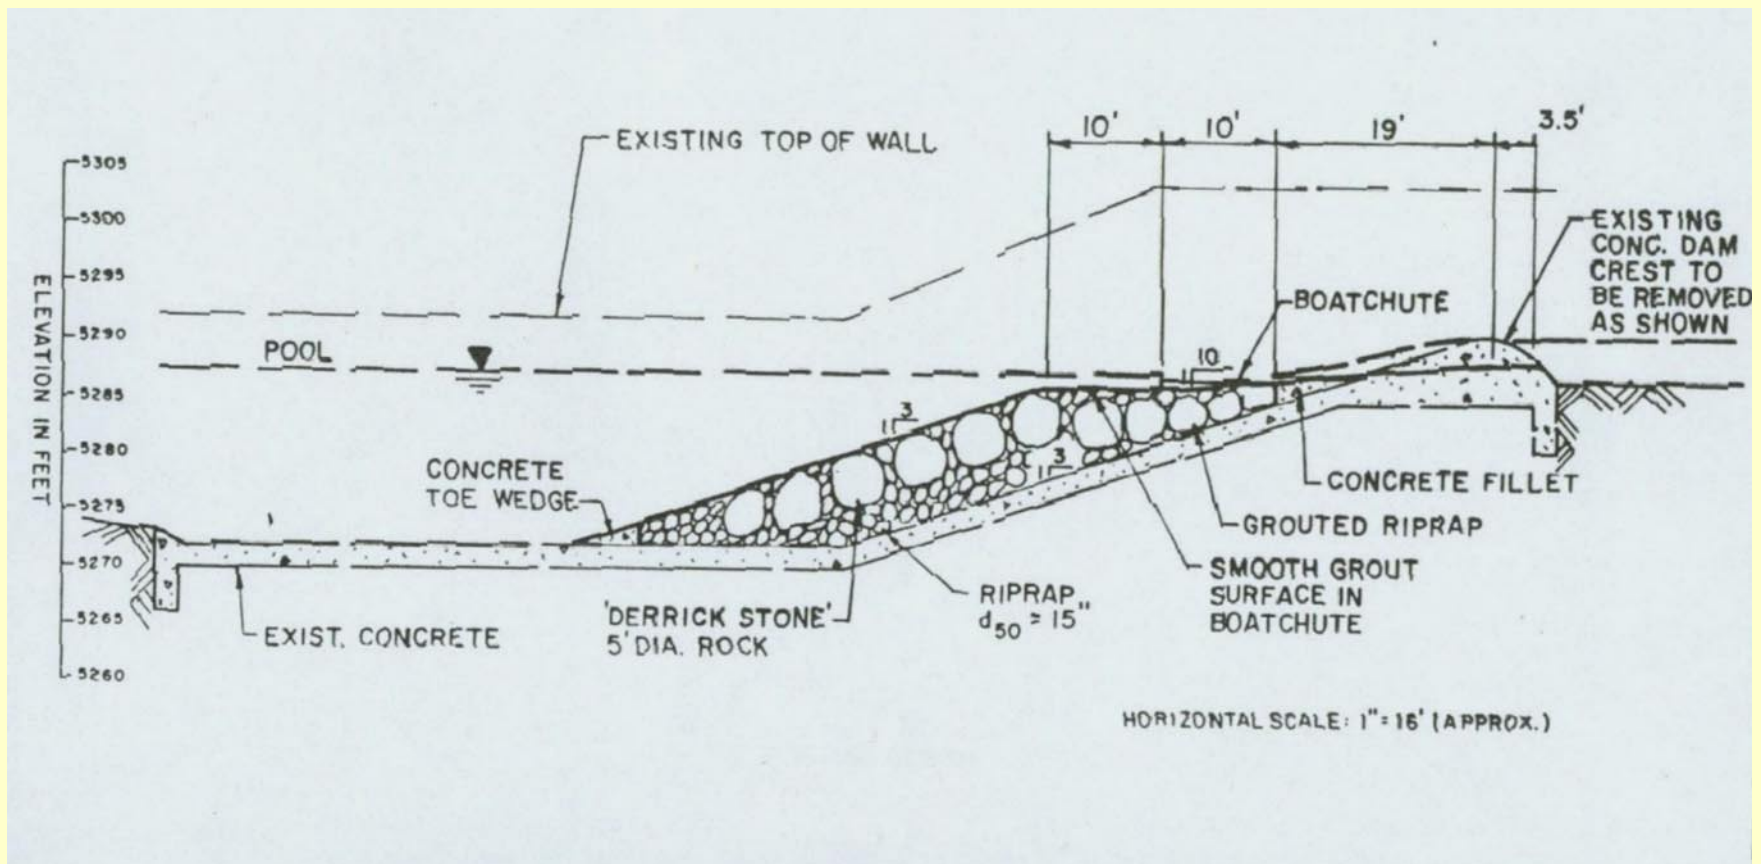
# Figure 7 – Boating Improvements to Union Avenue Dam (Section Thru Existing Dam)

When the USACE replaced the historic St. Petersburg Ditch diversion dam in 1985 on the South Platte River with a new structure, they did not give adequate consideration to the pre-design period recommendations of local recreational boaters. The new structure was called the Union Avenue Dam. Its profile is shown in Figure 7.

The new dam was an 18.5 feet high, concrete gravity dam with an over-the-dam spillway that sloped at 33 percent into a stilling basin, the hydraulic drop being 15 feet. Typical spring river flows over the dam of 700 cfs, and even up to higher flows such as 1,300 cfs, gave the sound and appearance of a good whitewater rafting experience, and the stilling basin provided an attractive urban setting for recreationists to practice hazard maneuvers. The South Platte River classification by the State of Colorado included recreational uses.

The solution was to build a boat chute near the right abutment and to flood the downstream face of the dam with a series of four downstream stair-stepped embankments so that each hydraulic drop would be only 3 to 4 feet high, and each embankment would include a designed boat chute that would safely convey recreational boaters without a reverse roller being formed.

Fortunately, the state agency was willing to have the design tested using a 1:18 hydraulic model built by the U.S. Bureau of Reclamation's hydraulic laboratory at the Denver Federal Center. The extensive model testing effort also included the placement of rock fill on the downstream face of the dam to eliminate dangerous currents, even during higher flow periods when discharges exceeded the boat chute flow. Their thorough and comprehensive model study and report by Klumpp, Pugh, and Fitzwater (1989) was highly successful; the resulting retrofit of the Union Avenue Dam converted a serious public hazard into a popular water recreational park.
