Investigation of Partial Discharge Activity and Insulation Life of a Large Hydro Generator

Keywords—stator winding, partial discharge, insulation life, delamination, dissection analysis

I. BACKGROUND

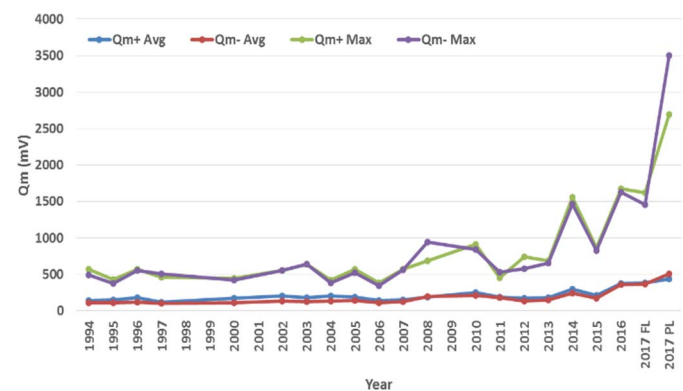
Since 1994, PD activity of the stator winding is monitored by means of four PD couplers per phase. Each phase has eight parallel circuits and the existing couplers monitor only half the winding. Nevertheless, periodic and more recently, continuous PD monitoring, has been an effective tool in evaluating the stator winding condition. Fig. 1 shows the PD activity of the generator in the form of the largest repeatedly occurring PD magnitude with repetition rate of 10 pulse per second, commonly known as Q_m [2]. The graph shows the maximum and the average Q_m for positive and negative pulses recorded by the total of 12 PD couplers. The graph shows that the PD activity has been fairly stable until 2006 with a maximum Q_m of 500 mV for a specific circuit and the average for all couplers of under 150 mV. From 2007, the maximum Q_m shows unstable behavior which is followed by a significant increase in beginning in 2013.

In addition, the last two measurements in 2017 show an inverse PD temperature/load effect. During a full load hot measurement at 485 MW and a stator winding temperature of

72°C, the maximum recorded Q_m was +1618/-1460 mV. With a load change down to 358 MW and stator winding temperature of 55°C, the Q_m increased to +2695/-3500 mV. Additional investigation of PD behavior using phase resolved PD (PRPD) patterns at different loads and temperatures suggested that the winding may have delamination and/or debonding. Delamination was considered likely given the winding design (i.e. 3 m core stack height) and the fact that this generator had been used as a peaking unit and been subjected to thermal cycling for over 30 years.

Fig. 1. Trend of PD activity of the generator. The data was taken at full load hot, except the last datapoint that was taken at partial load and a lower temperature.

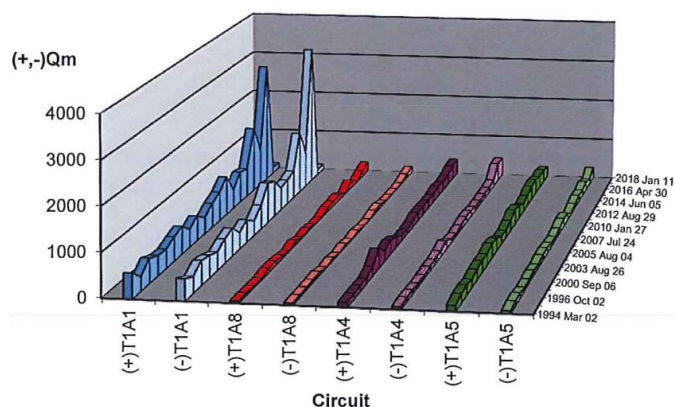
The continuous on-line monitoring system recorded PD activity exceeding 4000 mV, which was significantly above the published limits of concerns for the highest activity of hydro generators in the 16–18 kV voltage class [3]. On-line PD test results indicated that the maximum PD activity on all circuits with PD couplers had been less than 500 mV except for circuit T1A1 that had the maximum recorded PD on the winding. See Fig. 2 for historical PD readings of phase A couplers.

Fig. 2. Maximum PD activity trend of phase A circuits

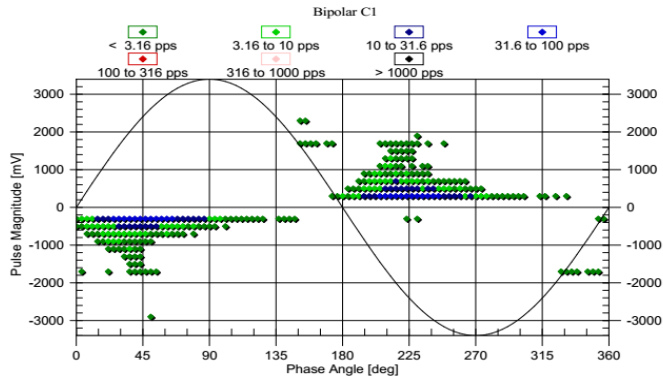
Fig. 3. PD Activity of bar 615 at 10 kV, measured with 1000 pF coupler

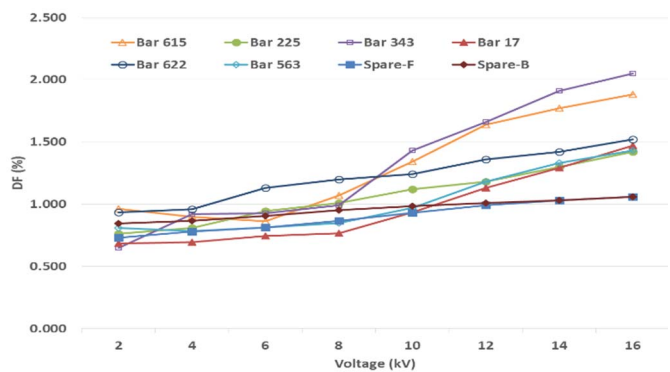
Fig. 4 shows that the bars have fairly comparable DF at voltages up to 8 kV, however the rate of increase in loss changes for different bars at higher voltages. Bars 615, 343, and 563 are three bars with fairly high dissipation factor tip-up, and ΔC (Fig. 5 and 6). This is believed to be a sign of major voids or delamination within the insulation. Spare-F bar and Spare-B bar show the lowest tip-up, and ΔC in both voltage ranges. This was expected and agrees with their low PD activity.

Fig. 4. Dissipation factor between 2 and 16 kV

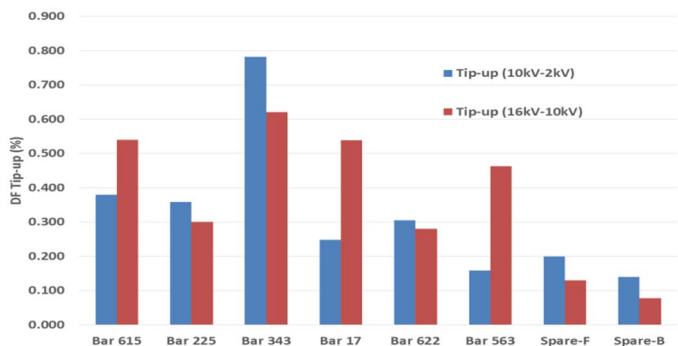
Dissipation factor (DF) and capacitance were measured over a range of voltages between 2 and 16 kV with 2 kV steps. Fig. 4 shows the DF for all the bars. Fig. 5 shows the DF tip-up in two voltage ranges. Tip-up between 2 kV and 10 kV could be considered as representative of the losses that are created by the electrical stresses at operating conditions. The DF between 10 and 16 kV represents losses that are triggered at higher than operating voltages. The comparison between these two DF tip-up values could be useful in estimating the extent of the larger voids/delamination that are triggered only at voltages higher than operating voltage. The change in capacitance value, ΔC , between two test voltages could also be an indirect indication of voids and delamination. Therefore, comparing the DF, tip-up, and ΔC , along with the PD patterns, could give an indication of voids/delamination and associated losses at different voltage levels.

Fig. 5. Dissipation factor tip-up between 10-2 and 16-10 kV

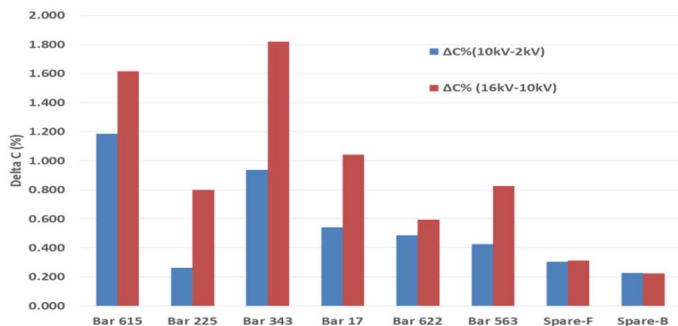
Fig. 6. ΔC between 10-2 and 16-10 kV

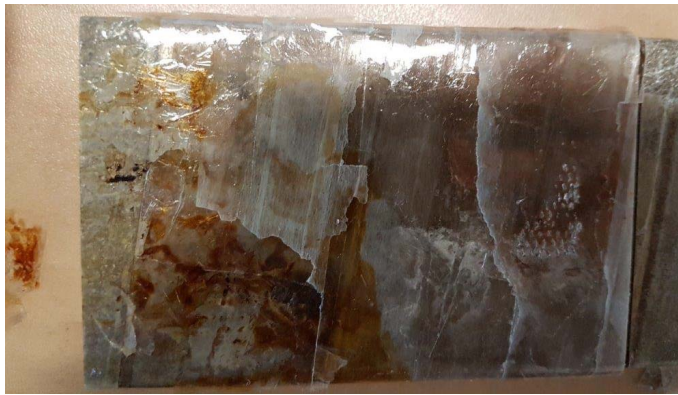
Fig. 7 shows signs of severe PD in the bar 615 innermost layers of insulation. This bar showed the highest on-line and off-line PD and corona probe readings. Fig. 8 shows debonding for the same bar. For the service-aged bars, the peeling method showed a very weak bond between the copper and insulation. Bonding in the bulk of the insulation was found to be fairly strong and the taping was consistent with minor folds and waves.

Fig. 7. Signs of severe PD in bar 615 within the innermost layers of insulation

After the bars were replaced, corona probe, off-line and on-line PD measurements showed significant PD reduction. After repairs, the T1A1 circuit Qm magnitude reduced to +113/-94 mV. Prior to bar replacement, this circuit had PD activity with a Qm of as high as 4125 mV. On-line PD monitoring proved valuable in detecting the high PD activity, helped in planning for targeted tests and investigations, and reduced the urgency for larger intervention in this and the sister generators.

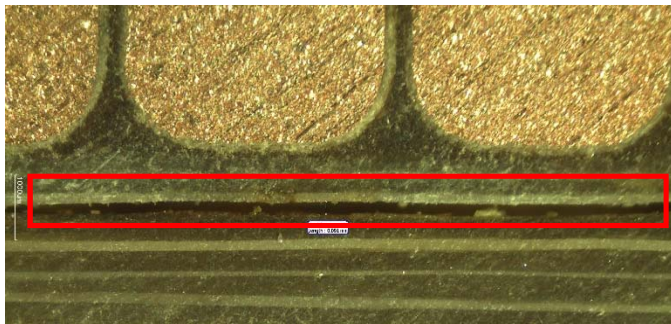
Fig. 8. Debonding of the insulation and copper in bar 615

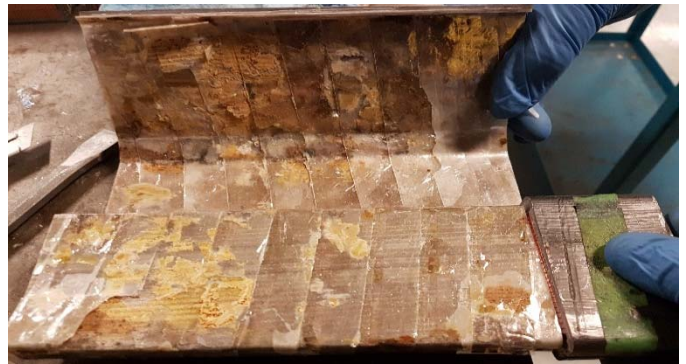
Fig. 9 shows the significant PD signs within the innermost layers of insulation for bar 225. The location of PD was consistent with the other bars, however the intensity was much higher in this bar due to the accelerated aging test (i.e. VE test) and the AC breakdown test. Despite the higher intensity, the PD activity was found to be contained within debonded area and not extended to the outer layers.

Fig. 9. Bar 225 survived the VE test despite the severe PD activity
