# Single Event Effect Test of the Embedded Local Monitor Board

H. Boterenbrood, H. J. Burckhart, B. Hallgren, H. Kvedalen and N. Roussel

**Abstract:** Embedded Local Monitor Boards (ELMB) were exposed to proton radiation up to an overall fluence of  $3.3 \cdot 10^{11}$  protons/cm<sup>2</sup>. The total number of soft SEEs detected amounted to 29, equally distributed among the different functional parts of the board. No destructive or permanent error occurred. The SRAM, EEPROM, flash memories of the master processor and the static registers were subject to a systematic study of the SEE cross-section.

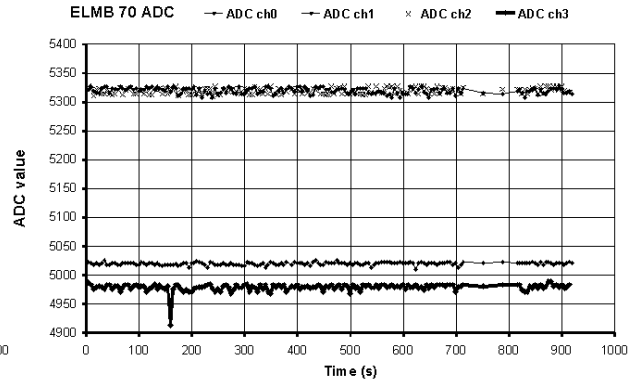
Figure 6: Bit error in channel 3 of ELMB 70

5 single bit errors were detected in the readings. They are displayed in Figures 6 and 7. (64-3, 64-4, 64-5, 64-6 and 70-2)

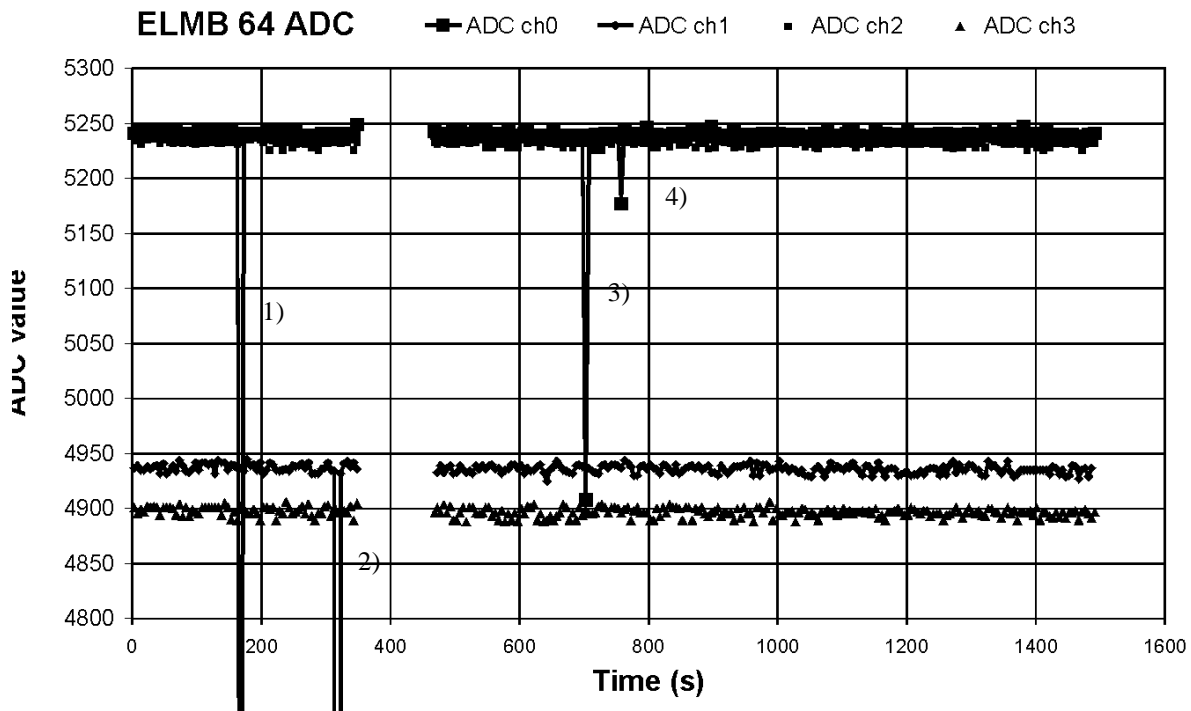
Figure 7: The following 4 bit errors were found in the readings of ELMB 64:

- 1) ADC ch0 bit error in data byte = 0x107C instead of 0x147C t=168 s
- 2) ADC ch1 bit error in data byte = 0x0344 instead of 0x1344 t=318 s
- 3) ADC ch0 bit error in data byte = 0x132C instead of 0x142C t=702 s
- 4) ADC ch0 bit error in data byte = 0x1439 instead of 0x1479 t=757 s

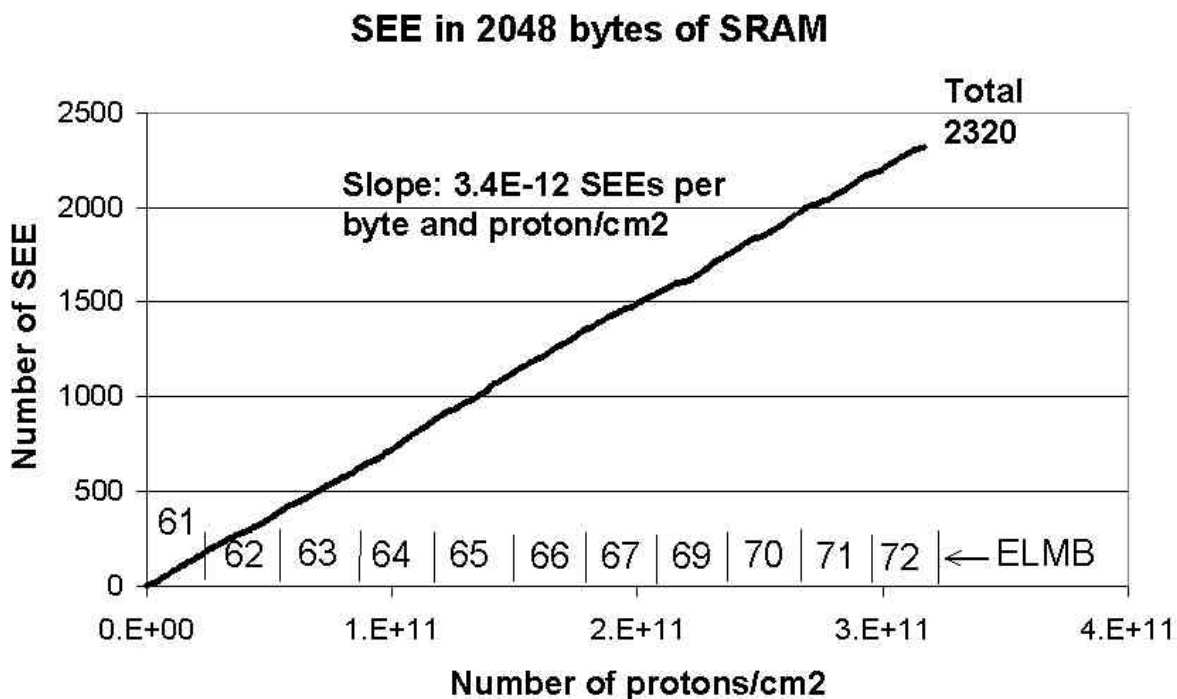
The test involved 2 Kbytes of the SRAM embedded in the ATmega103L. Figure 8 displays the total number of SEEs detected since the beginning of the test versus fluence. The series number of the ELMB under test is indicated along the X-axis. The 11 ELMBs behaved in the same way, with a common cross-section of  $3.4 \cdot 10^{-12}$  SEEs per byte and proton/cm<sup>2</sup>.

Figure 8: Total number of SEEs detected in the SRAM of the ATmega103L versus fluence

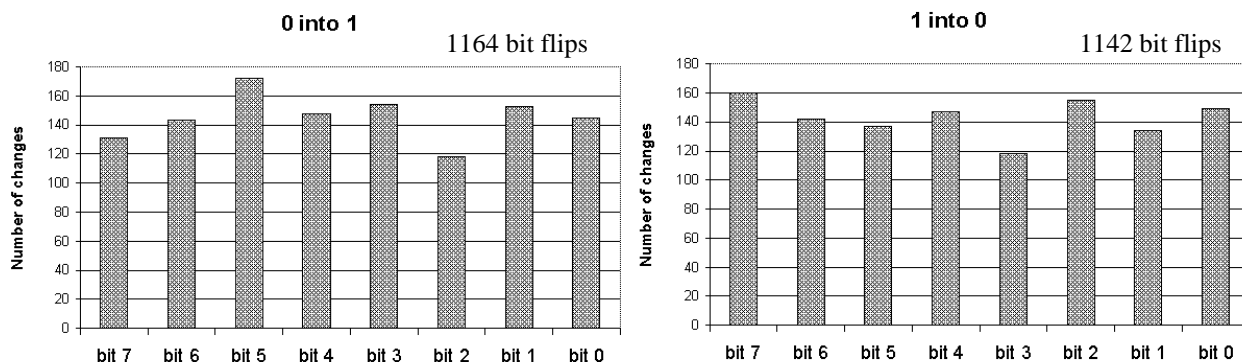
The SEEs comprised 2300 single bit flips and 3 double bit flips. There were 17 additional SEEs for which the erroneous byte value was not indicated, because more than 8 errors were detected in SRAM during each of the corresponding test cycles. The number of changes from logic 0 to logic 1 (1164) was within the statistical error the same as the number of opposite changes (1142). Moreover for both types of changes, the 8 bits were evenly affected.

Figure 9: Number of changes from 0 to 1 (from 1 to 0, respectively) in the 8 bits of the SRAM bytes

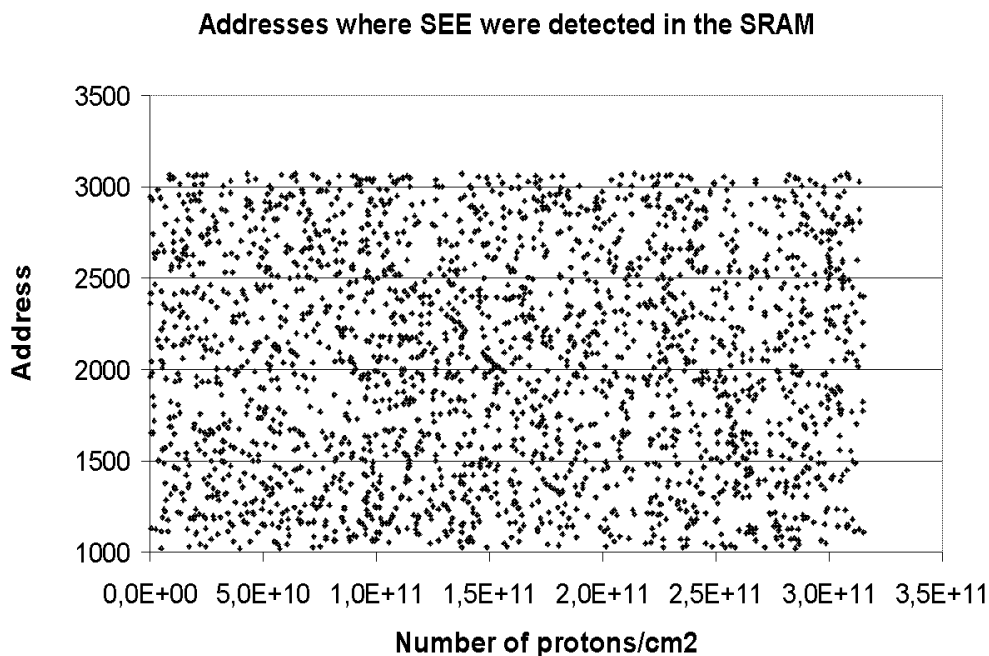
The test involved addresses 0x400 to 0xBFF (1024 to 3071 in decimal). Figure 10 indicates for each SEE in SRAM the address where it was located and the value of the fluence when it occurred. The projections of this chart onto each axis are displayed in Figures 11 and 12. They show that the SEEs were distributed evenly over the different addresses and independent from the fluence.

Figure 10: Addresses of the SRAM where the SEEs were located versus fluence

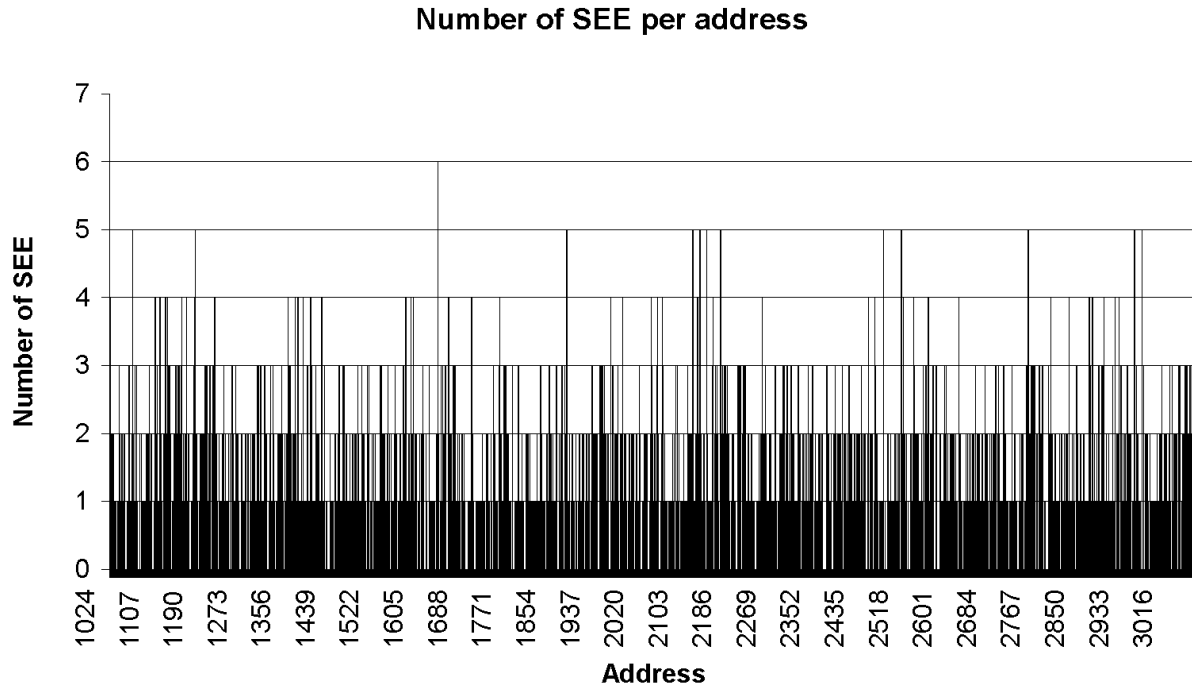
Figure 11: Number of SEEs detected in all the ELMBs per address in the SRAM

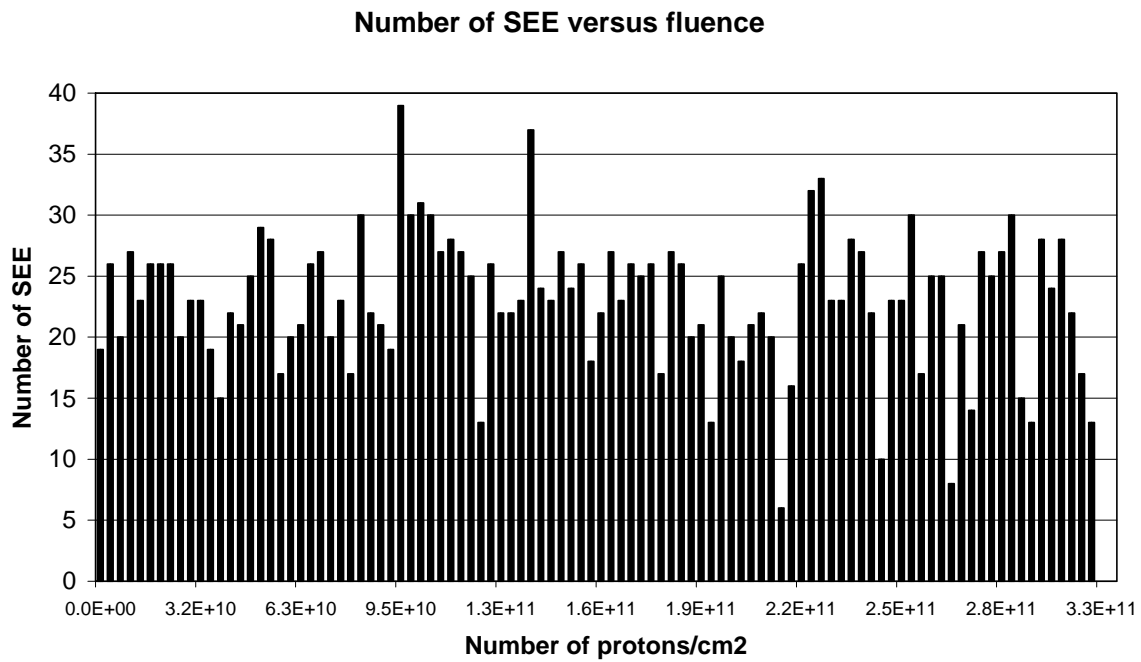
Figure 12: Number of SEEs in the SRAM versus fluence

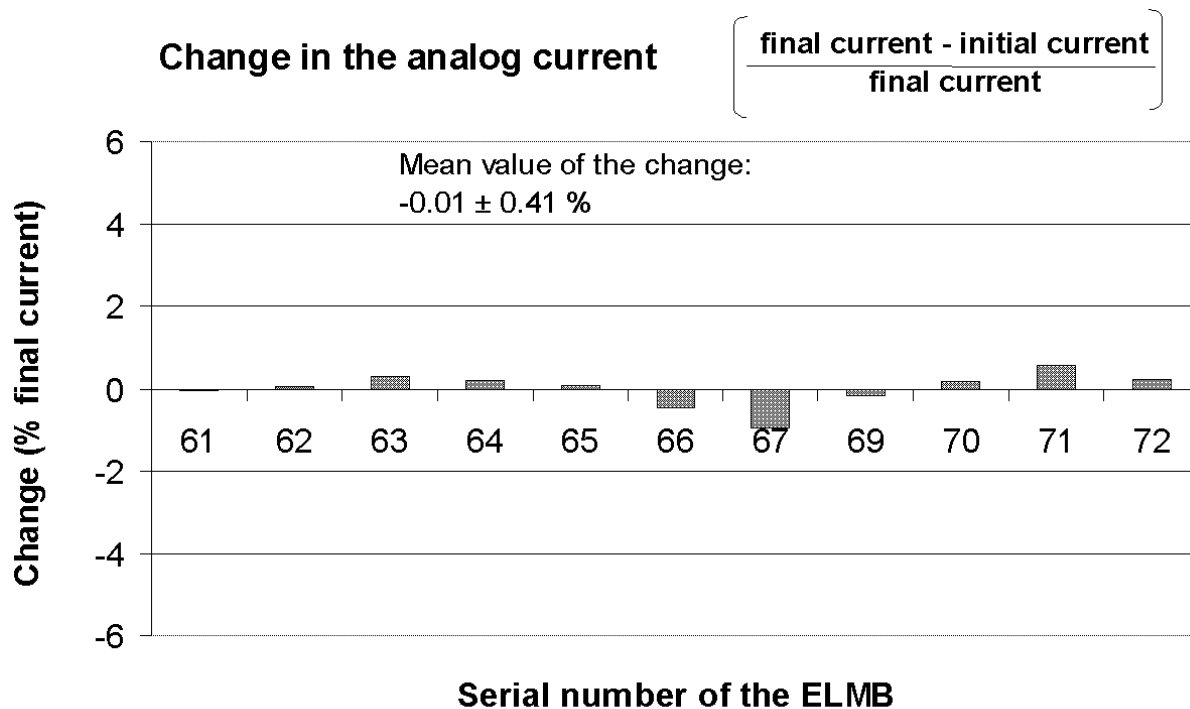
The differences between the two values are displayed in the charts below. They are all very small and within the specification.

Figure 13: Change in the analog current between the beginning and the end of the test

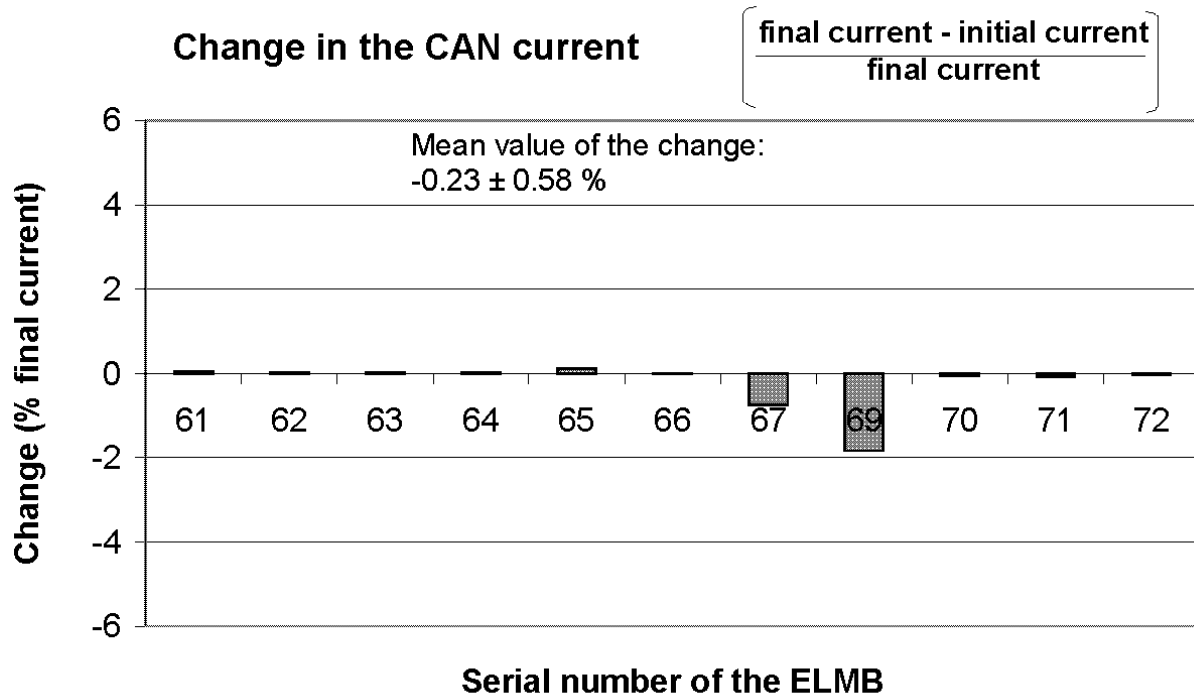
Figure 14: Change in the CAN current between the beginning and the end of the test

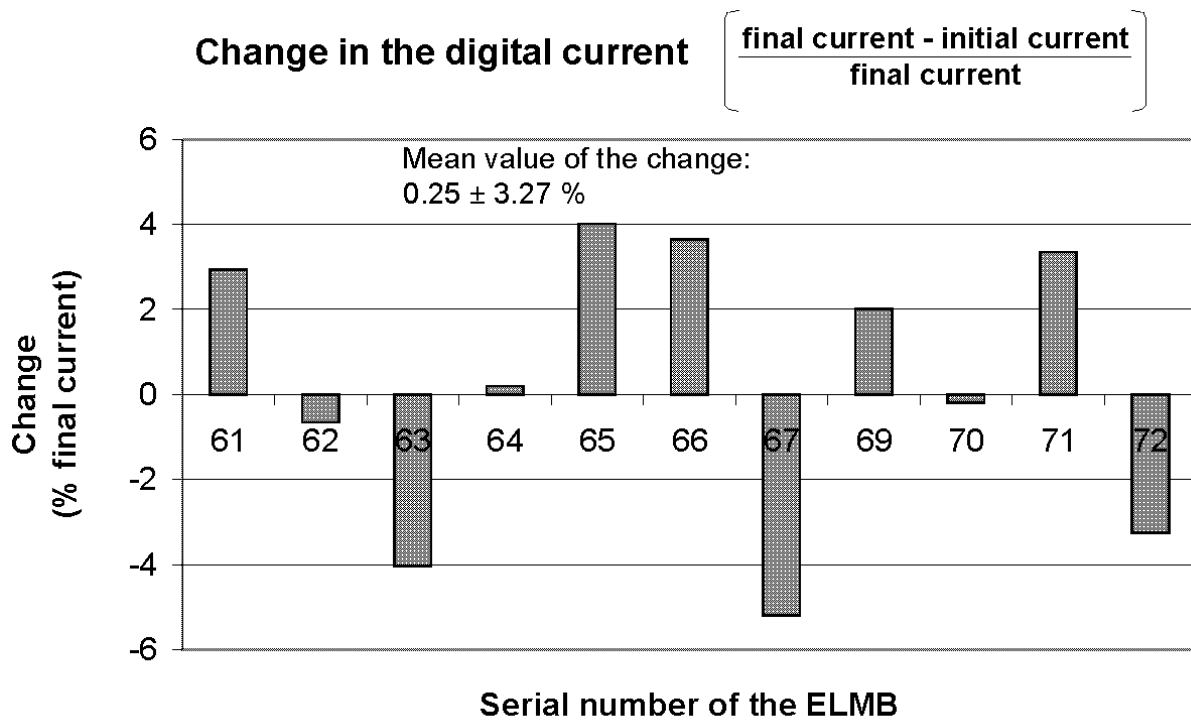
Figure 15: Change in the digital current between the beginning and the end of the test

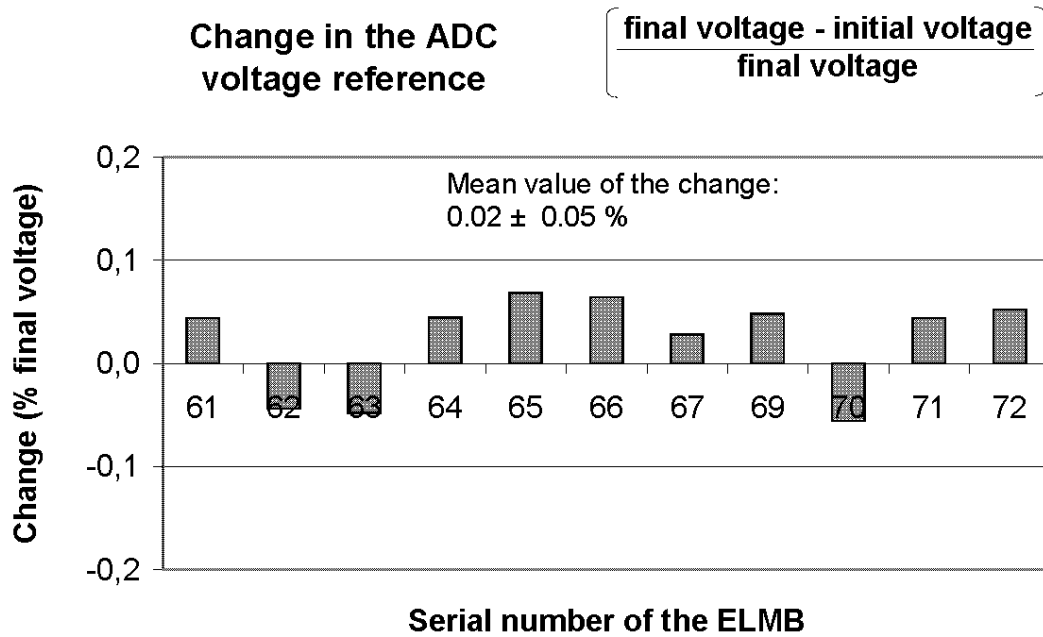
- the ADC voltage reference AD680JR, which was very stable ( $10^{-3}$ ).

Figure 16: Change in the ADC voltage reference between the beginning and the end of the test

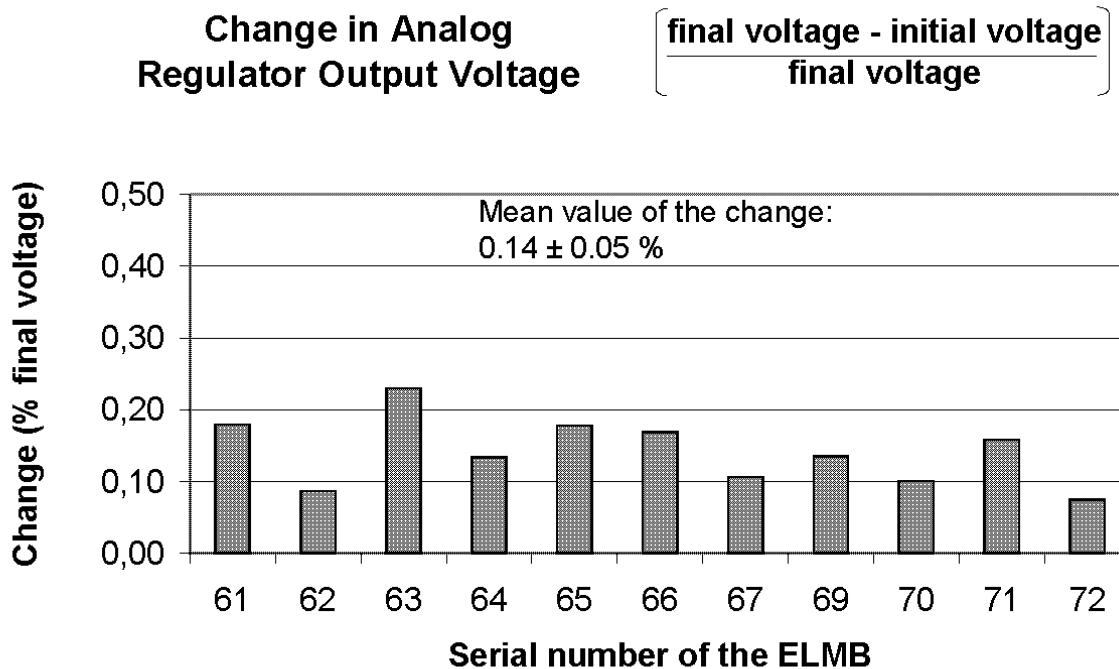
- the voltages at the output of the analog, CAN and digital regulators. All of them increased very slightly but stayed within the specification of  $\pm 3\%$ .

Figure 17: Change in the analog voltage between the beginning and the end of the test

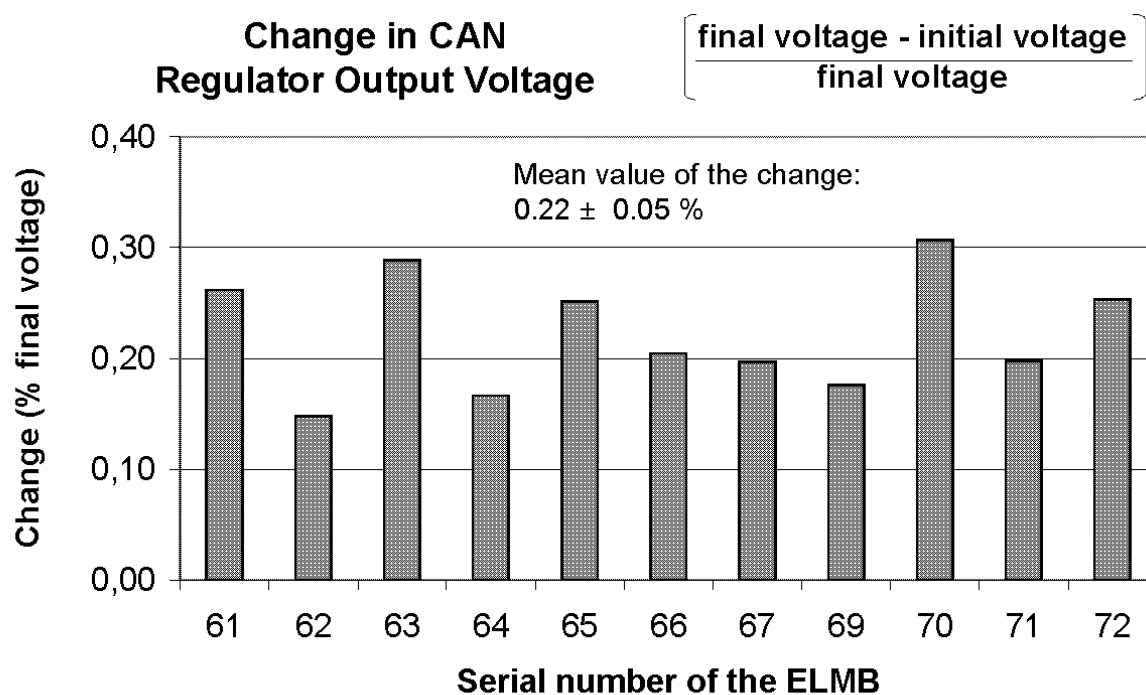
Figure 18: Change in the CAN voltage  
between the beginning and the end of the test

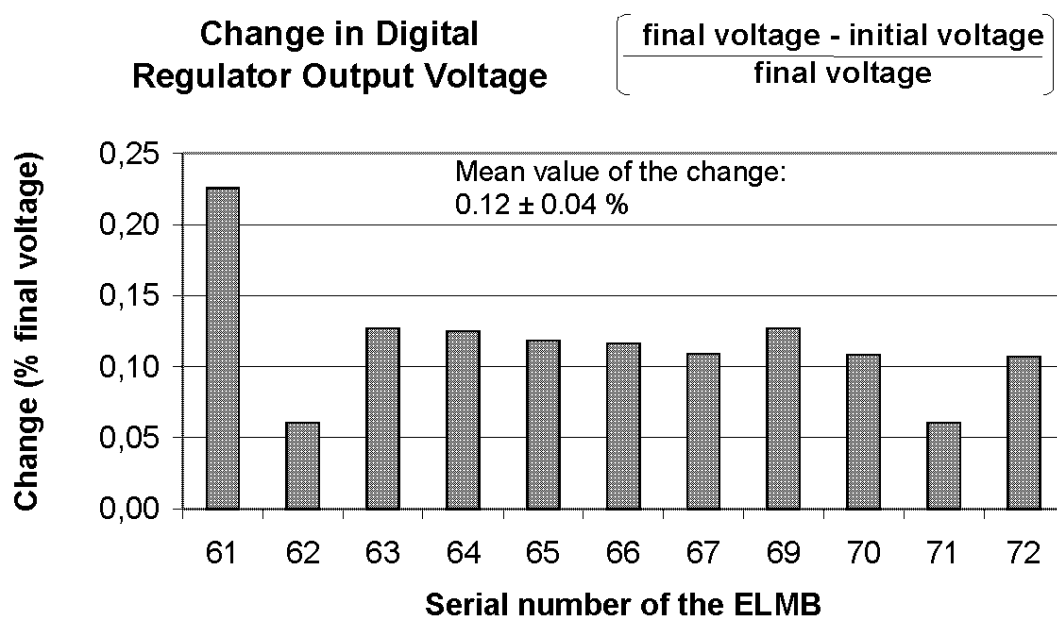
Figure 19: Change in the digital voltage  
between the beginning and the end of the test

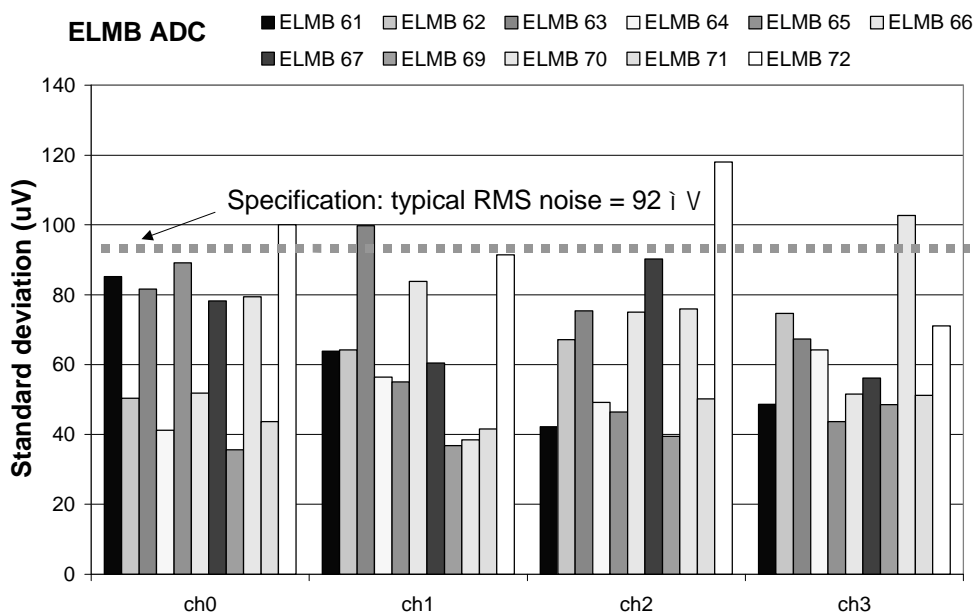
The readings of the 4 tested channels showed a standard deviation of 4.3 LSB (1 LSB =  $1.53 \times 10^{-5}$  V). The calculation has not included the wrong readings of ELMB 64 channels 0 and 1, mentioned in paragraph 3.3.1. This result is good in view of the specification indicated in the product data sheet, since the typical RMS noise is 6 LSB for the ADC configuration used during the test (1V input range and 61.6 Hz output rate). Moreover, fluence does not seem to have any influence on the noise amplitude.

Figure 20: Standard deviations of the readings of the 4 ADC channels for each ELMB
