# *Capstone Home Inspection, LLC*

## Home Inspection Report

Inspection prepared for:  
Date of Inspection: 11/7/2017

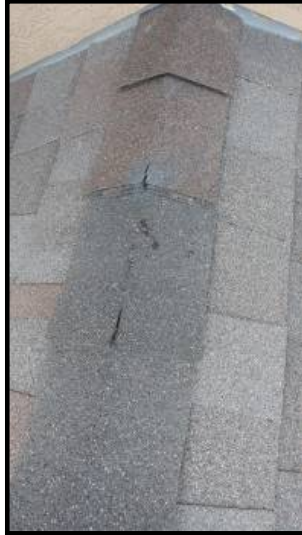
- No major system safety or function concerns observed at the readily accessible areas.
- ... typical Ridge cracking observed.

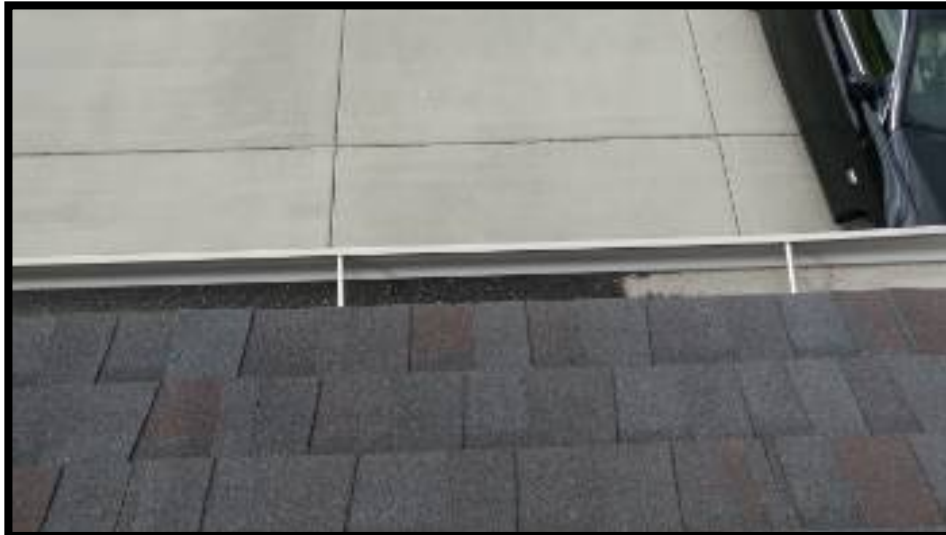
- No major system safety or function concerns observed at the readily accessible areas.
- Debris- Significant amounts of debris evident.

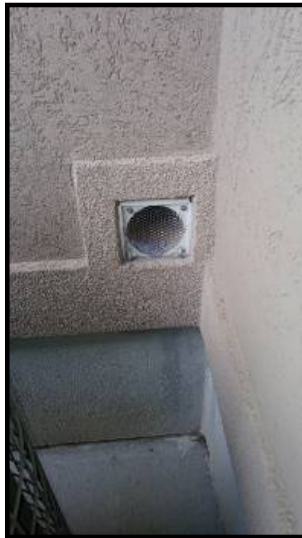
- Damaged- The dryer vent has a damaged exterior cover.

Missing cover.

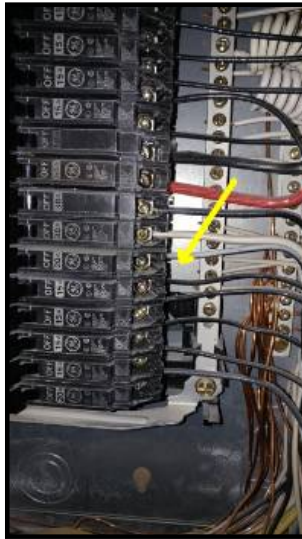
- **Recommend contacting a certified electrician to evaluate / repair if necessary. Safety hazard. One and one only 20 amp breaker is not rated for the attached wire.**

6 breaker up on the right side appears to have a 14 gauge wire for a 20 amp breaker the appropriate wire should be 12 gauge wire.

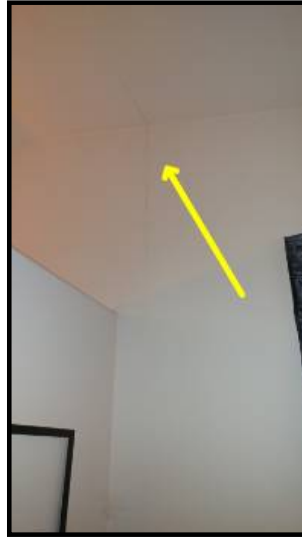
- Missing/damaged drywall observed.

There is a large crack in the ceiling and wall in the living room adjacent to the partition wall between the dining room.

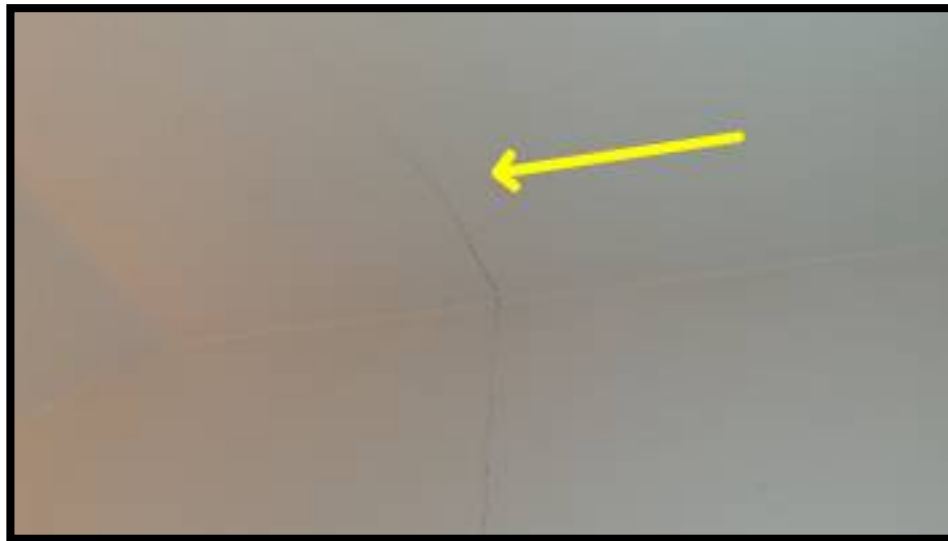
- Missing/damaged drywall observed.

Large living room crack extends to ceiling

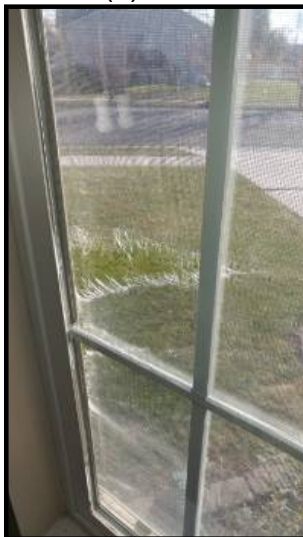
Living room window screen torn

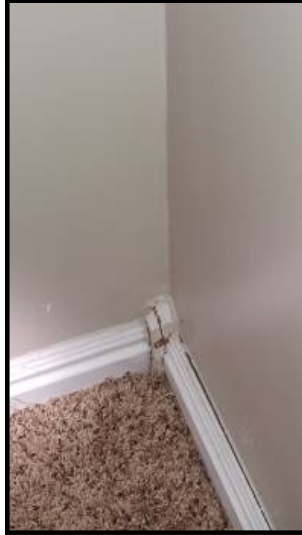
North East basement room.

- Damaged baseboards observed.

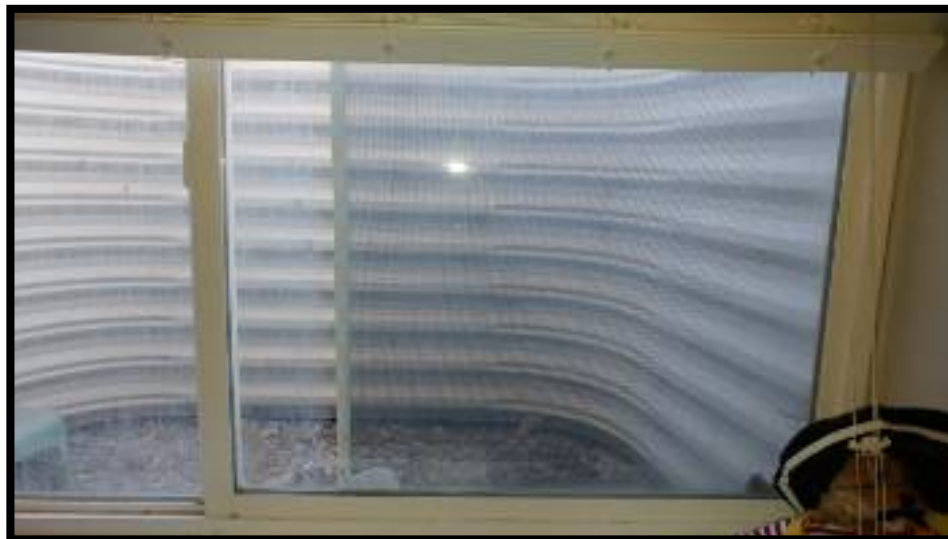
- Satisfactory- Components appeared in satisfactory condition at time of inspection.
- Screen is wrong size for window north east corner Room.

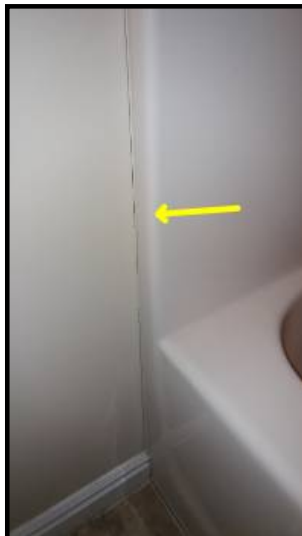
- No major system safety or function concerns noted
- Caulking deficient in areas. Recommend resealing.
- Slow drain observed.

Some areas around tub have poor caulking.

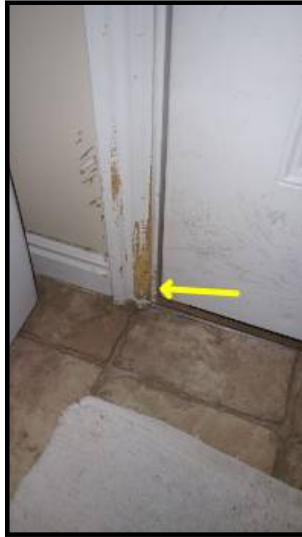
There are a few spots where a dog has scratched away at the trim
