Car Damage Detector & Reporter

Damage Analysis Report

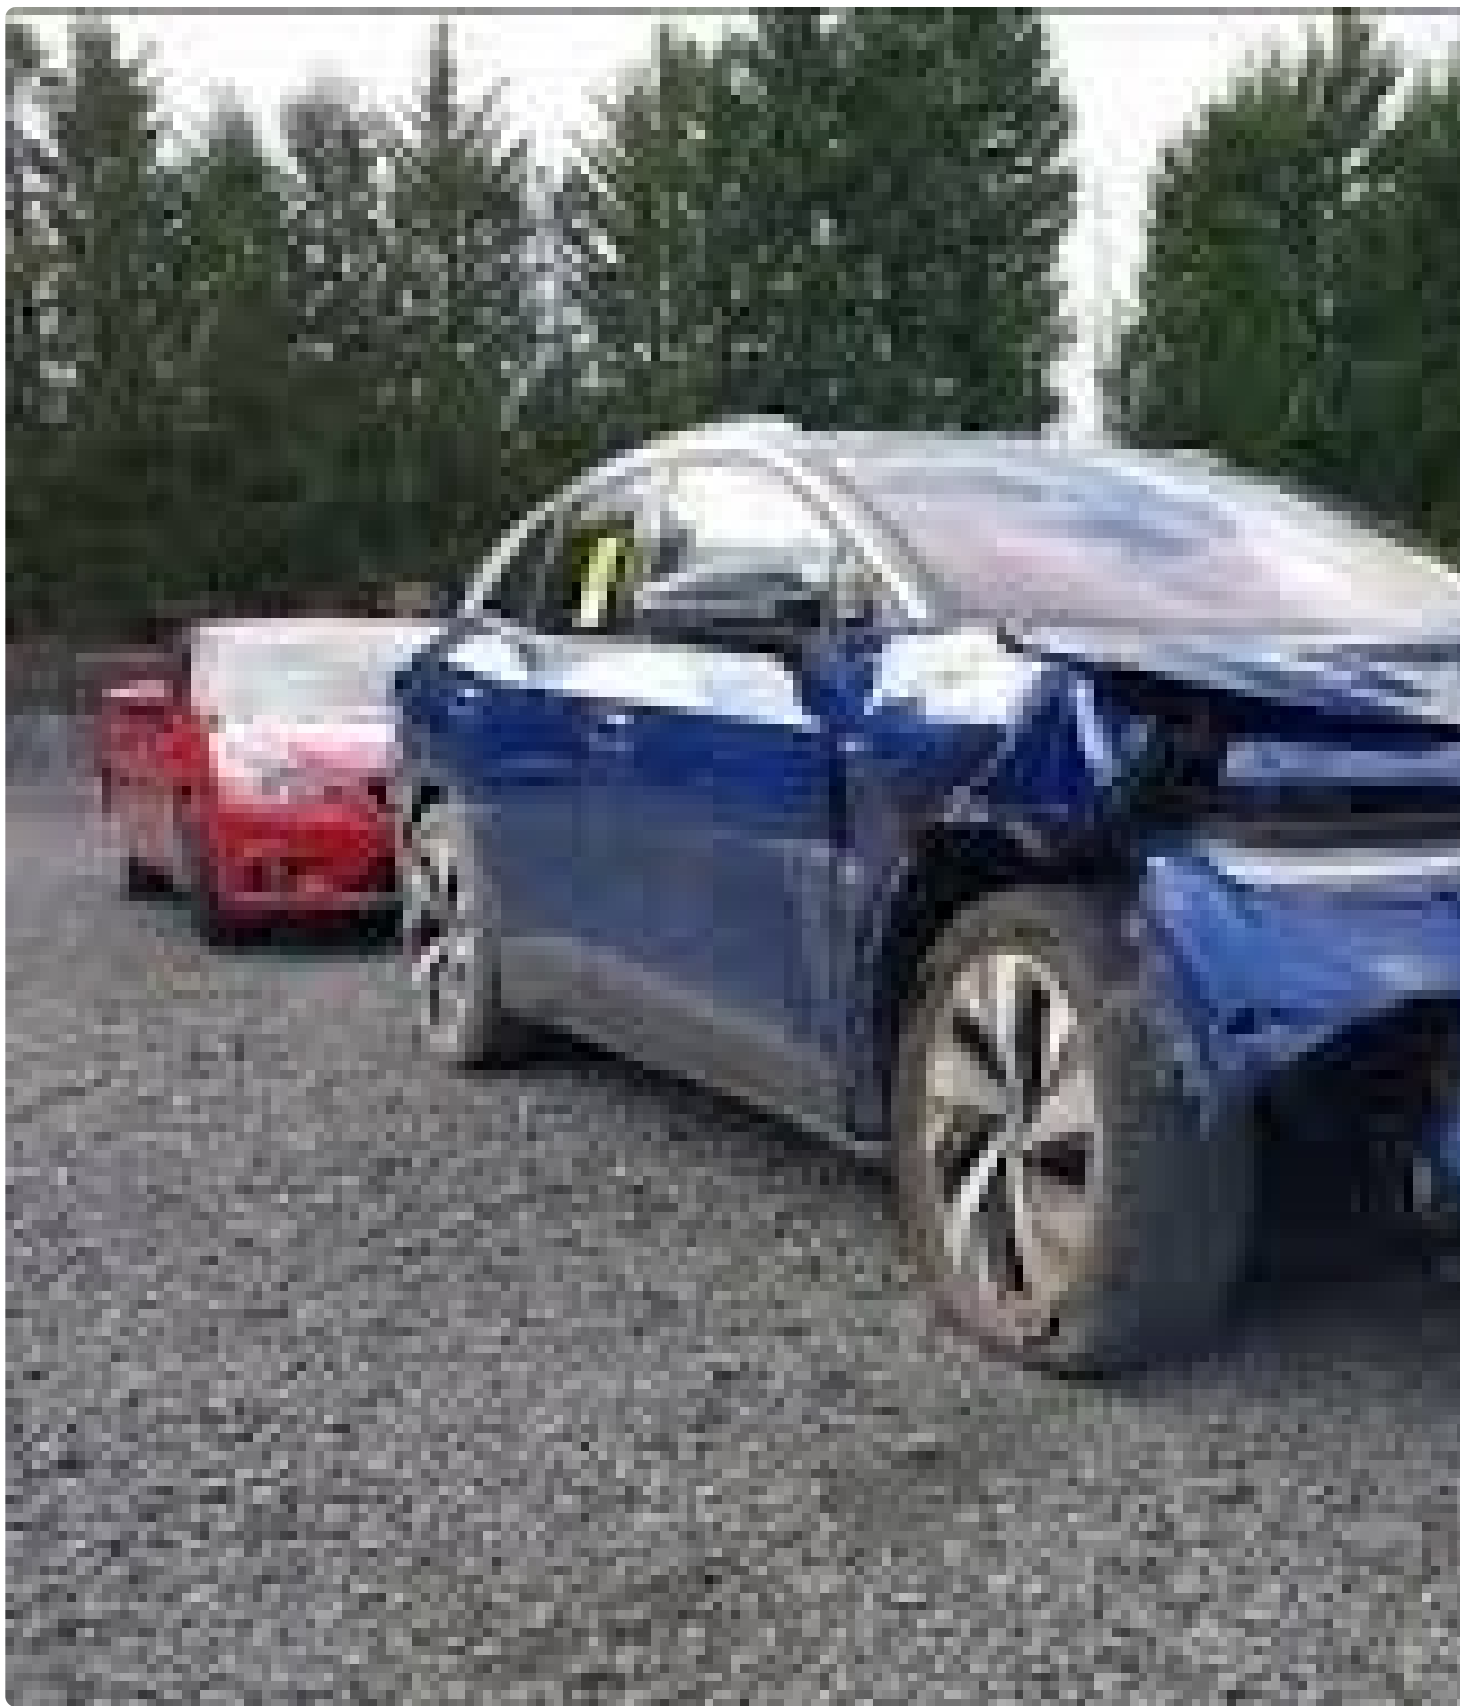
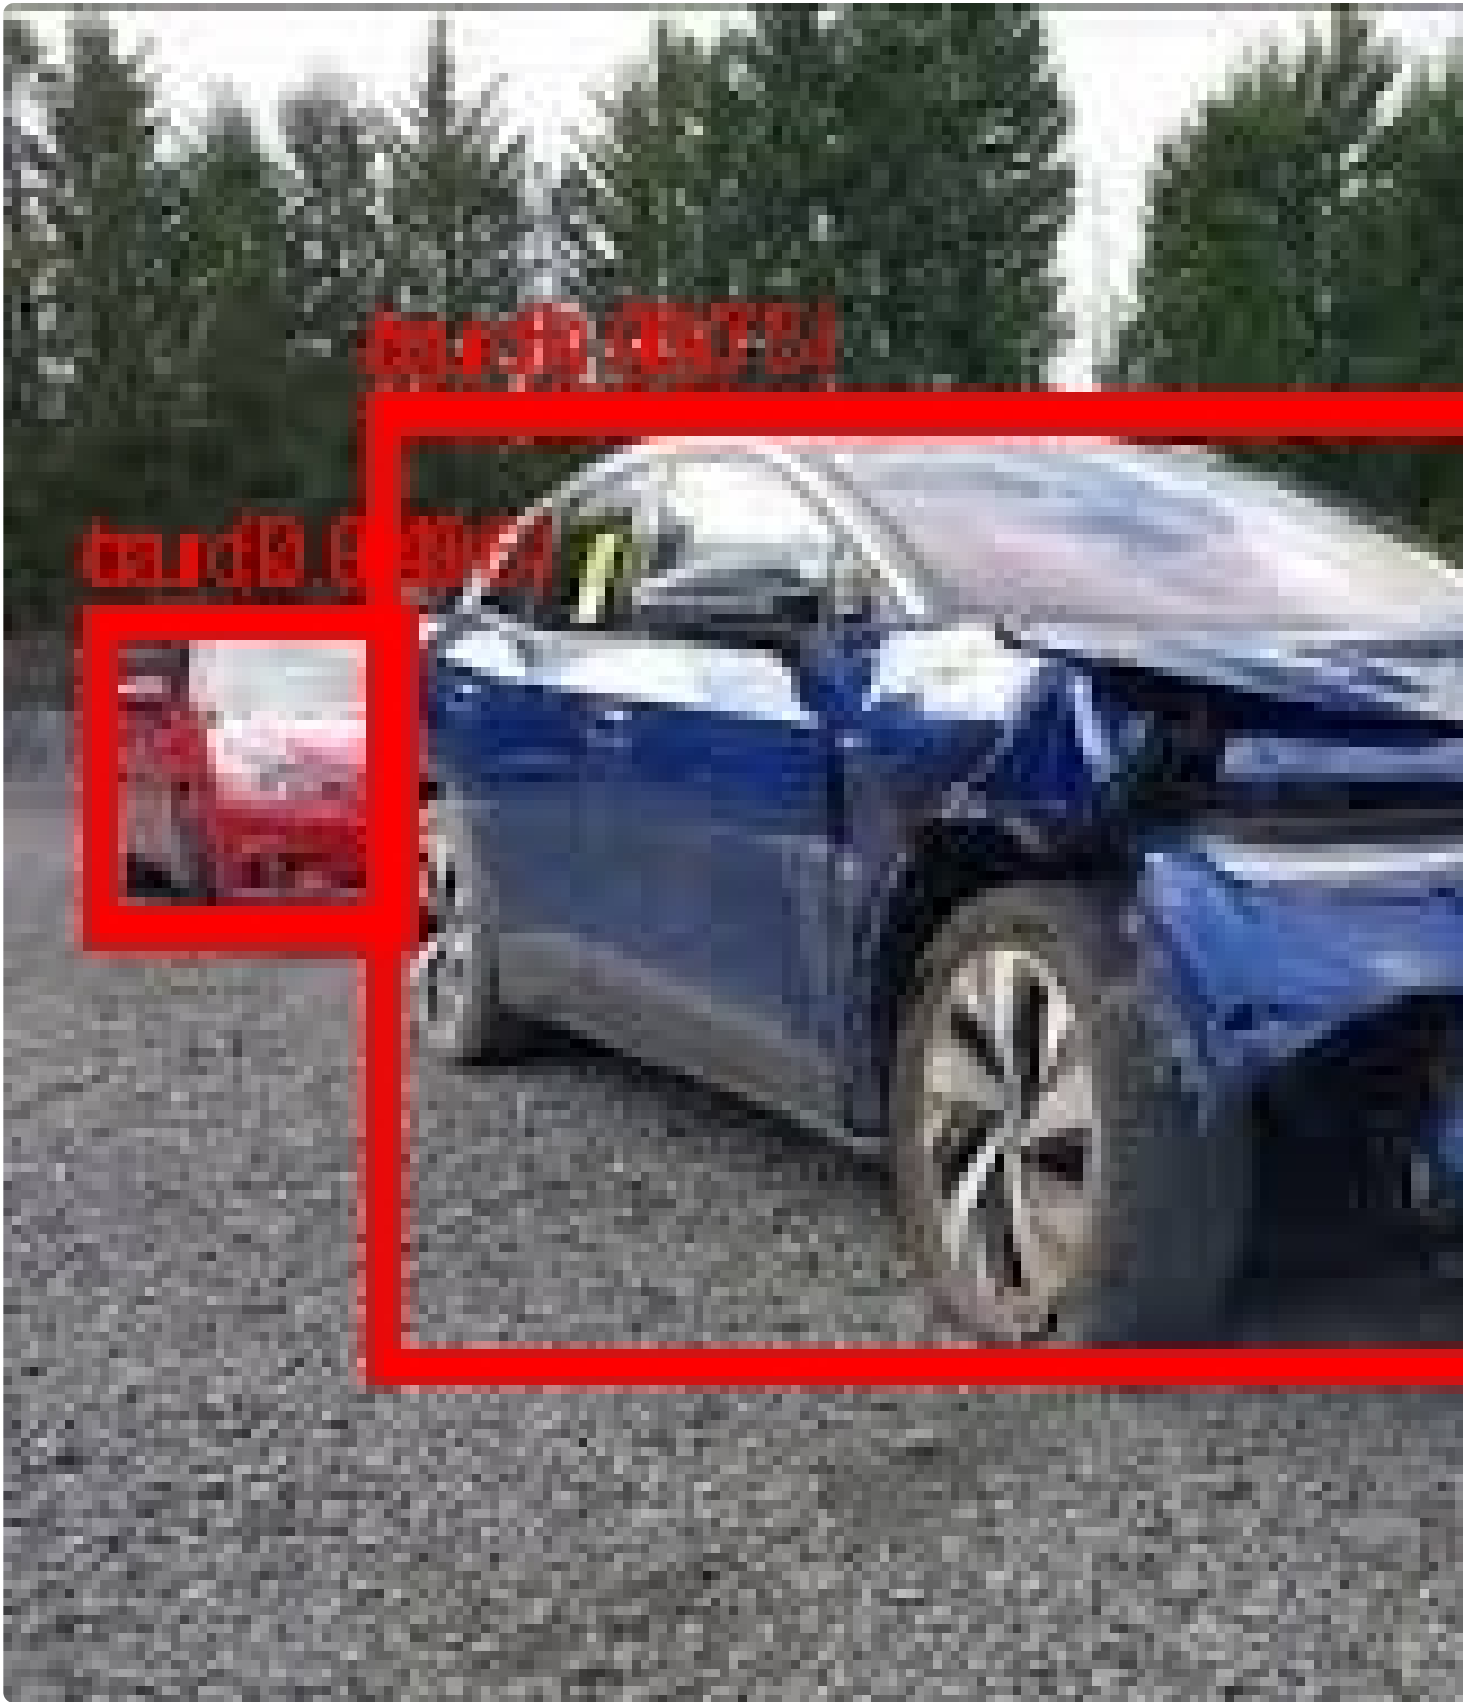
Okay, let's analyze the damage to this blue Volkswagen ID.4. Based on the image, here's a breakdown of the visible damage:

1. Front Bumper:

- Part: Front Bumper

- **Location:** The bumper is severely damaged, particularly on the driver's side. It's crushed and pushed inwards. There appears to be a large dent on the bottom corner.
- **Severity:** Significant – Likely requires full bumper replacement. The damage extends significantly into the front fascia.

2. Hood:

- **Part:** Hood
- **Location:** There's a pronounced dent and crease across the driver's side of the hood.
- **Severity:** Moderate to Significant – Likely requires bodywork repair and possibly paint matching.

3. Headlight:

- **Part:** Headlight Assembly
- **Location:** The driver's side headlight assembly appears damaged, likely broken.
- **Severity:** Moderate - Likely will require replacement of the whole headlight assembly.

4. Fender:

- **Part:** Fender
- **Location:** On the driver's side, there is visible damage to the fender.
- **Severity:** Moderate - Will likely need bodywork repair and paint matching.

Overall Assessment:

This is a severe collision. The extent of the damage indicates a significant impact. A professional assessment by a collision repair estimator is highly recommended to
