Car Damage Detector & Reporter

Damage Analysis Report

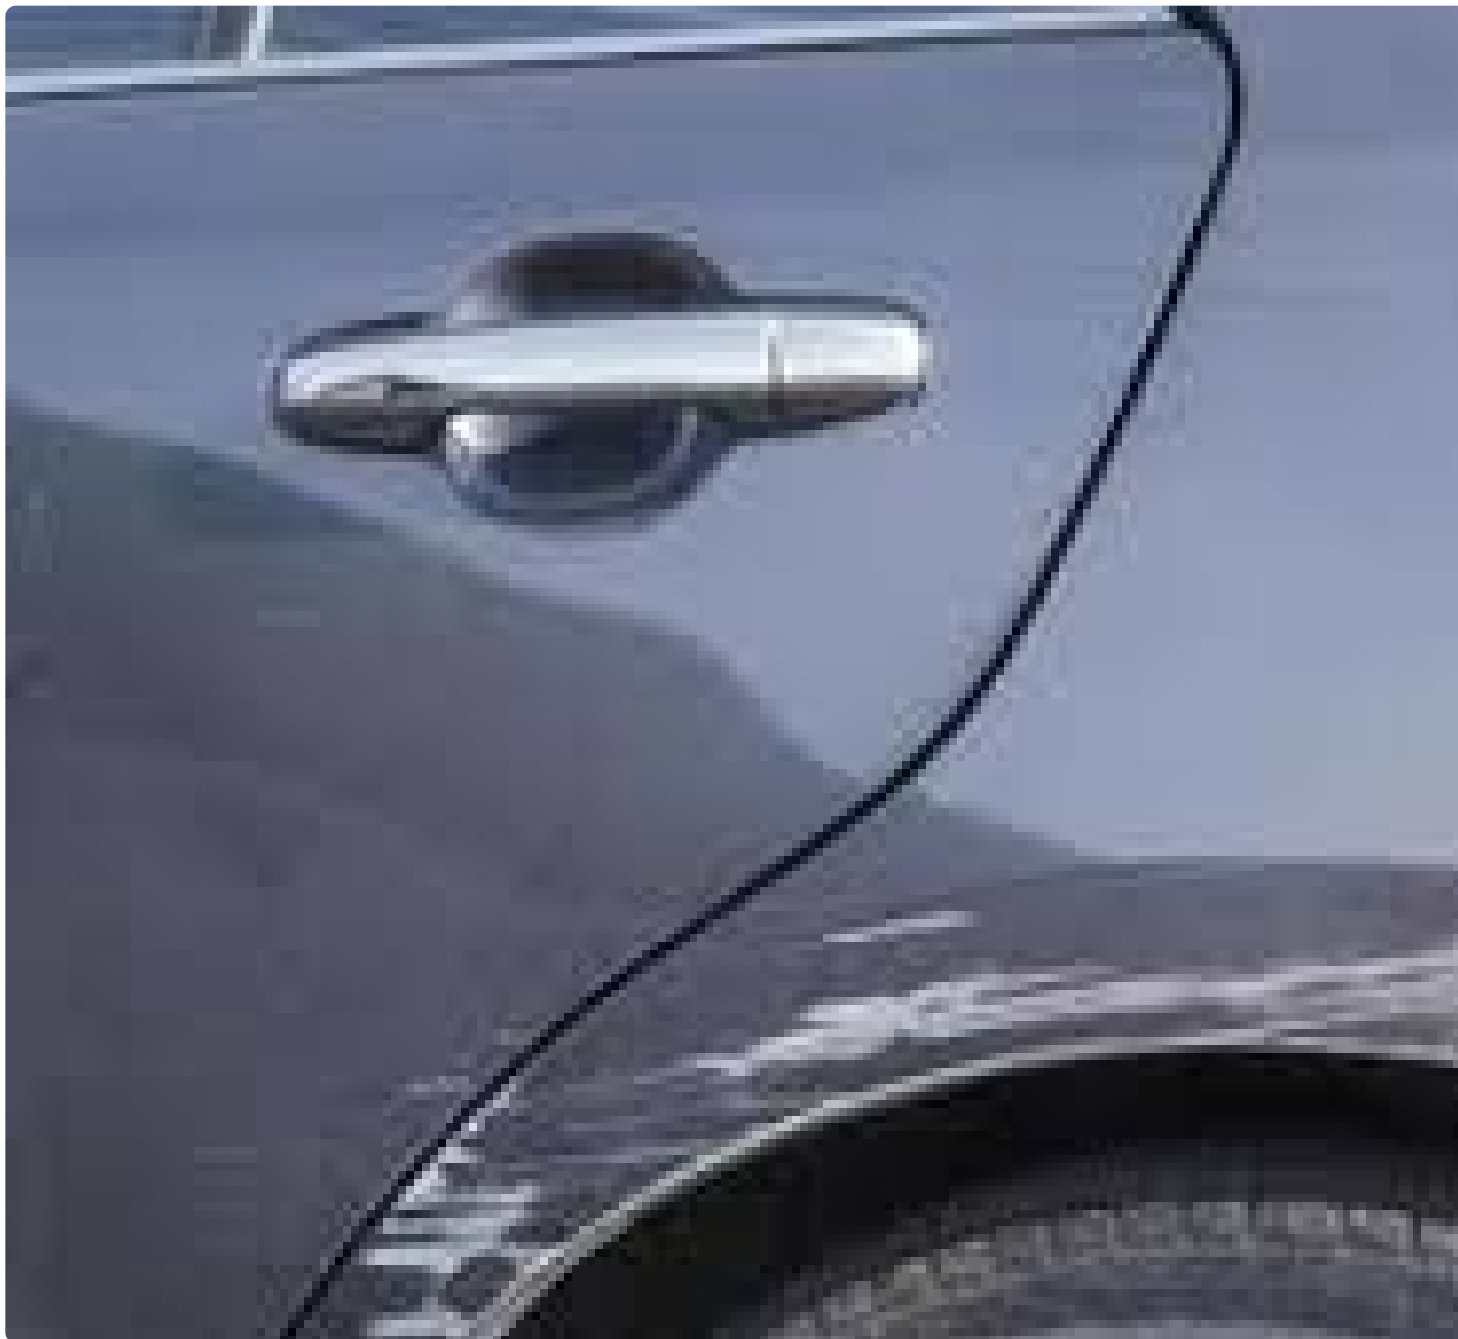
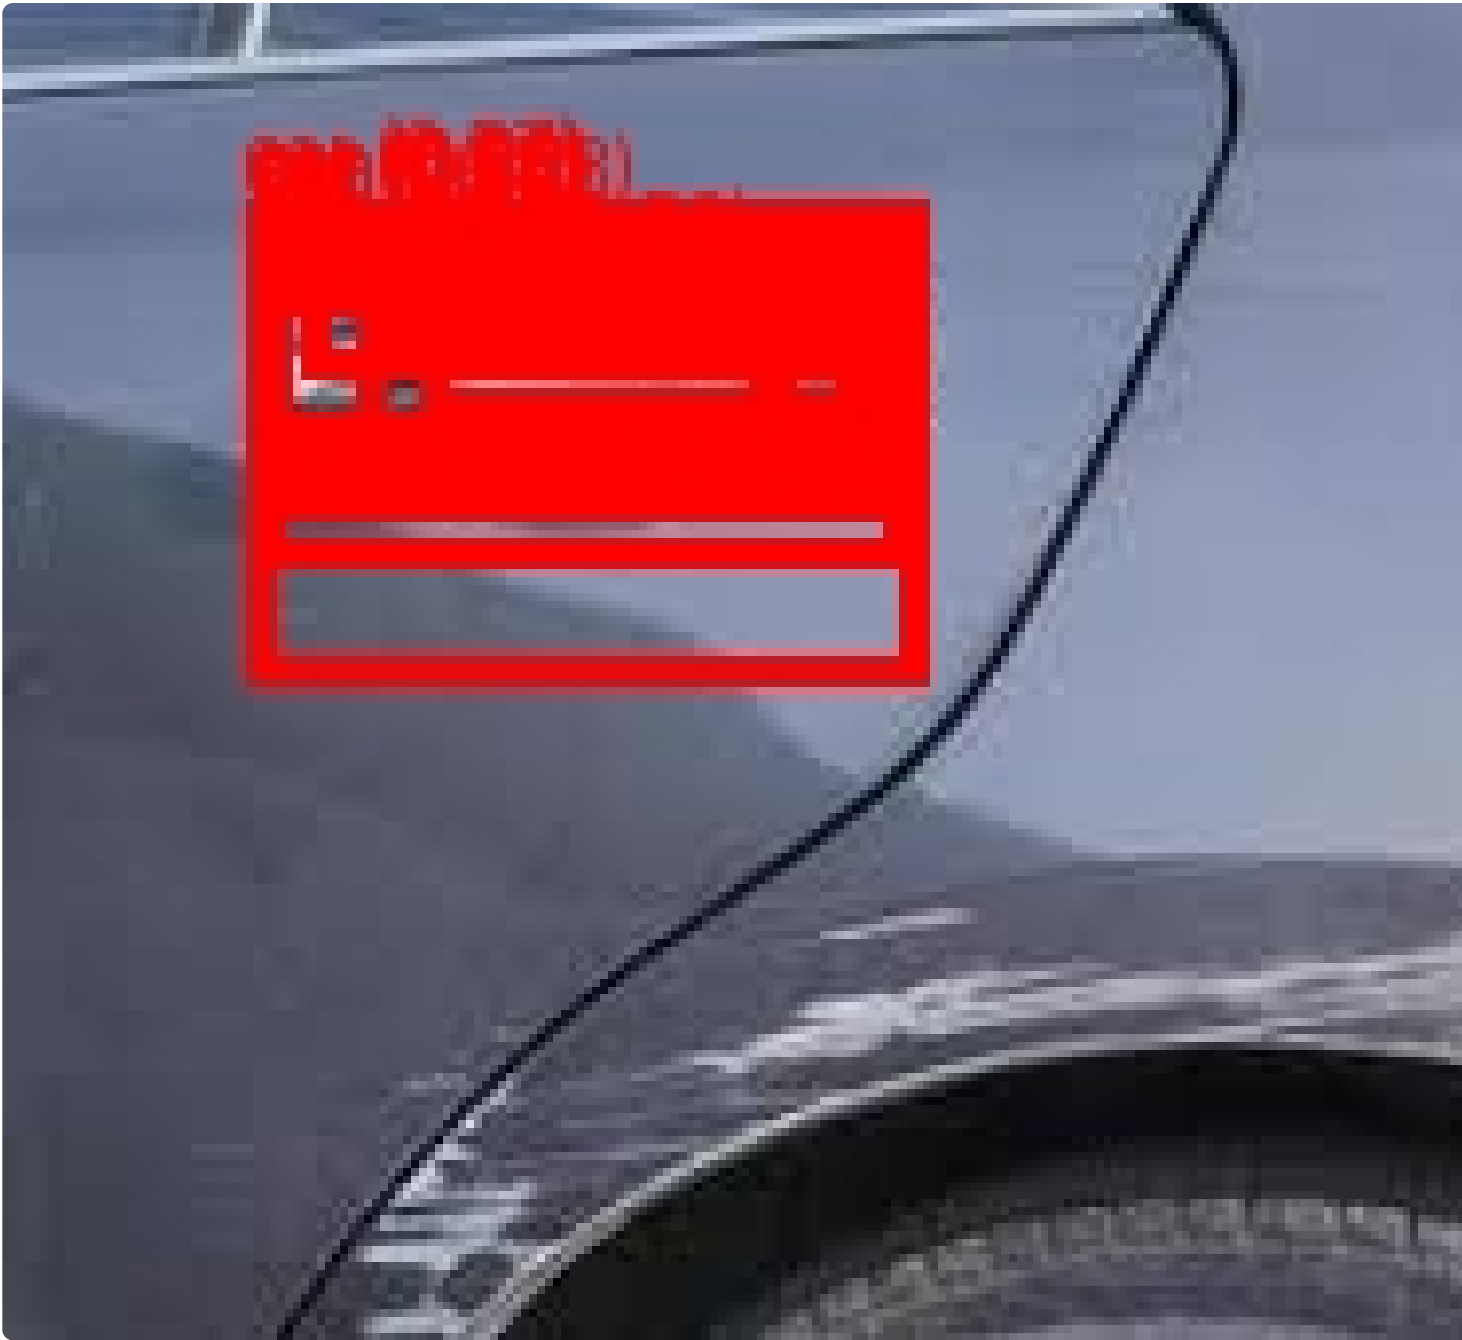
- **Part:** The primary damage is to the lower driver's side door panel. Specifically, it appears to be on the fender area adjacent to the wheel arch.
- **Location:** The damage is concentrated along the lower curve of the fender, running roughly 15-20 centimeters (6-8 inches) in length, and appears to be on the unc
- **Severity:** The damage appears to be a significant scrape or grinding mark, resulting in several deep scratches and a noticeable change in the paint finish. There ar

Overall Impression: This is a substantial scrape that has deeply affected the paint and likely damaged the underlying metal. It would require a repaint and potential b
