Car Damage Detector & Reporter

Damage Analysis Report

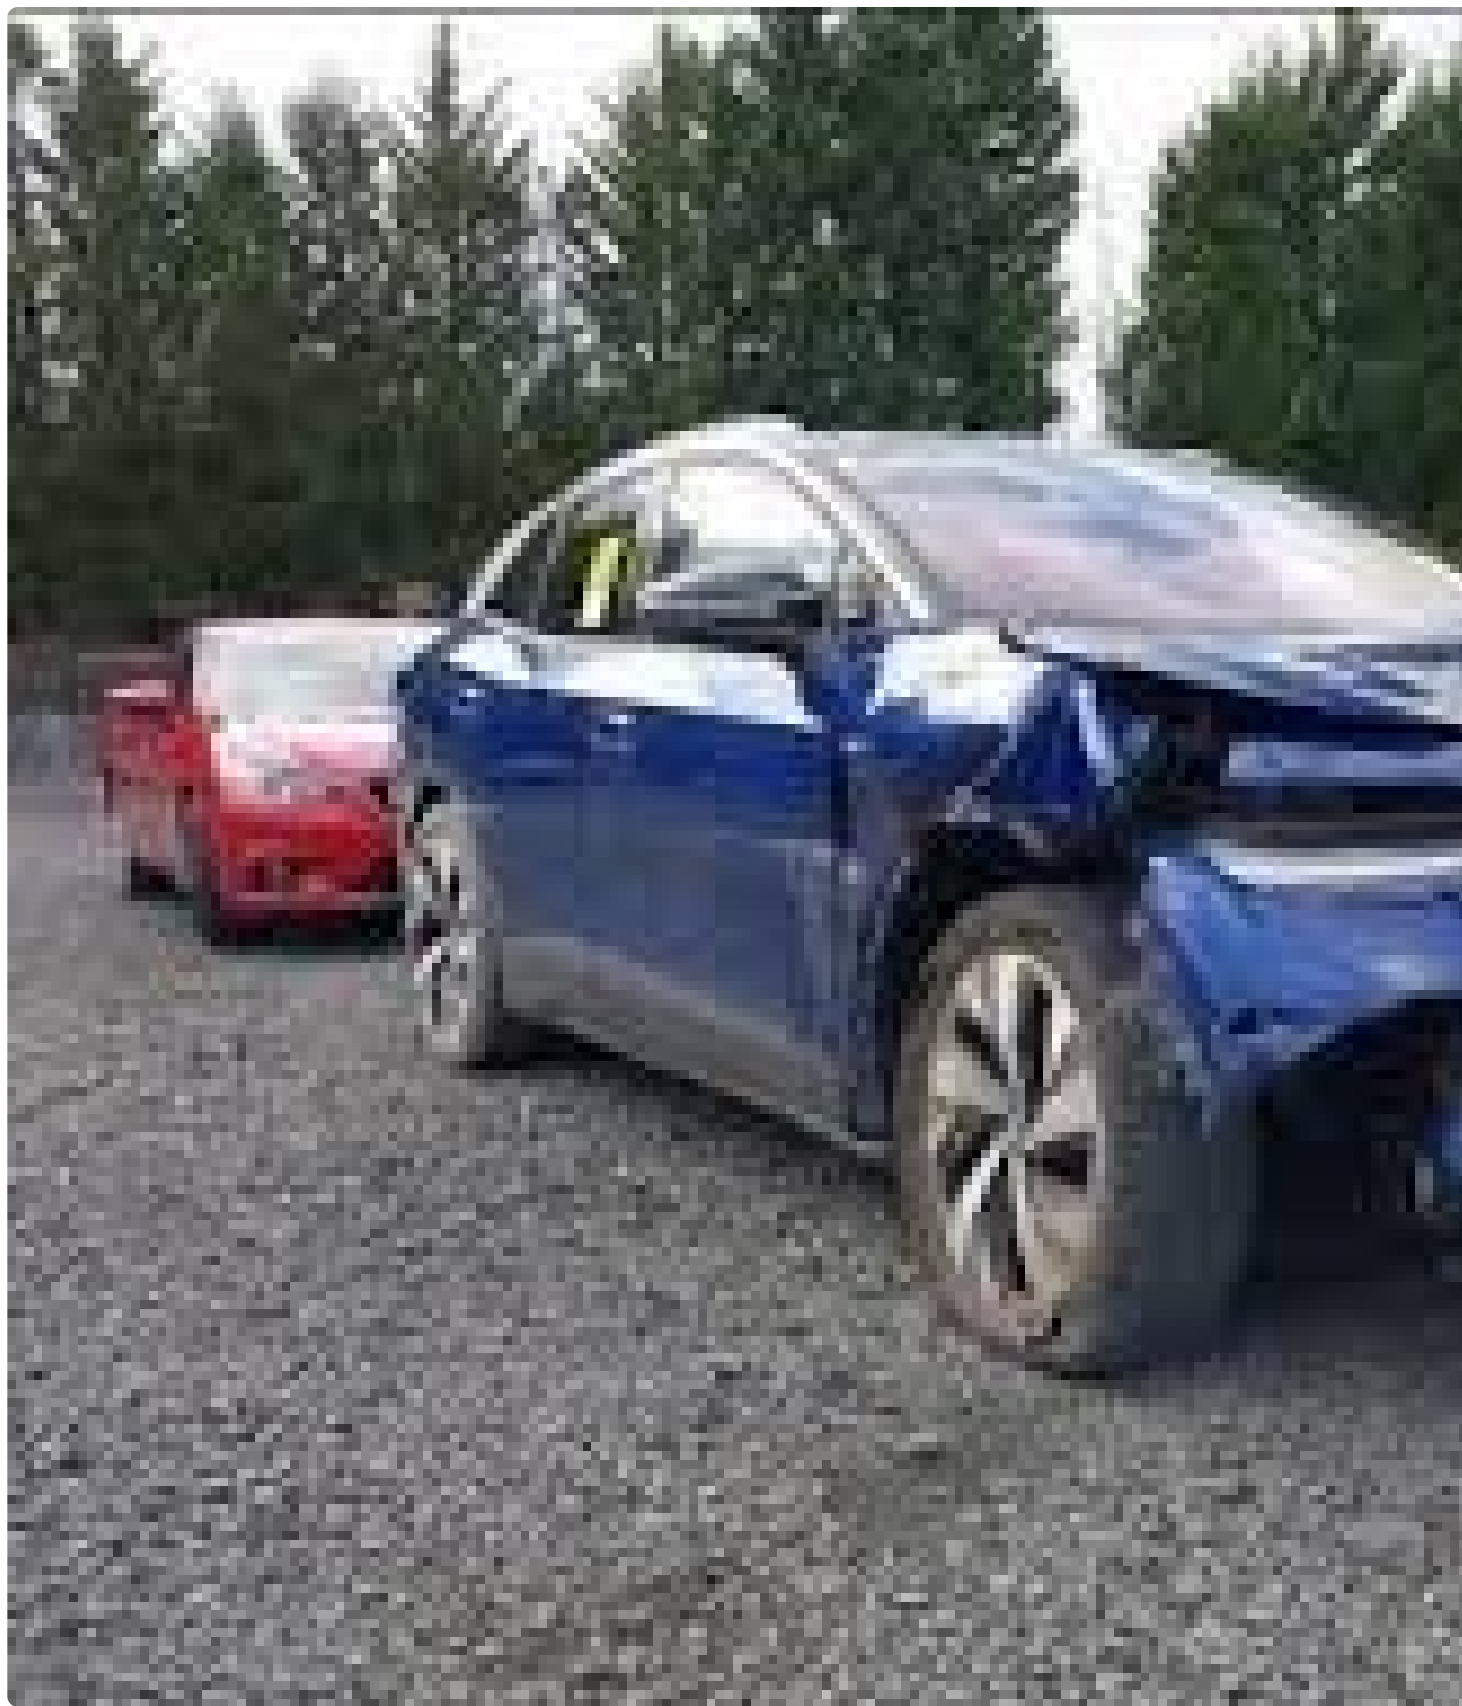
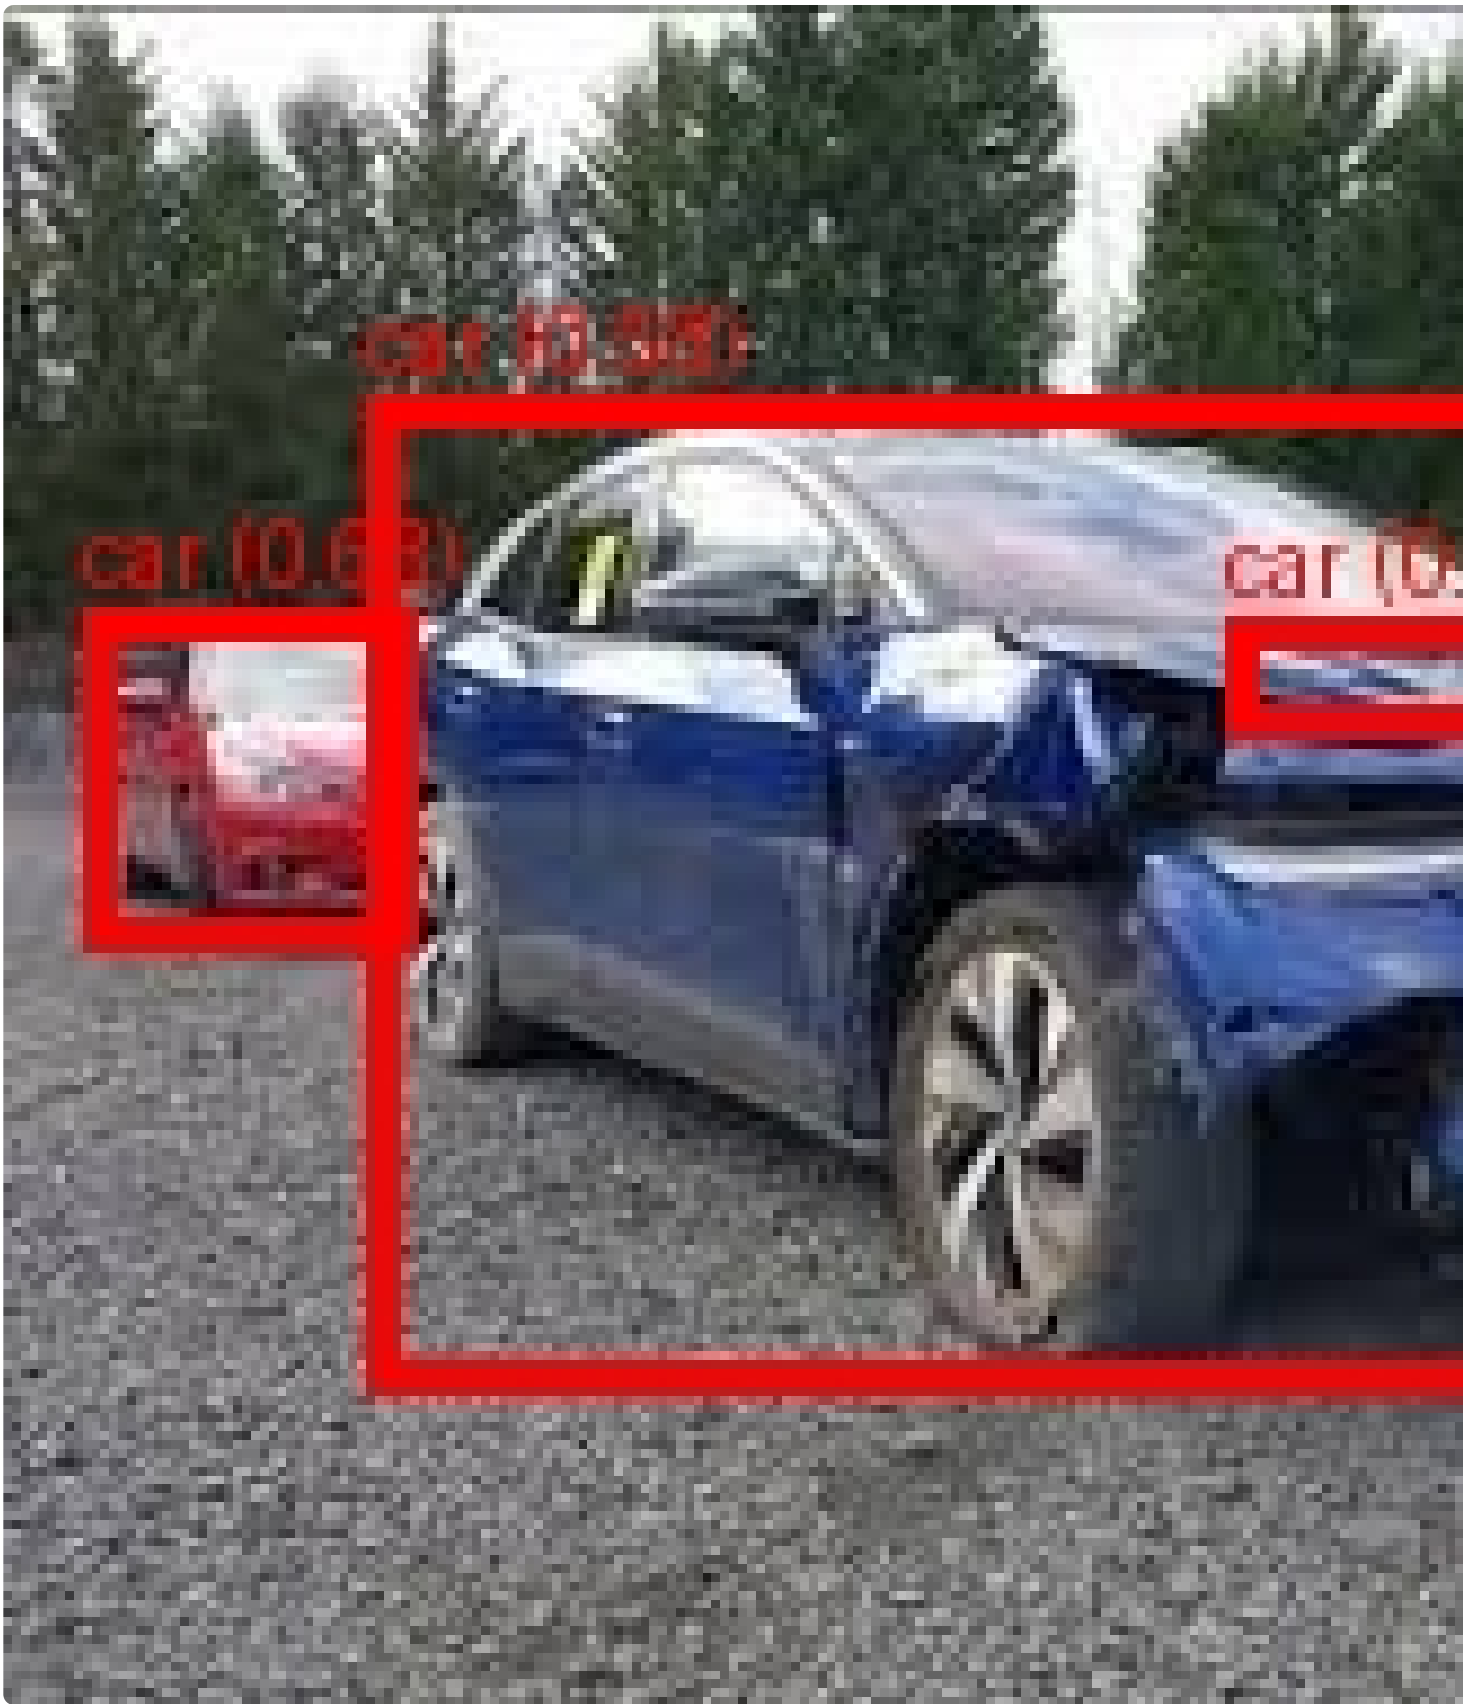
Okay, let's assess the damage to this blue Volkswagen ID.4 based on the image provided.

Overall Assessment: The vehicle has sustained significant damage to its front-left corner.

1. **Front Bumper:** The front bumper is severely deformed and crumpled, particularly around the lower portion. It appears to have been pushed in significantly.
2. **Hood:** The hood is also heavily dented and pushed inward, likely caused by the impact.
3. **Headlight:** The headlight assembly appears to be cracked or broken, likely due to the force of the impact.
4. **Fender:** The fender (wheel arch) is visibly crushed, particularly around the wheel well.
5. **Wheel Arch Liner:** The wheel arch liner is also damaged, probably from the impact.

Severity: The damage appears to be at least a 'Major' damage classification according to most damage assessment scales. The extent of the deformation indicates a l
