TECHNICAL SERVICE BULLETIN

B-Pillar Ticking Sound

23-2262
25 September
2023

Ford	Double Cab
2022-2024 Ranger	
2022-2024 Everest

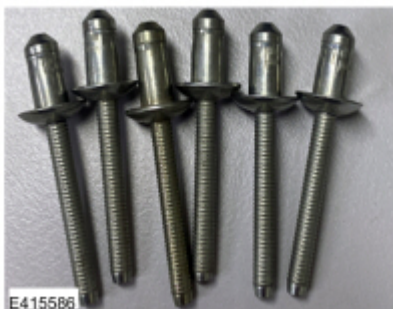
Figure 1

1. Domed head steel rivet (Qty 6) with a steel mandrel and diameter of 6mm. (Figure 1)
