Field Service Action 23B15

Reissue 2: August 23, 2023 (Destroy previous copy).

SUBJECT: 23B15 **S2 – RANGER/**EVEREST** - EXHAUST HOT END BRACKET REPLACEMENT**

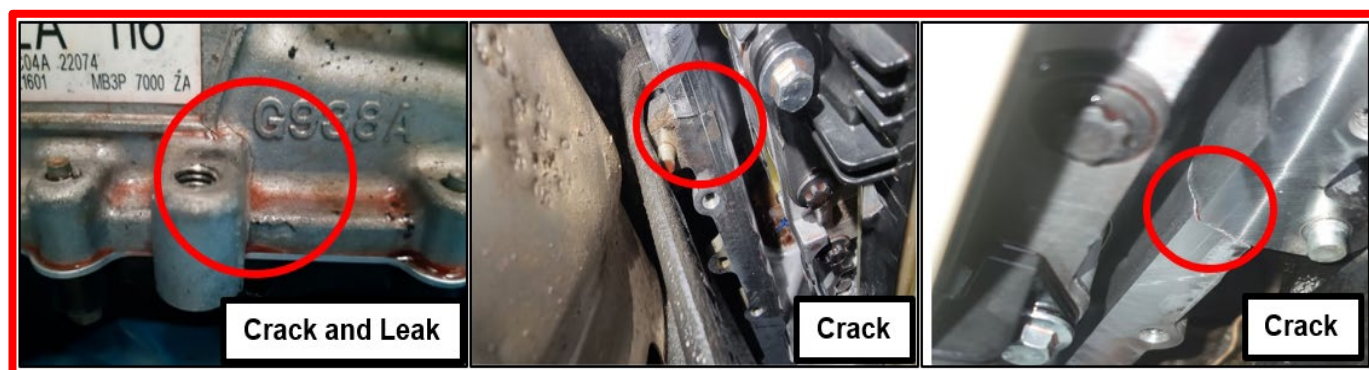
FIGURE 8

8. Clean the transmission housing around the area of the rear mounting bracket and inspect for cracks and leak/seep/weep. Refer figure.

Are any signs of crack and/or leak/seep/weep evident on the transmission housing?

| | Replace the transmission assembly before proceeding to Step 9. Refer to WSM Section - 307-01C Automatic Transmission - 10-Speed Automatic Transmission – 10R80 - Removal and Installation |
| No | Proceed to Step 9 |
