Field Service Action 22B07

Reissue 2: September 12, 2022 (Destroy previous copy).

SUBJECT: 22B07 *S2* - PANTHER 2.0L ENGINE OIL PUMP FAILURE

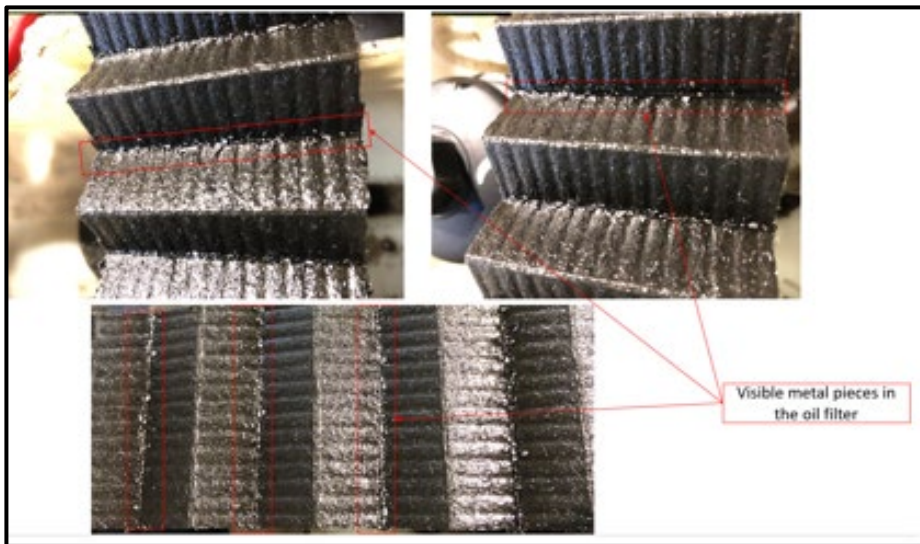
FIGURE 2

****Oil filter cartridge check** – Remove the cartridge and look in the outer passages with a flashlight for obvious large metallic debris, If there is no obvious debris, peel the oil filter cartridge and thoroughly check for debris (Ref Figure 2) .

5. Remove oil filter cartridge.
6. Cut the Oil Filter cartridge and inspect for presence of any broken metal pieces. See Figure 2.

Is any sign of metal contamination present?

Yes	Replace Engine. Return the oil filter cartridge (with the metal debris) in a sealed zip lock bag to PRC for analysis. Engine to be retained by dealer in conditions described in W&PM section G, and retained for the period described in W&PM attachment G.
No	Proceed to oil pump replacement Step 7
