TECHNICAL SERVICE BULLETIN

Vehicles Equipped With Manual Front Seat(s) Only - Front Seat Squeak

21-2035

Ford
2011-2021 Ranger
2015-2021 Everest/Endeavour

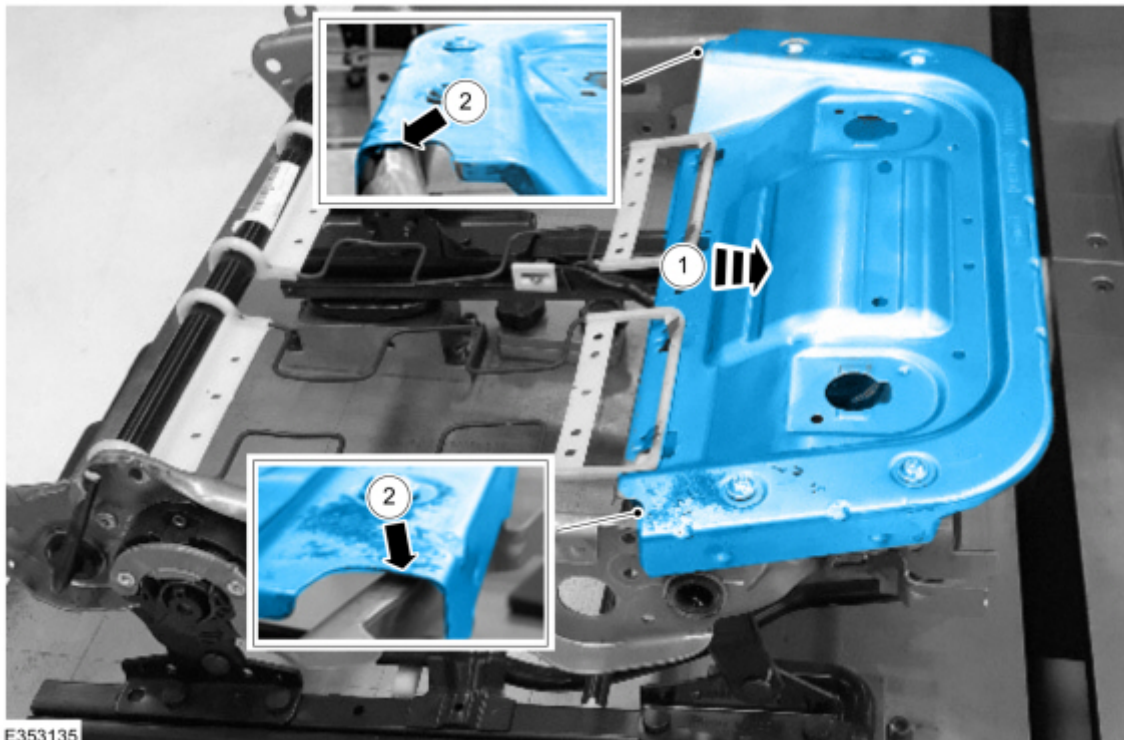
Figure 1

1. Push on the front of the seat cushion(s) area to confirm if the squeak is present. Is a squeak identified from the front seat cushion?
 - (1). Yes – proceed to Step 2.
 - (2). No – this TSB does not apply, refer to Workshop Manual (WSM) Section 501-10A for normal diagnosis/repair.
2. Remove the front seat cushion. For additional information, refer to WSM Section 501-10A.
3. Inspect the front seat cushion. (Figure 1)
 - (1). Press on the front half pan and check for a squeak type noise.
 - (2). Check for a zero gap between the front half pan and both side frames.

4. Is there a squeak identified and/or a zero gap between the front half pan and side frame(s)?
- (1). No - this TSB does not apply, refer to WSM Section 501-10A for normal diagnosis/repair.
 - (2). Yes – proceed to the Service Procedure below.
