TECHNICAL SERVICE BULLETIN

23-2323

Vehicles Built To 20-Oct-2022 – Interior Rattle At The Front Of The Vehicle Below The Instrument Panel

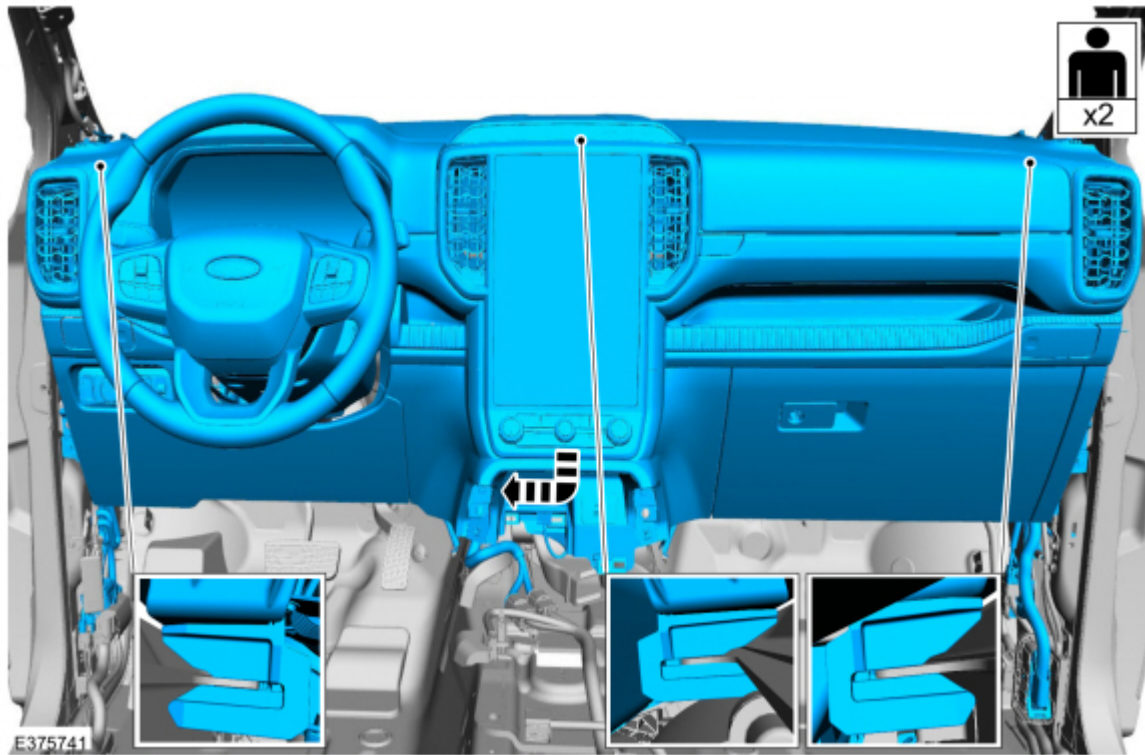
Figure 1

2. Check the color of the instrument panel clips installed on the instrument panel. (Figure 1 and 2).

(1). The clips will be either black in color or blue. Depending on the color, this will affect whether new clips are required in Step 5 or whether the existing clips can be re-used.
