# FCSD Field Service Action 21P08

**Subject: 21P08 - Endura - 2.0L EcoBlue (Panther) EGR Mesh Filter Blockage**

## **21P08 - Endura - 2.0L EcoBlue (Panther) EGR Mesh Filter Blockage**

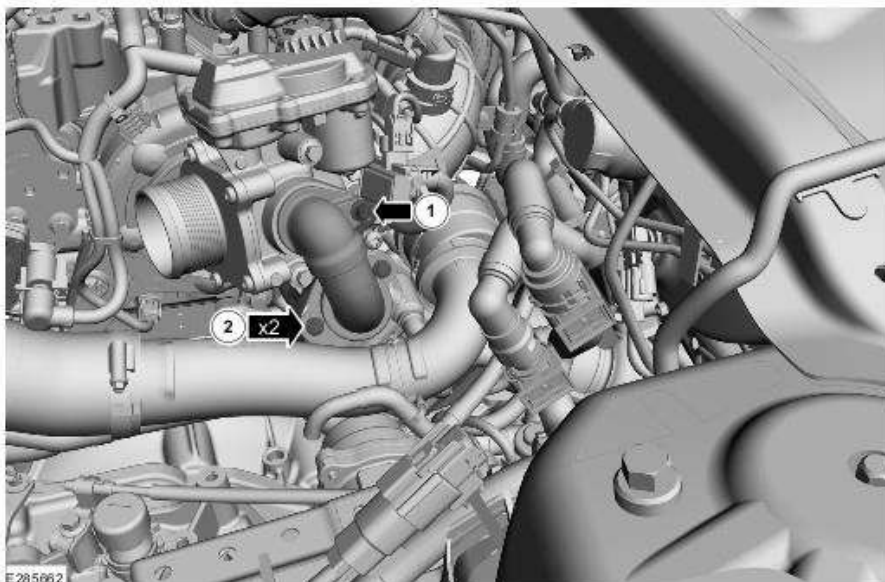
**FIGURE 1**

1. Remove the EGR cooler to EGR valve tube. Please refer to the Workshop Manual Section 303-08. See Figure 1.

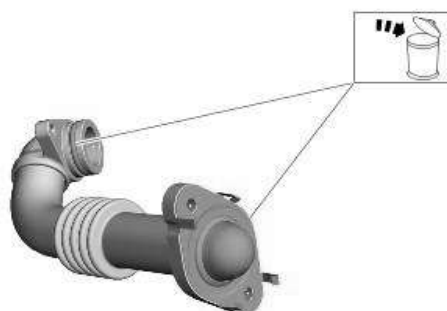
**FIGURE 2**

2. Remove and discard the gasket and O-ring. See Figure 2.

**NOTE:** Install new gasket / O-ring.
