TECHNICAL SERVICE BULLETIN

Vehicles Equipped With A 2.0L (Panther) Engine – Rattle Type Noise From The Transmission Area At Light Accelerator Input

23-2263

19
September
2023

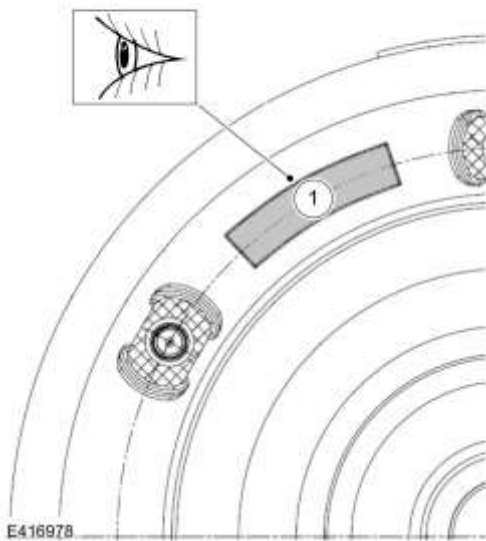
Figure 1

Callout 1: Ford Part Number Prefix and Suffix 3mm Max High Here

7. Remove the transmission and verify the torque converter part number Prefix and Suffix. Ensure the torque converter part number is JB3P-(7902)-JD or later. If the part number is JB3P-(7902)-JC or earlier, then replace the part with a new torque converter (JD or later). (Figure 1)
