TECHNICAL SERVICE BULLETIN

Vehicles Built To 1-Dec-2022 - Liftgate Water Leak From The Liftgate Mounted Rear Lamp

23-2303

Ford 2021-2023 Everest	Build Date: Up to 01 December 2022
---------------------------	------------------------------------

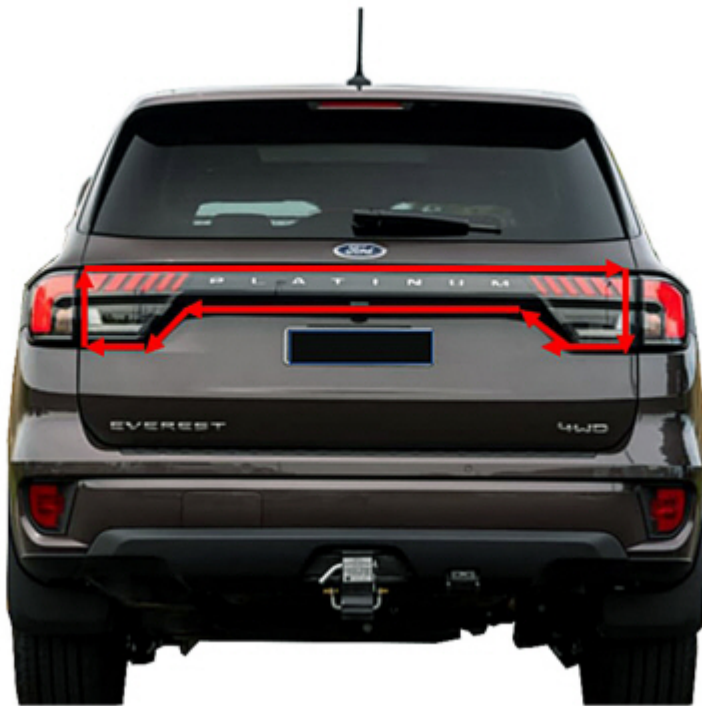
Figure 1

Issue: Some 2021-2023 Next-Generation Everest vehicles built to 1-Dec-2022 may experience a water leak from the liftgate into the cabin or water flow from the liftgate drain hole. A possible cause for this concern is a leaking liftgate mounted rear lamp.

1. Remove the liftgate trim panel. For additional information, refer to Workshop Manual (WSM) Section 501-05.
2. Conduct a water leak test on the liftgate to detect the source of the water leak. Using a pressure washer aimed perpendicular to the target and holding at a distance of 300mm from the vehicle, spray all areas of the liftgate edges of the liftgate mounted rear lamp and liftgate handles for 10 seconds from left to right on the top edge of the liftgate mounted rear lamp and a further 10 seconds approximately to the lower edge of the liftgate mounted rear lamp. Also apply the same spray rate from the top to bottom edge of the liftgate seals. (Figure 1)
