Field Service Action 23P23

December 22, 2023

SUBJECT: 23P23 - Ranger/Everest Stage V Panther 2.0L Bi-Turbo Charge Air Cooler Duct Loose

23P23: Ranger/Everest Stage V Panther 2.0L Bi-Turbo Charge Air Cooler Duct Loose

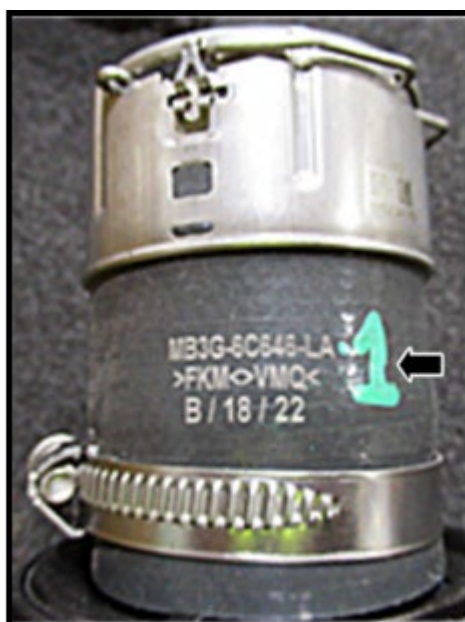
FIGURE 1

- The numeral "1" hand marked in green immediately after the part number. Refer Figure 1

1. Remove and replace the Charge Air Cooler (CAC) intake duct. Refer to Workshop Manual (WSM) Section 303-12C. Ensure replacement part is the revised level part.

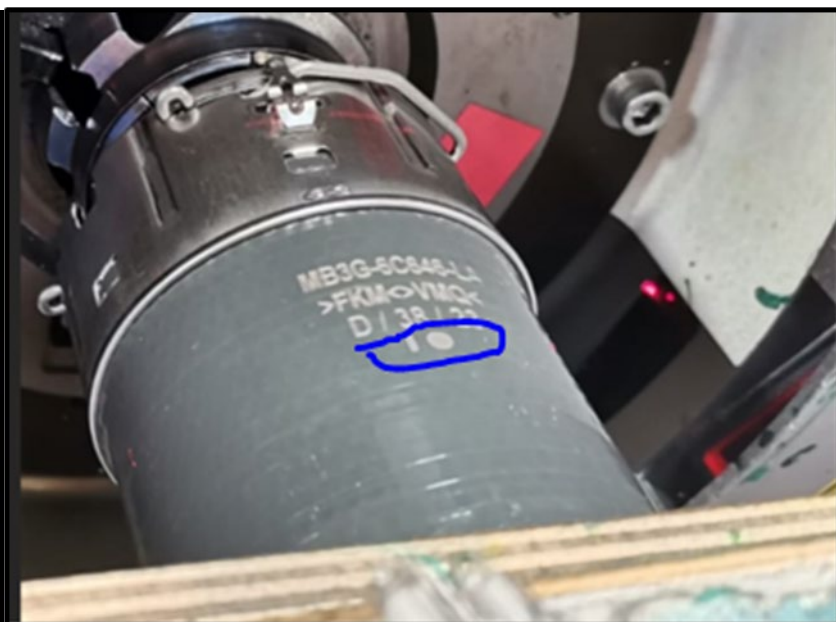
FIGURE 2

- A line and a dot (resembling the number 10). Refer Figure 2.
