Aviation Investigation Report AIR-25-07

Ensure Learjet Main Landing Gear Are Securely Attached

On February 10, 2025, about 1438 mountain standard time, a Learjet 35A, N81VN, was landing on runway 21 at SDL when it departed the left side of the runway and impacted a parked Gulfstream G200.¹ The Learjet's captain was fatally injured, the first officer (FO) and one passenger were seriously injured, and one passenger received minor injuries; additionally, an occupant inside the parked airplane, which was not operating at the time, sustained serious injuries. The Learjet was substantially damaged. The corporate flight was operating under the provisions of Title 14 Code of Federal Regulations (CFR) Part 91.

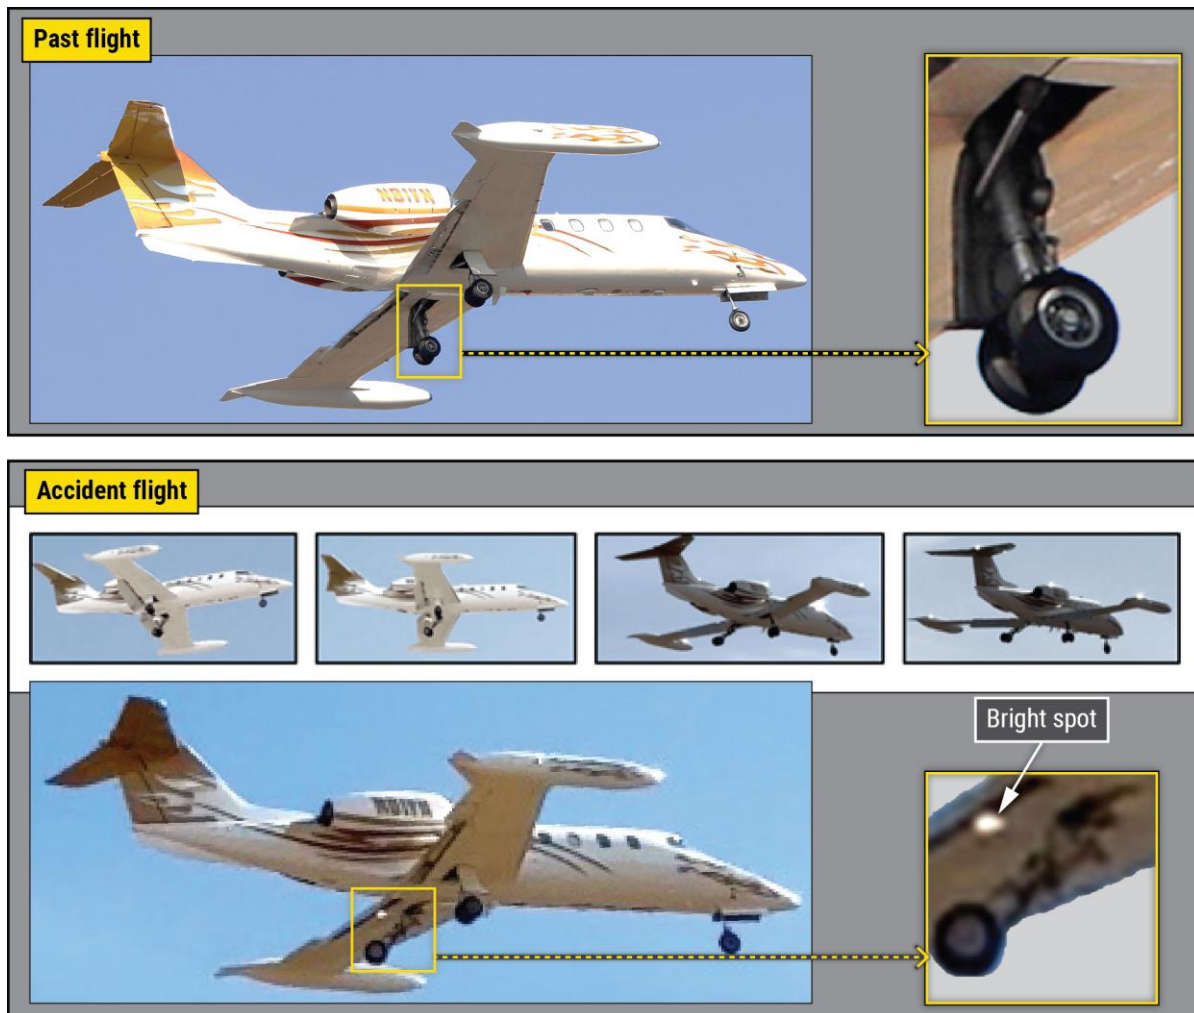
A witness at a golf course near the final approach path captured an 11-second video showing the airplane on final approach with the left landing gear trailing aft from its normal position. Figure 1 shows still images from the video of the accident

approach compared to a photograph of the airplane from a previous flight. Evaluation of the video indicated that the strut was facing aft.²

Figure 1. Still images from a witness-supplied video showing the left landing gear askew while on approach to the runway, compared with a prior photo of the accident airplane (Source of previous flight photo: www.jetphotos.com).

² A circular bright spot can be seen on the bottom of the left-wing flap above the dangling left landing gear strut. The appearance of the bright spot is consistent with it being illuminated from the left landing gear light, which normally illuminates in the forward direction; however, the location of the bright spot in the video suggests the strut is facing aft.

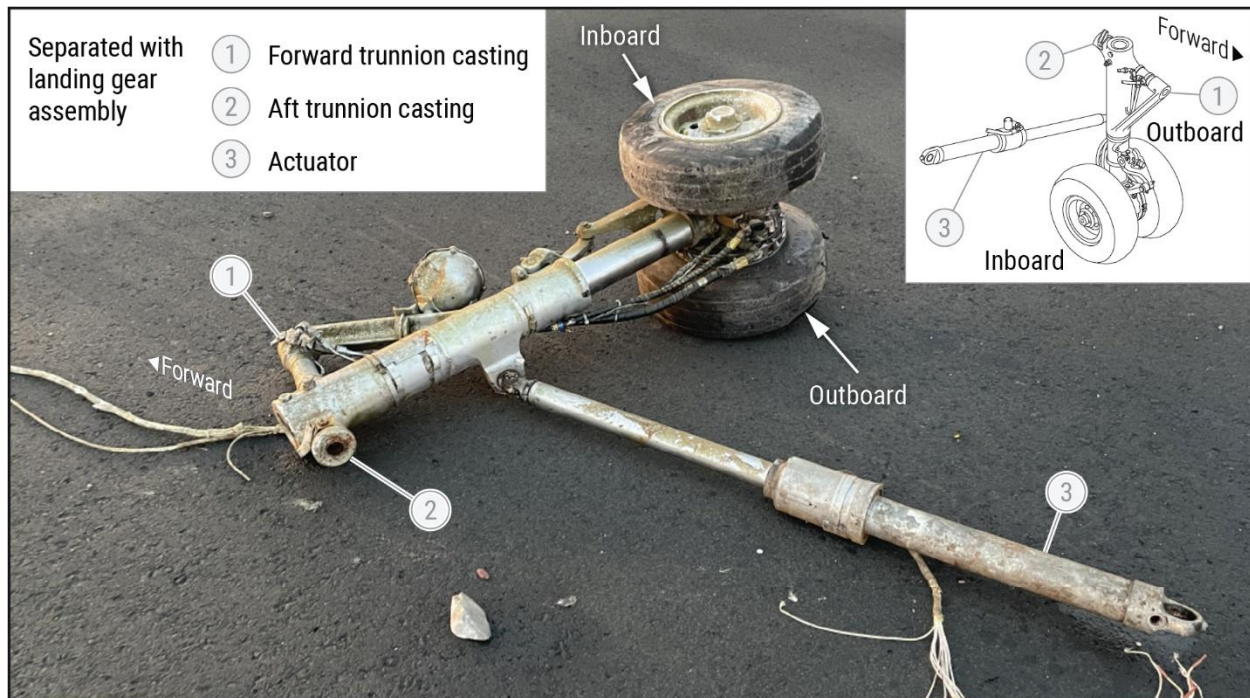
runway 21 just before the aiming point markings with full flaps extended.³ The airplane immediately entered a left-wing-low attitude and began veering left, exiting the runway surface. The airplane traveled over the rock-covered runway safety areas located between the runway and taxiways. The left main landing gear separated from the airplane and came to rest, as shown in figure 2, adjacent to taxiway B. The airplane crossed taxiway B, collided with a windsock, and entered the ramp area where it struck the right side of the parked Gulfstream G200 (see figure 3). The airplane was not equipped with thrust reversers and the drag chute was not deployed.⁴

Figure 2. Left main landing gear at the accident site with inset diagram of the landing gear assembly (Inset source: Bombardier).

Each main gear assembly attaches to the airplane (wing) structure at three points (indicated in figure 2): through the forward and aft trunnion pins (with striker plates on the trunnions to actuate microswitches) and through the main gear hydraulic actuator.^{5,6} Figure 4 provides an illustration of the left main gear assembly and aft trunnion attachment in its correct configuration. During installation, the aft trunnion pin is inserted through a bushing on the aft trunnion fitting (located on spar 7), into the aft side of the trunnion casting.^{7,8} When properly positioned, holes in the aft trunnion pin and the trunnion casting align, allowing a retaining bolt to be

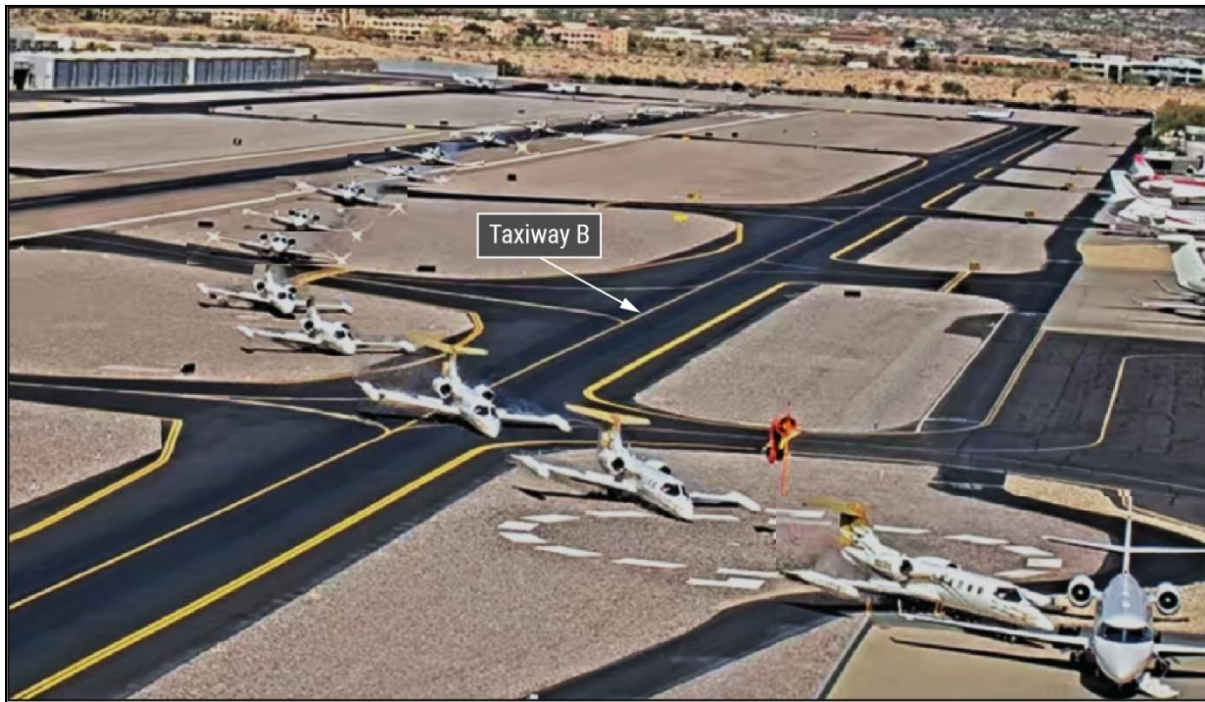
Figure 3. Video excerpts showing the landing rollout to impact.

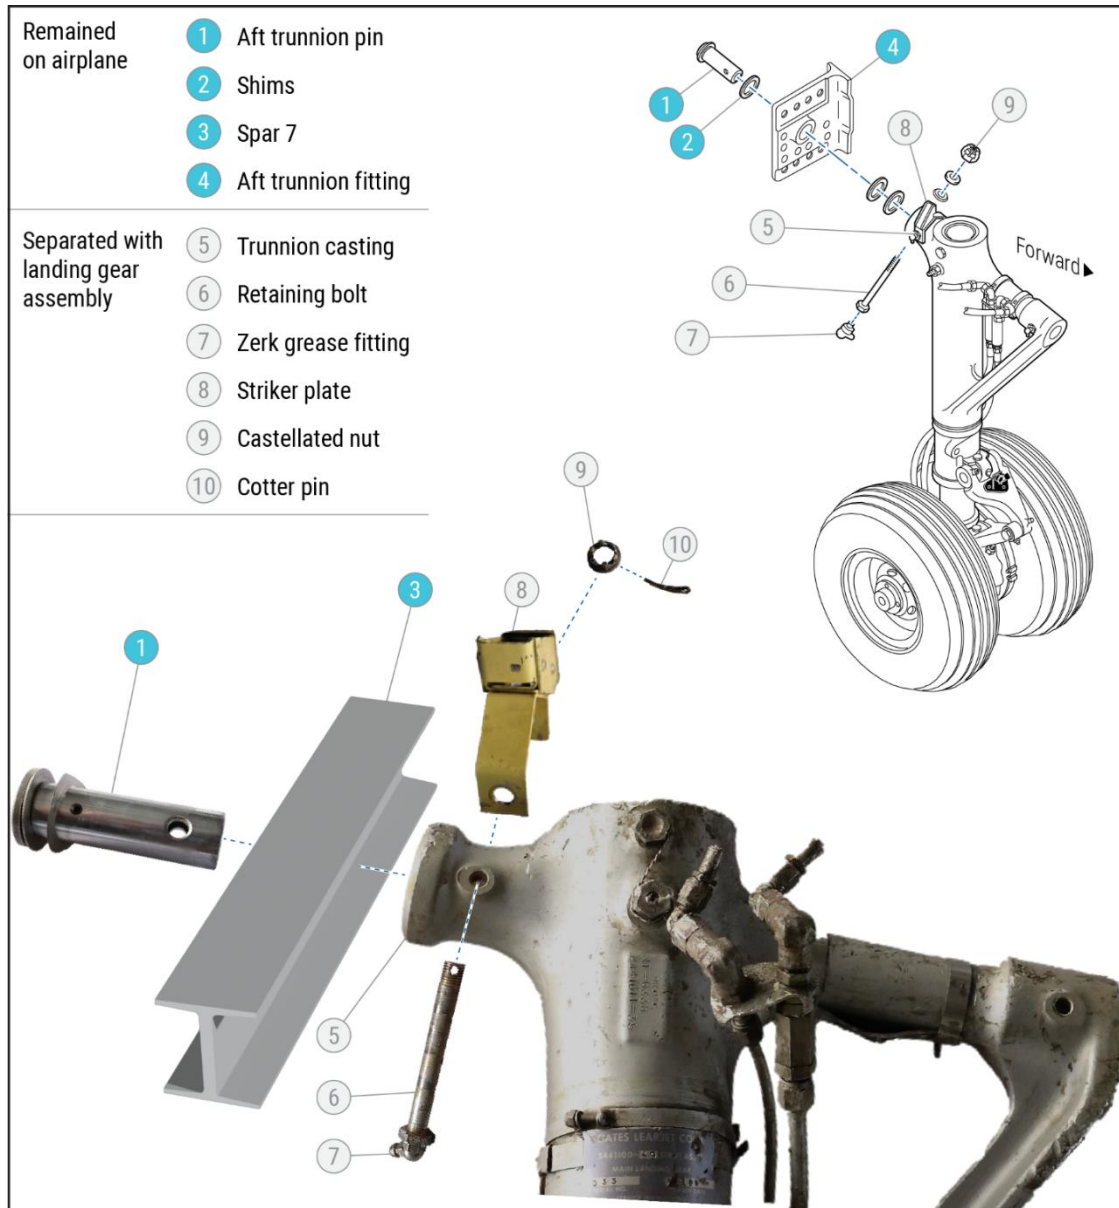
Figure 4. Accident parts composited into a schematic view of the left main landing gear assembly (Inset source: Bombardier).

Preliminary findings in this ongoing investigation indicate that, months earlier, the aft trunnion pin was not correctly installed when the main landing gear was installed. The aft trunnion pin was inserted through the aft trunnion fitting but had not been inserted far enough into the trunnion casting for the two holes to align. The retaining bolt had been installed and secured in the aft trunnion casting without going through the hole in the aft trunnion pin.

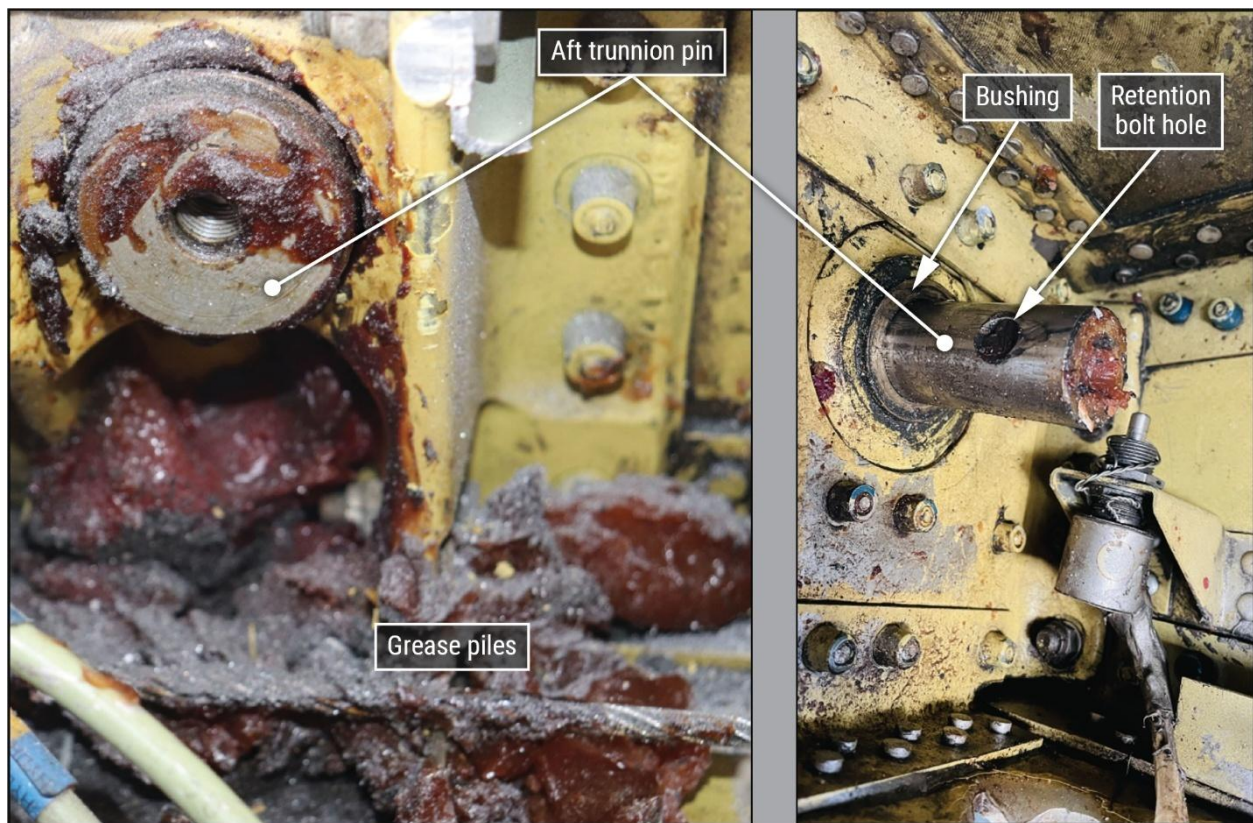
Postaccident examination of the left wheel well found the aft trunnion pin intact and still positioned in the aft trunnion fitting on spar 7, though no forward shims were present. Removal of the access panel adjacent to the aft trunnion fitting gave investigators visual access to the trunnion pin's shoulder and aft shims, which were not making contact with the aft surface of the aft trunnion fitting. An excessive amount of grease was piled below the pin (see figure 5).

Figure 5. Left main landing gear aft trunnion pin.

Note: The left photograph shows the area aft of spar 7; this area is not visible unless an access panel is removed and remains very difficult to view even with the panel removed. The right photograph shows the interior of the left wheel well.

During further examination of the aft trunnion fitting, investigators measured the distance between the shoulder of the aft trunnion pin and the aft surface of the aft trunnion fitting. The aft trunnion pin's shoulder was protruding off the aft trunnion fitting by 1 3/8 in—a distance that corresponds to the depth within the aft trunnion casing at which the retaining bolt is located (see figure 7).¹⁰ If the retaining bolt is secured through the trunnion casting without engaging the trunnion pin in the trunnion casing, as was found during the examination of the accident left main landing gear assembly, then the trunnion pin's grease hole (intended as an access point for lubricating the bushing) will protrude aft of the bushing, allowing grease to migrate into the wing bay behind spar 7. This scenario is consistent with the observed excess grease piled below the trunnion pin in the wing bay behind spar 7.

Each of these SBs recommend that operators, within the next 25 flight cycles, remove the access panel on spar 7, confirm that the aft trunnion pin is seated flush against the shim and bushing flange, ensure the retaining bolt is correctly installed through the strut and trunnion pin, and correct any discrepancies before the next flight.¹³

Therefore, the NTSB recommends that the FAA require, as a condition of continued airworthiness, operators and owners of applicable Learjet models to comply with Bombardier Service Bulletins (SBs) A23/24/25-32-20, A28/29-32-21, A31-32-25, A35/36-32-29, A55-32-26, and A60-32-42.

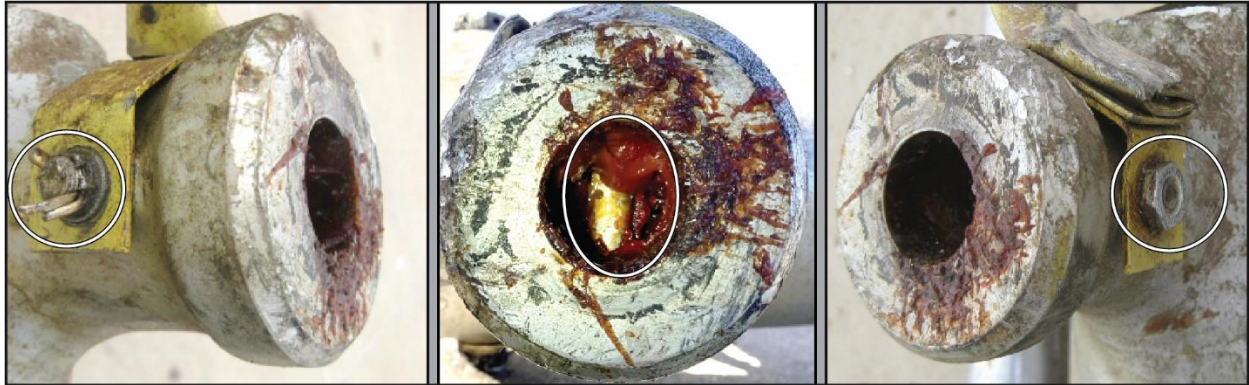
More significantly, the on-scene examination found that the aft trunnion pin was no longer seated within the aft trunnion casting: The aft trunnion casting

remained intact on the left main gear, which, as previously mentioned, had separated from the airplane. The retaining bolt—intended to pass through the aft trunnion pin to secure the main gear strut to the airframe—was found intact on the left main landing gear, inserted through its aft trunnion casting and secured with a castellated nut and cotter pin (see figures 6 and 7). The absence of the aft trunnion pin (which remained intact on the airplane) from the trunnion casting indicated that the retaining bolt was secured to the aft trunnion casting without passing through the aft trunnion pin.

Figure 6. Left main landing gear aft trunnion casting at the accident site with white lines indicating attachment of the retaining bolt and striker bracket.

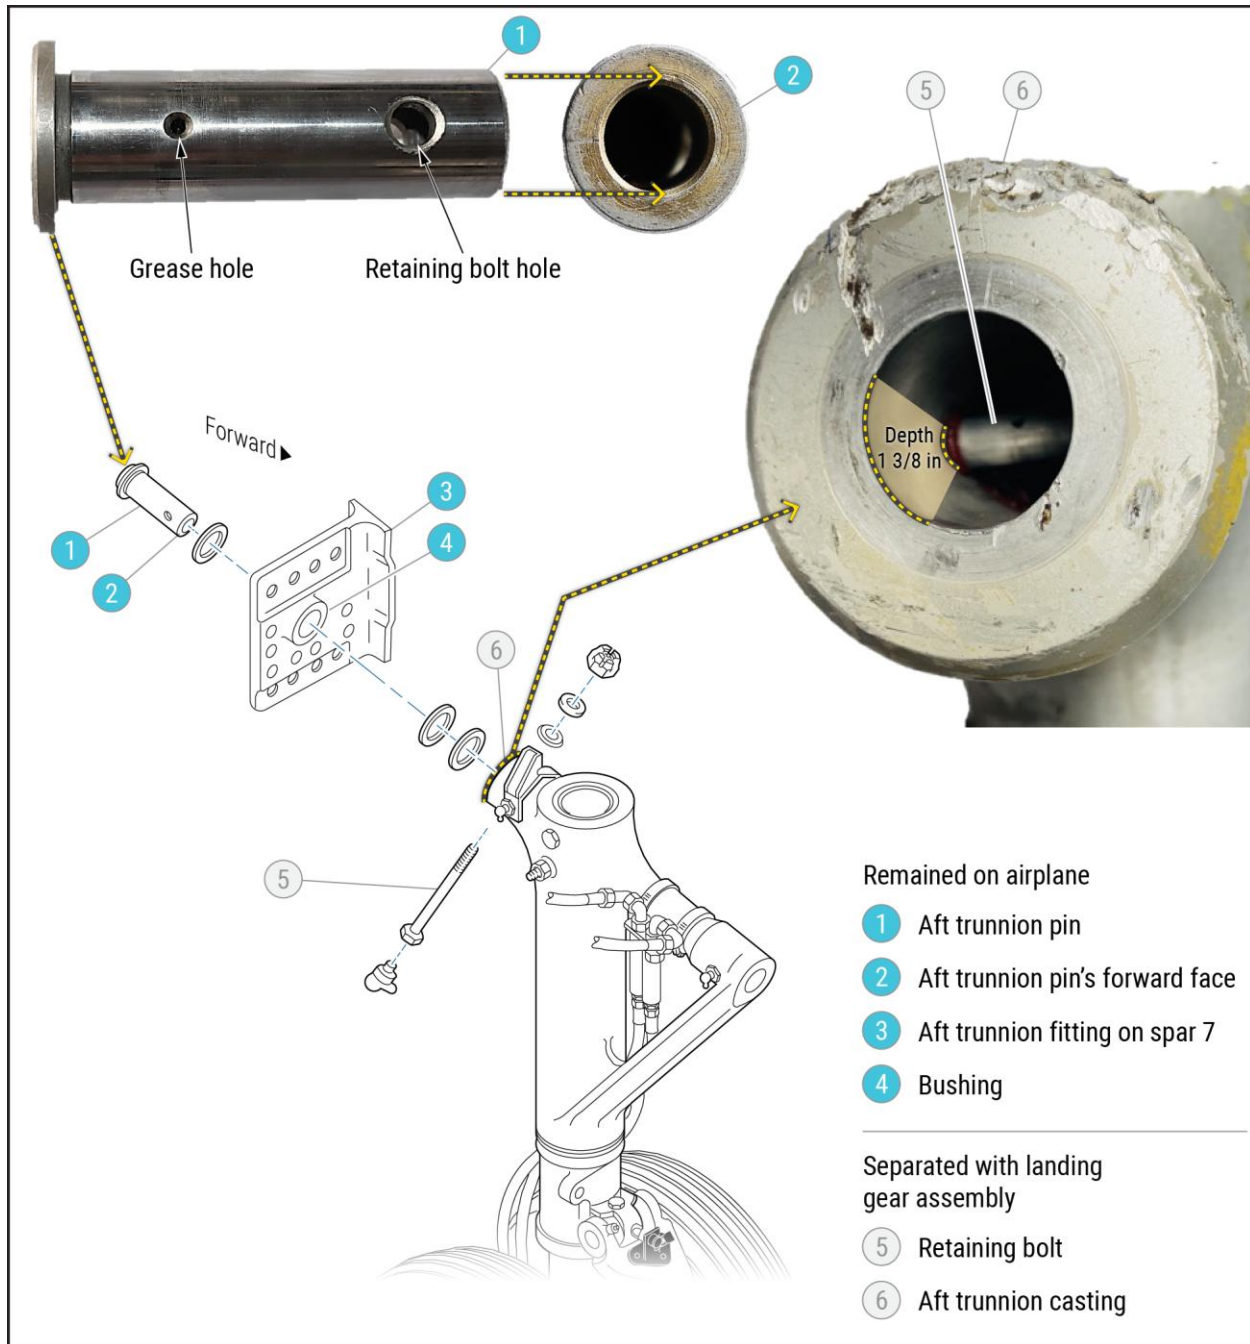
Figure 7. Left main landing gear aft trunnion pin and aft trunnion casting from the accident airplane, with retaining bolt secured through the latter but not the former (Source [inset diagram]: Bombardier).

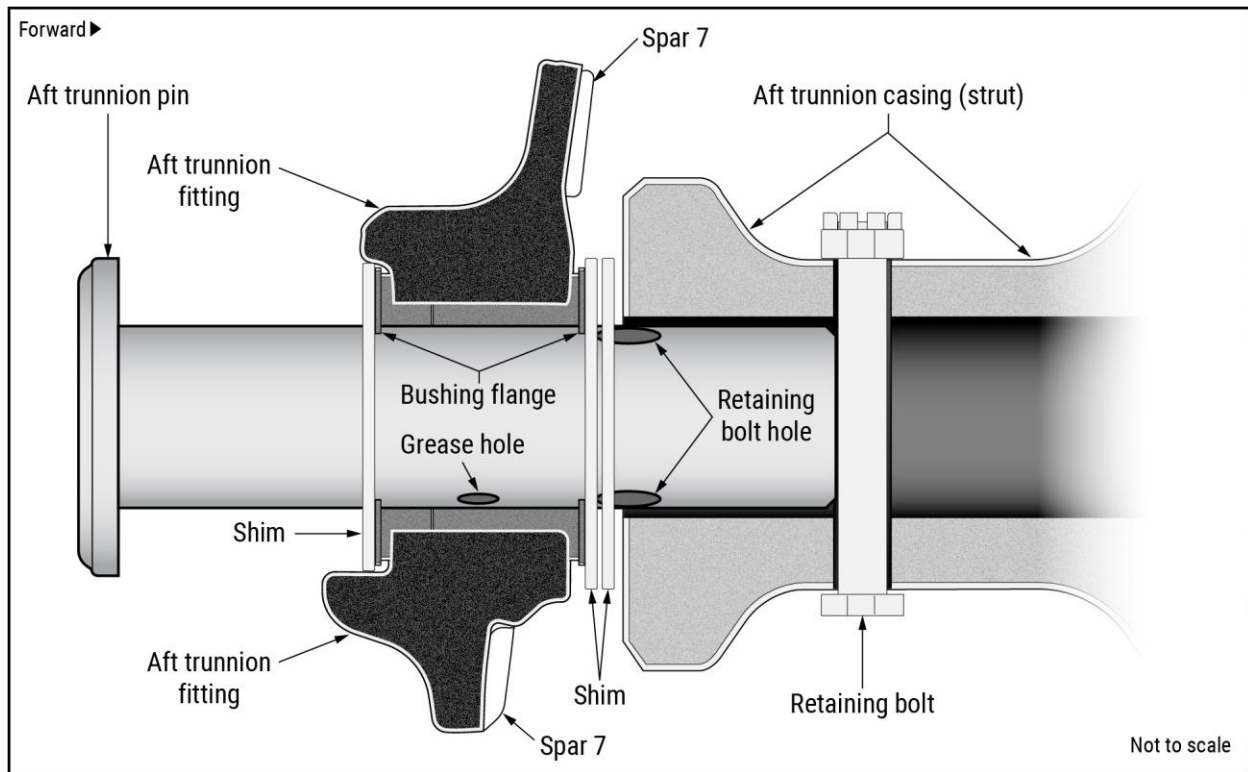
When assembled correctly, the pin is fully inserted into the trunnion; therefore, the pin's shoulder head will sit flush against the surrounding wing strut structure/fitting. When the retaining bolt is not inserted through the hole in the pin, the retaining bolt prevents the pin from being (correctly) fully inserted into the trunnion. As shown in figure 8, this obstruction results in the pin bearing against the retaining bolt rather than seating fully within the trunnion, leaving the pin's shoulder visibly protruding from the aft spar surface.

Figure 8. Cross-sectional illustration of insecurely attached landing gear.

Therefore, the NTSB recommends that the FAA require Bombardier to revise the maintenance procedures for the applicable Learjet models to include a check of the position of the aft landing gear trunnion pin and retaining bolt, following maintenance on the gear that requires removal of the aft trunnion, to ensure that the landing gear has been correctly attached to the airplane wing structure.

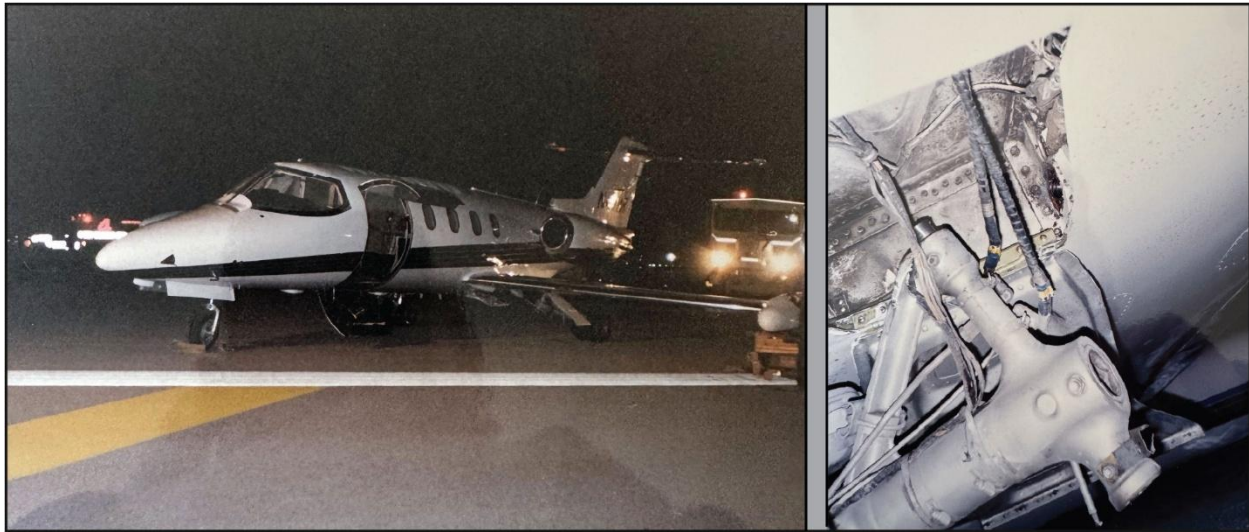
On October 4, 1995, the left main landing gear of a Learjet 25B airplane, N47MR, collapsed during landing rollout at Will Rogers World Airport in Oklahoma City, Oklahoma. The pilot was able to pull the airplane up and perform a go-around, after which the pilot landed the airplane on the right main gear and nose gear. The airplane sustained minor damage, and there were no injuries. During postincident examination, it was discovered that the left main gear's aft trunnion pin was incorrectly installed and had backed out, allowing the gear to collapse (see figure 9).

Figure 9. Composite of N47MR accident photos (Source: Jon Dudek).

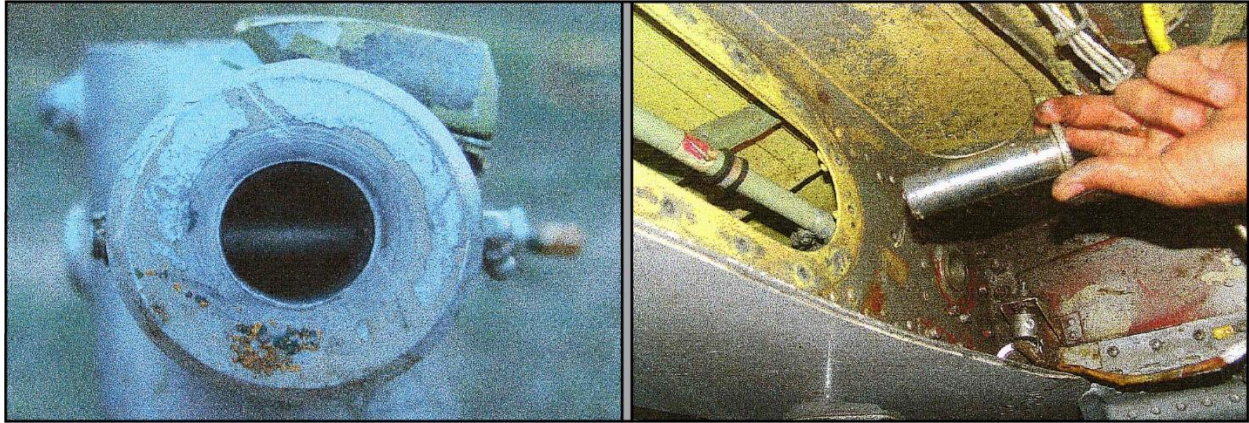
On March 28, 2008, a Learjet VU-35A airplane operated by the Brazilian Air Force, FAB 2712, experienced a runway excursion after the left main landing gear collapsed upon touchdown at Recife/Guararapes–Gilberto Freyre International Airport in Recife, Brazil. The airplane sustained substantial damage; the three crew members and four passengers were uninjured. A report by the Brazilian Aeronautical Accident Prevention and Investigation Center, which investigated the accident, determined that the left main landing gear did not retract after takeoff; instead, the entire strut shifted backward. During landing, the pilot lost directional control of the airplane. Postaccident examination found the left aft trunnion pin loose in the wing

bay behind spar 7 without any signs of fracture or fatigue. The retaining bolt was found intact and still fastened through the left main landing gear's casting—having been installed without engaging the aft trunnion pin (see figure 10).

Figure 10. VU-35 accident photos (Source: Aeronautical Accident Prevention and Investigation Center of Brazil).
