Device TC37xEXT
Marking/Step (E)ES-AA
Package see Data Sheet

This Errata Sheet describes the deviations from the current user documentation.

Version	Date	Remark
1.0	2018-12-20	This is the first version for TC37xEXT step AA

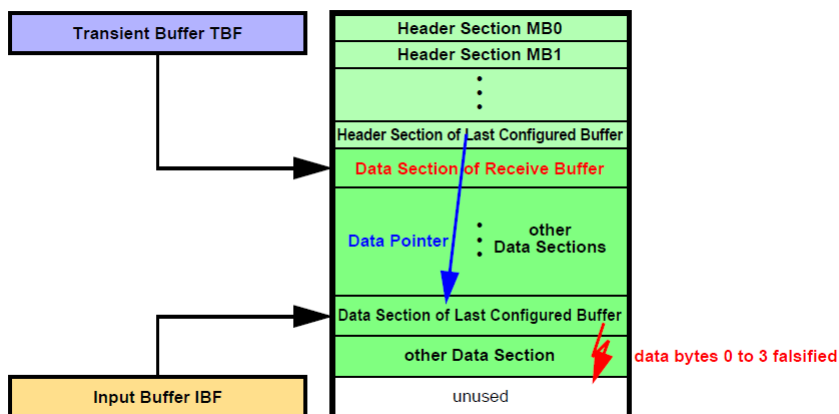
Figure 2 Message buffer transfer from IBF to Message RAM

After the Data Section of the selected message buffer in the Message RAM has been written, one additional write access overwrites the following word in the Message RAM which might be the first word of the next Data Section.
