SMARTscan Survey Report

Area 6 – M11 Junction 6 – Junction 9

Prepared by:
Wayne Wallace, Integrated Support

31st MAY 2018

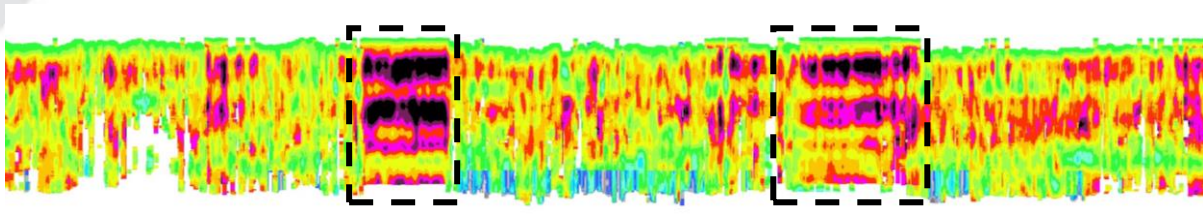
Peaks in the trace caused by concrete footings for an over-bridge resulting in a high SCS score
