LIGHT LEAKAGE DEFECTS

8000series

Light leak repair methods

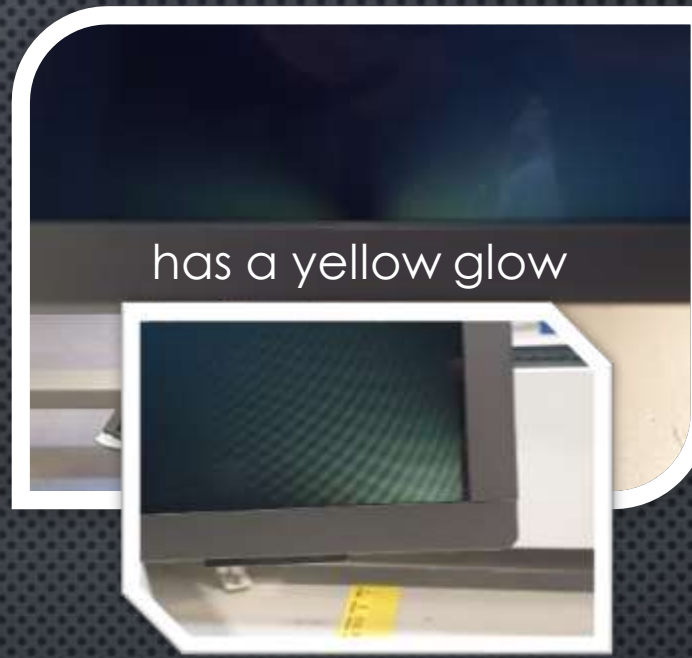
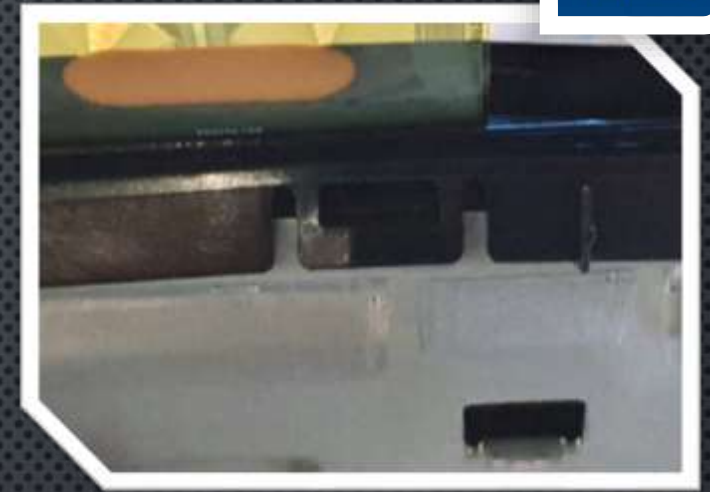
LIGHT LEAKAGE BY POINT PRESSURE

Light leakage caused by point pressure, e.g. rubber under the OC pressing on the OC, foreign body under the FC, incorrect FC assembly

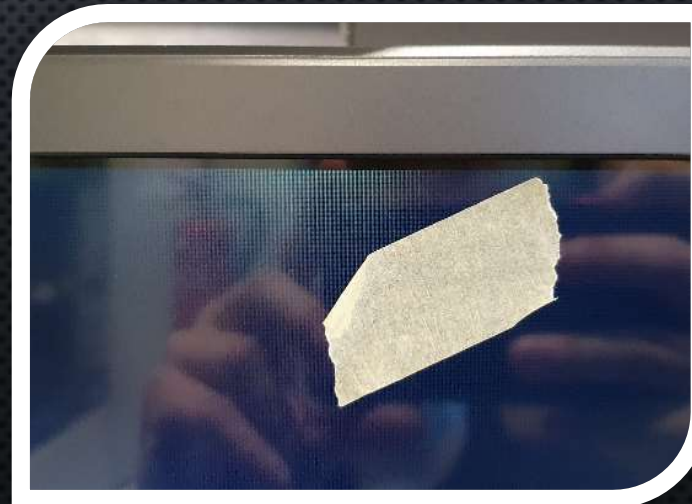
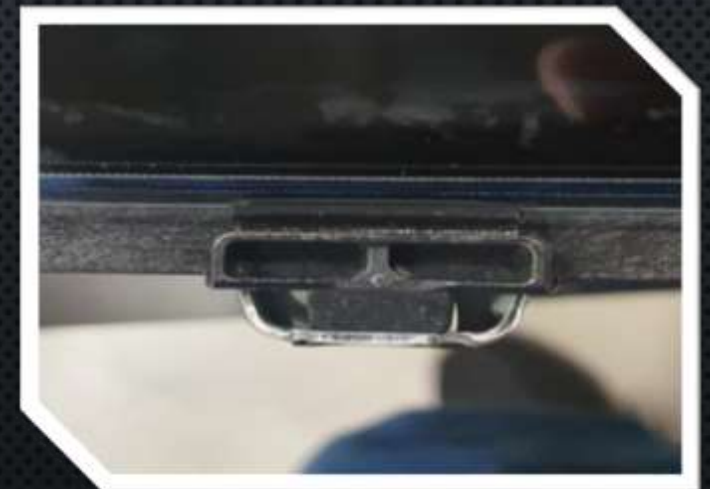
LIGHT LEAKAGE

Light leakage caused by incorrectly installed reflector, B/L deformation, uneven backlight, middleframe bent

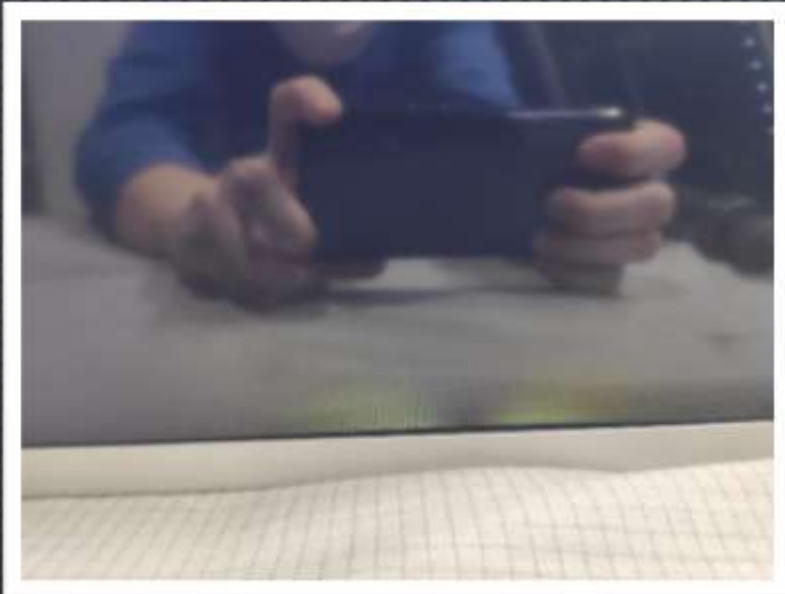
LIGHT LEAKEGE
BY POINT PRESSURE

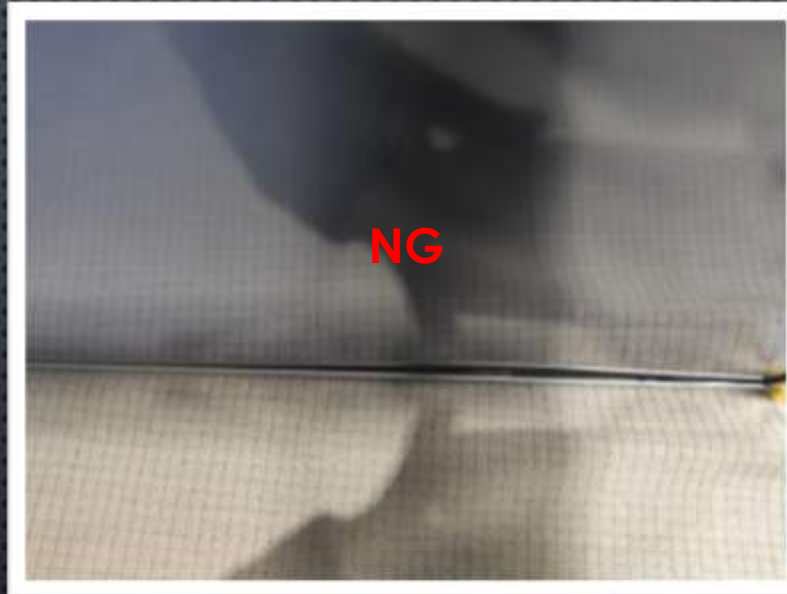
LIGHT LEAKEGE
CAUSED BY VISIBLE FC DENT

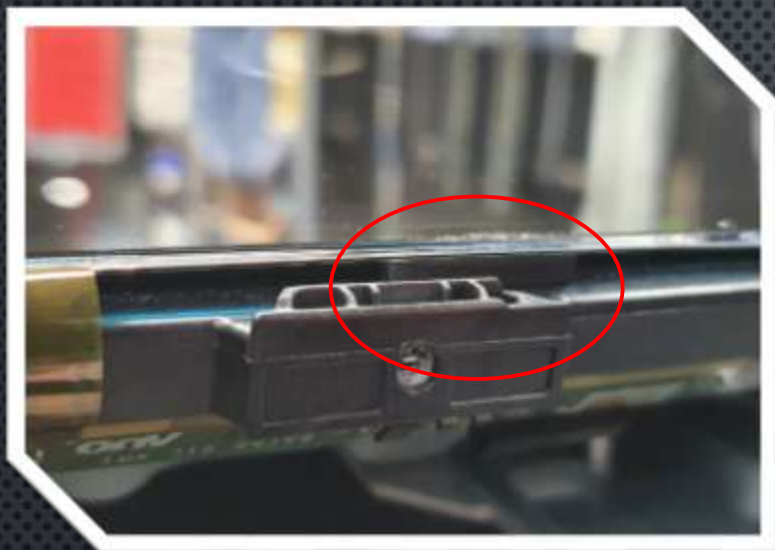
NG

Example of light leakage caused by point pressure under the OC - incorrectly glued rubber

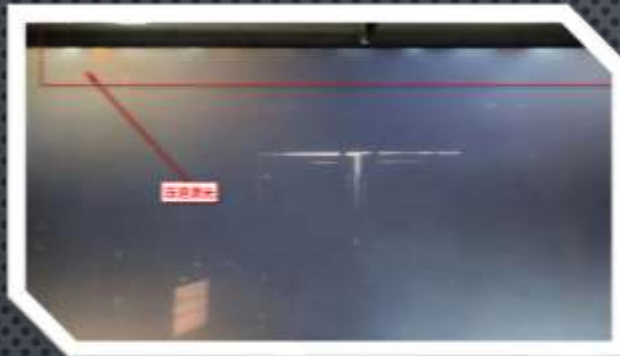
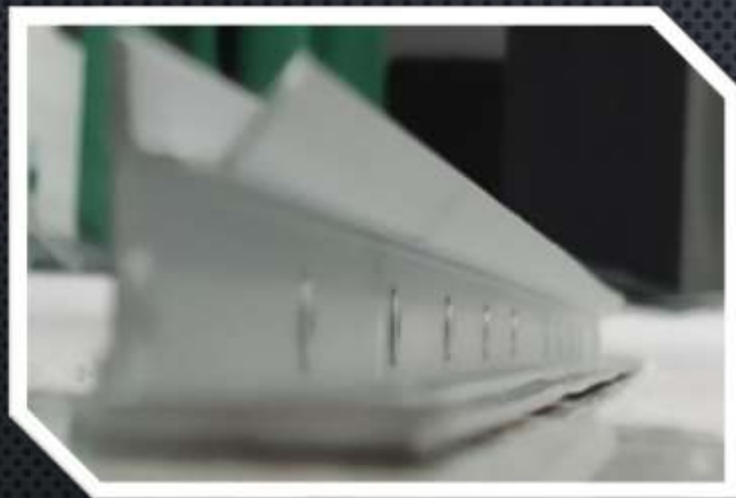
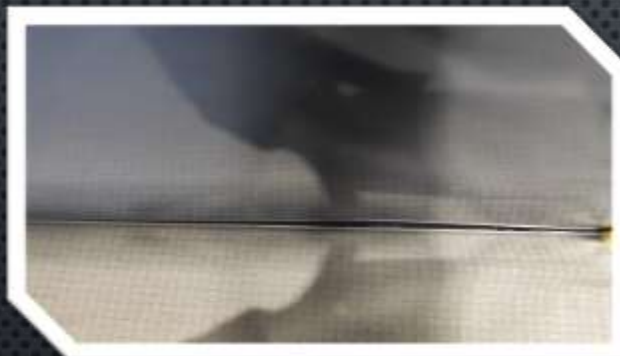
The problem occurs in large inches

The most serious location of light leakage is the wavy deformation of the middle frame pushing up to the OC light leakage. Confirm the upper limit of the bending angle on the sky side of the interference point of the backplane, and the upper limit of the mounting ear height.
