ADP1850 PCB design error

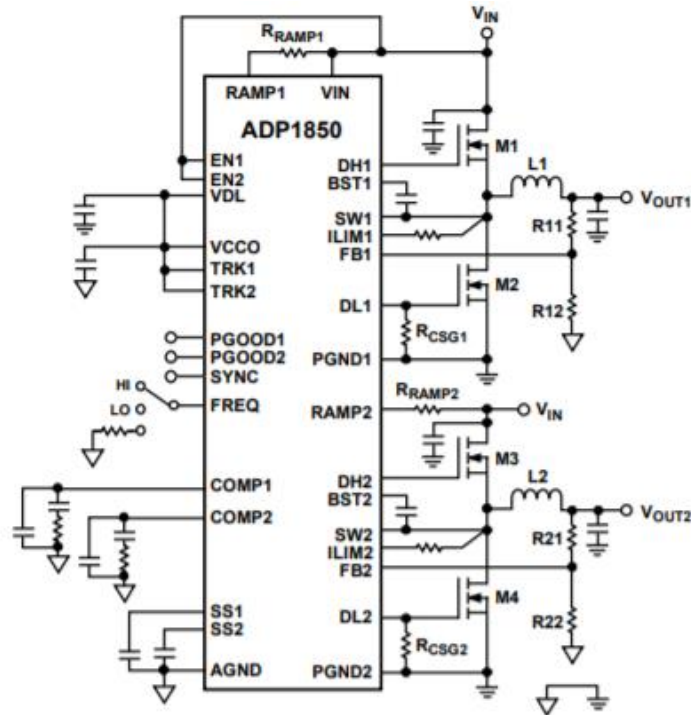
Figure 1: Typical Operation Circuit

As can be seen in the following figure (Fig. 1), VCCO (Pin no. 4) and VDL (Pin no. 5) need to be shorted for normal operation of ADP1850. The VCCO pin provides 5V supply to the VDL pin which acts as the supply for low side switch gate drivers.

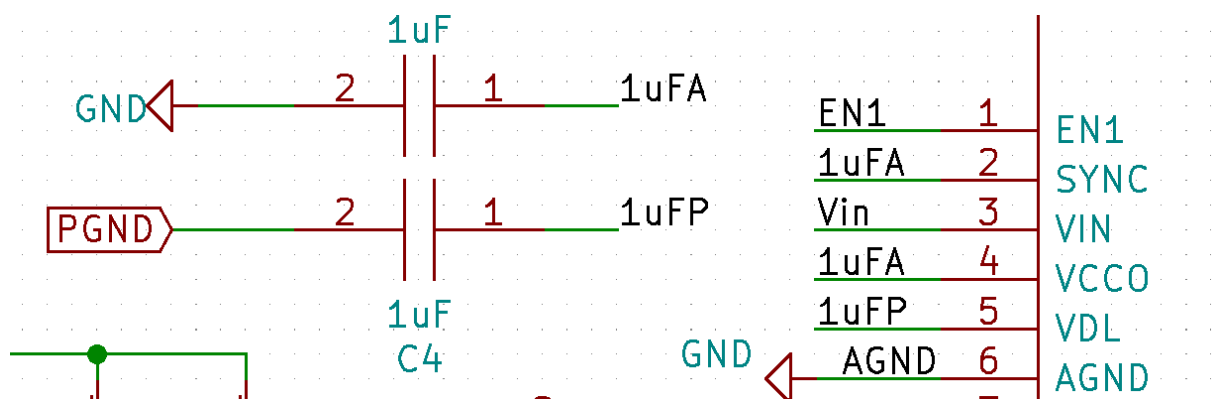
Figure 2: KiCAD PCB Schematic for ADP1850

In the PCB Schematic KiCAD files for ADP1850 the two pins were not shorted which has since been rectified. New Gerber files were generated and uploaded to TIFR's GitLab server.
