Republic of the Philippines  
**Tourism Infrastructure & Enterprise Zone Authority**

**SUBJECT** **MT. DATA HOTEL FINDINGS /CORRECTIVE ACTION**

Mt. Data Hotel  
Sinto Bauko, Mountain Province

Building structure status report of Mt.Data Hotel.

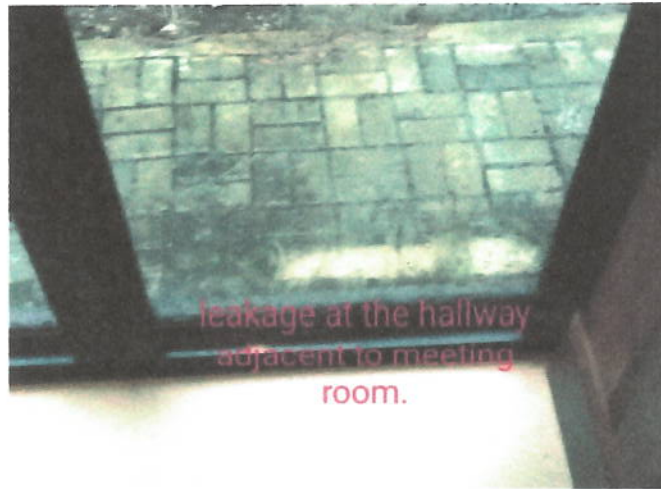
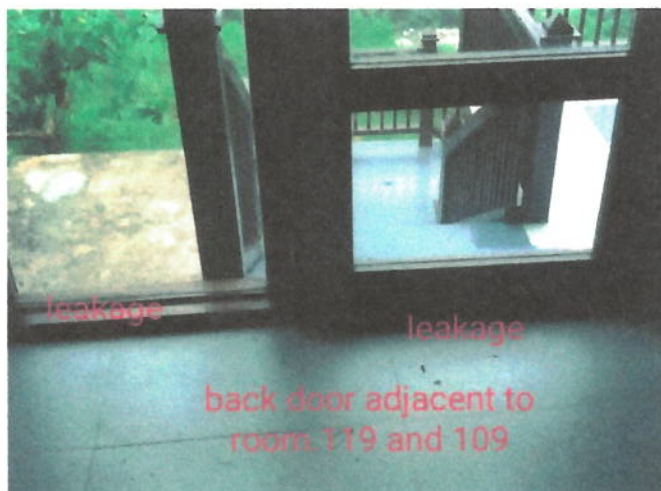
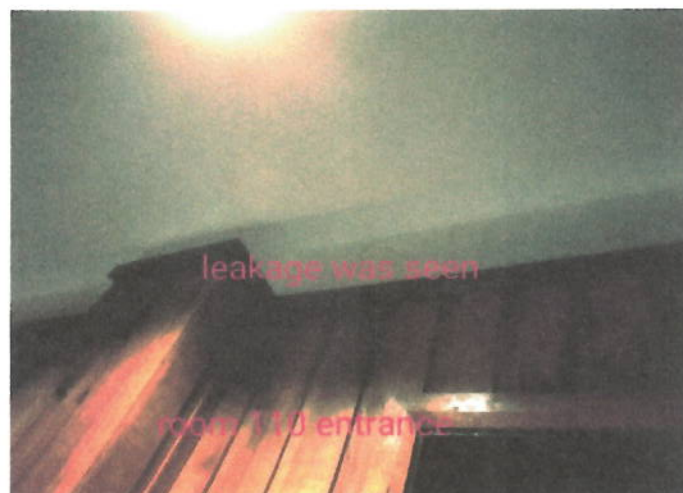
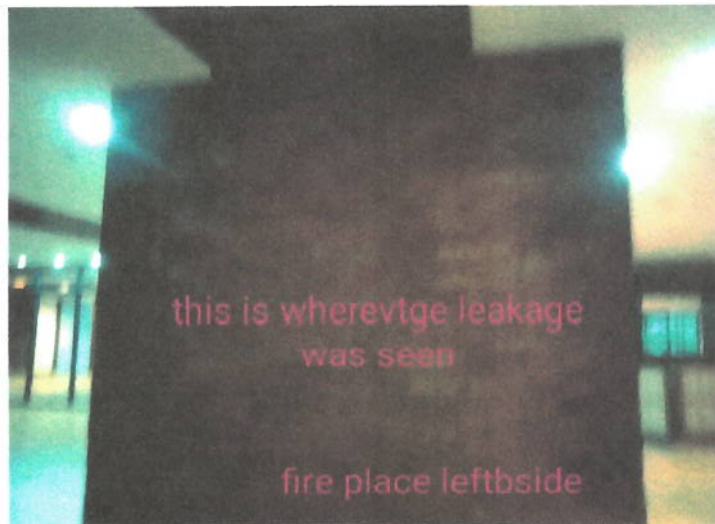
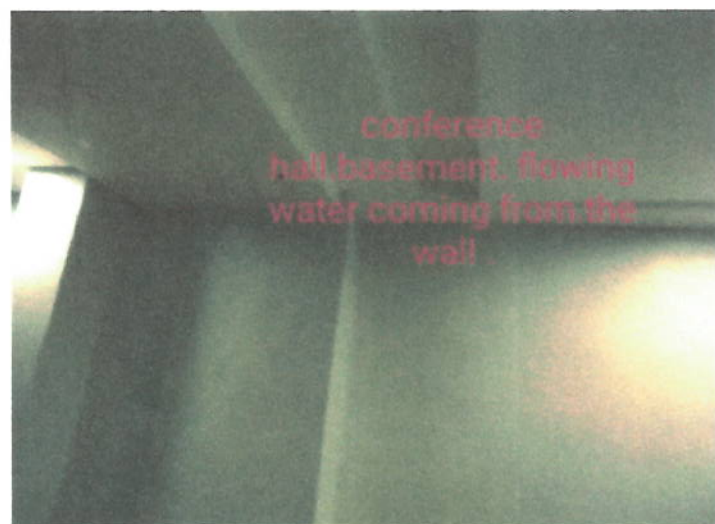
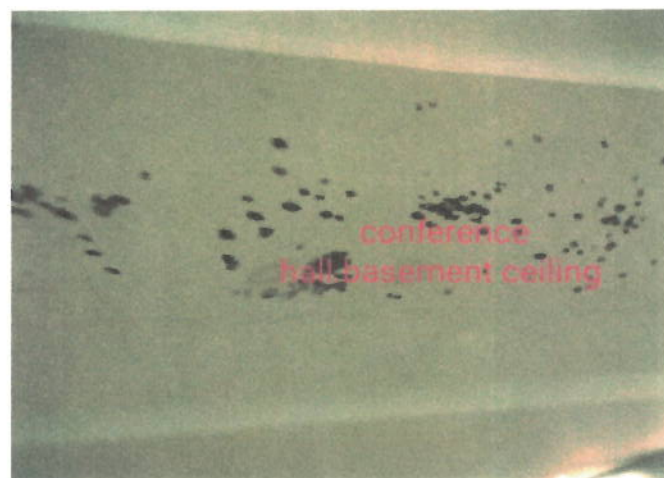
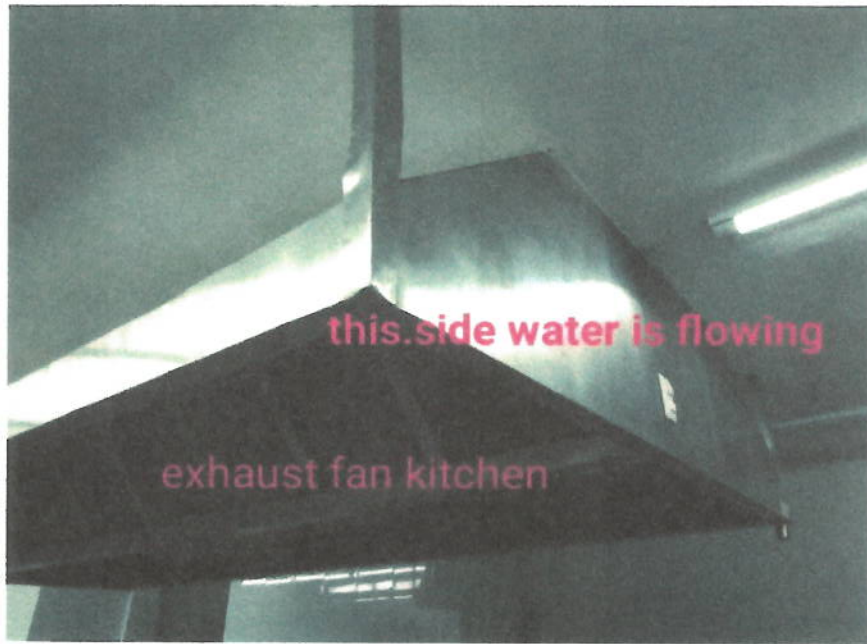
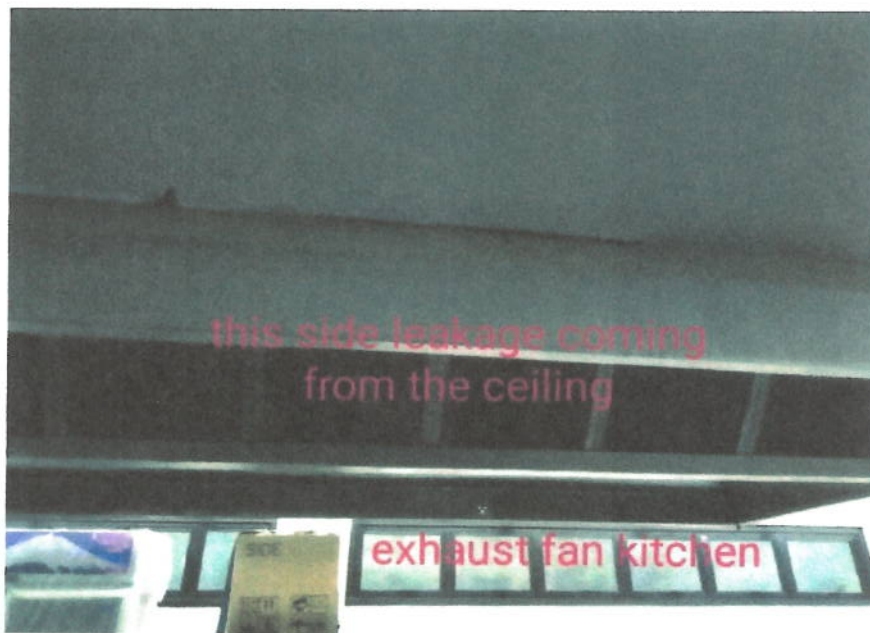
The observations were mostly water leaking or dripping in the conference room ceiling, walls, stairs, hallway (near room 119, and 109), glass wall panels, fire place, kitchen exhaust as shown in the photos attached.  
Project Engr. Dado Partolan was verbally informed immediately.

1. Conference hall at the basement, a lot of water is flowing down from the ceiling and corner wall submerged on the floor.
  2. Windows beside the stairs going down to the basement there is also leakage during typhoon Maring water was collected on the stairs.
  3. Back door end of Hallway adjacent to Room 119 and 109 during typhoon i observed water coming from the door base/below and leaking from the glass wall.
  4. Fire place, a huge amount of water was seen flowing coming from the ceiling .
  5. Kitchen, leakage is coming from on the portion where the exhaust chimney is placed.
  6. All portions with exhaust chimney has leakage.
- Sir/ mam as per observations sealant that was applied is not enough which caused the leakages.

We write to inform you of the need by the contractor to do corrective actions on various observations noted during the October 11-12, 2021 Typhoon 'Maring' that affected the newly rehabilitation Mt. Data Hotel.
