SUBJECT : **INSPECTION REPORT NO. 9**

DATE : March 17, 2021

PROJECT NAME : Assets Rehabilitation Plan Lights and Sound Museum

LOCATION : Victoria Street, Intramuros, Manila

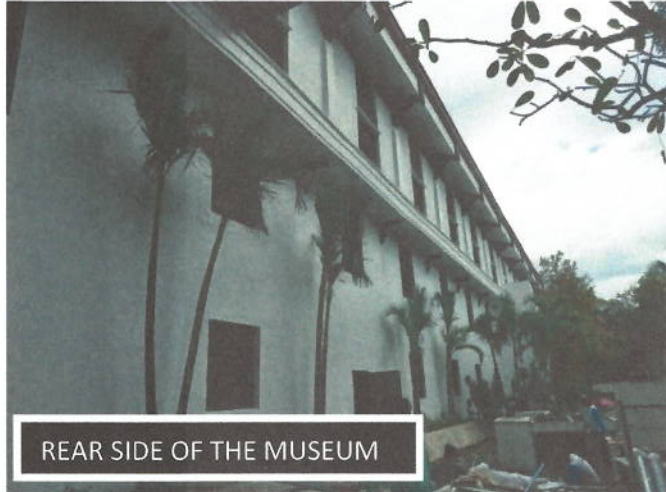
REAR SIDE OF THE MUSEUM

1. The repainting of exterior walls is almost complete, only the wall at roof deck area is undone.
2. The replacement/repair/refurbish of existing corbels is 100% complete.

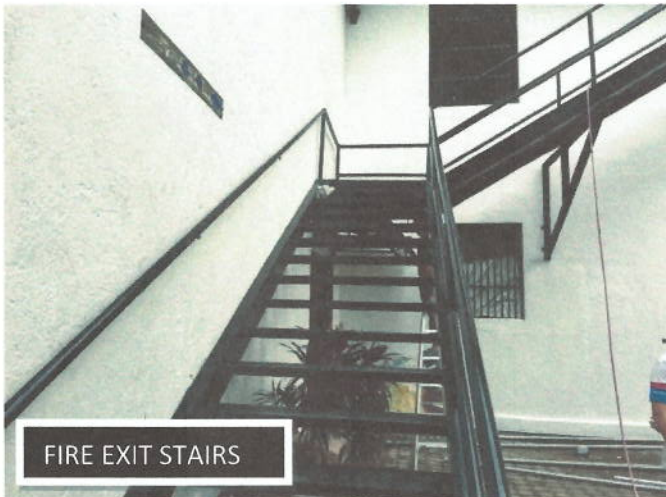
FIRE EXIT STAIRS

14. The steel framing for the installation of canopy at main entrance is done.
15. The repair of fire exit stairs is almost done, but there are some flat bars at the stairs that are damaged and is needed to be replaced.

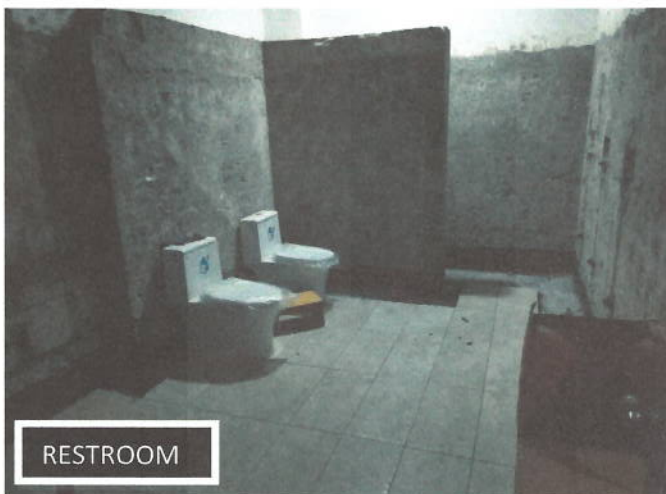
RESTROOM

12. The restrooms' waterlines are already replaced and the floors at second floor are already waterproofed, also the ceiling works are already done. The installation of tiles can be done but the contractor is not making any progress in this work.
