Republic of the Philippines
Tourism Infrastructure & Enterprise Zone Authority

MEMORANDUM

SUBJECT **MT. DATA HOTEL FINDINGS /CORRECTIVE ACTION**

Mt. Data Hotel
Sinto Bauko, Mountain Province

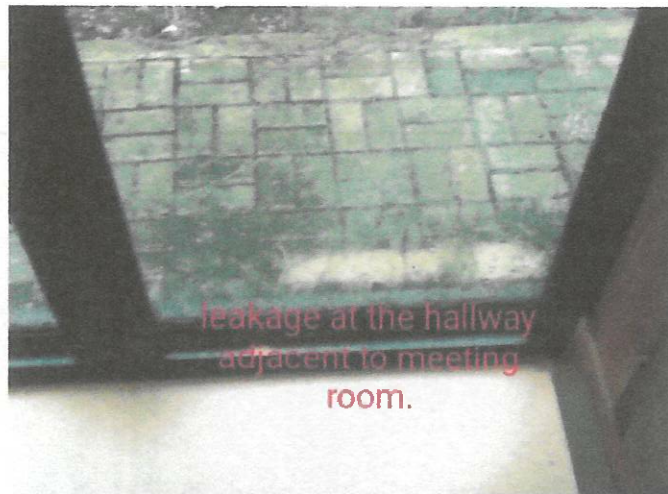
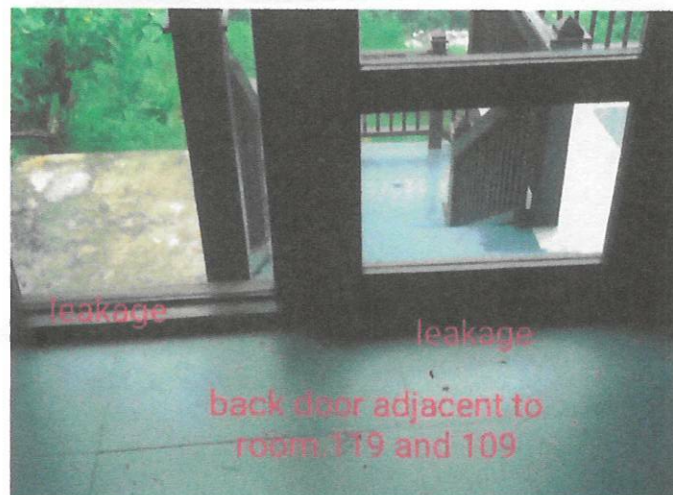
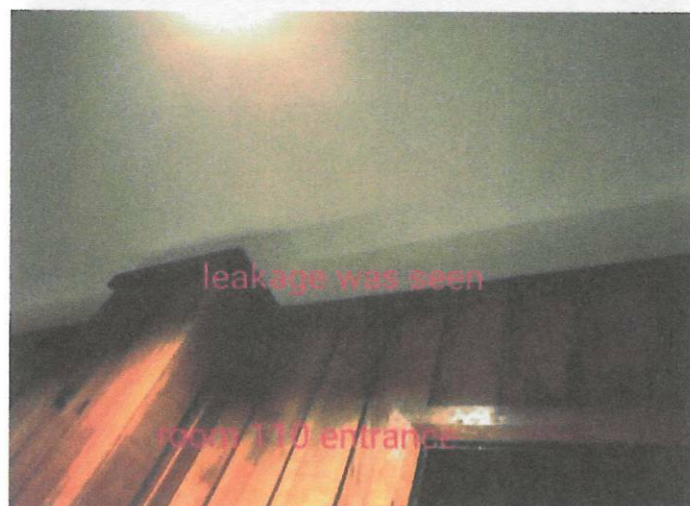
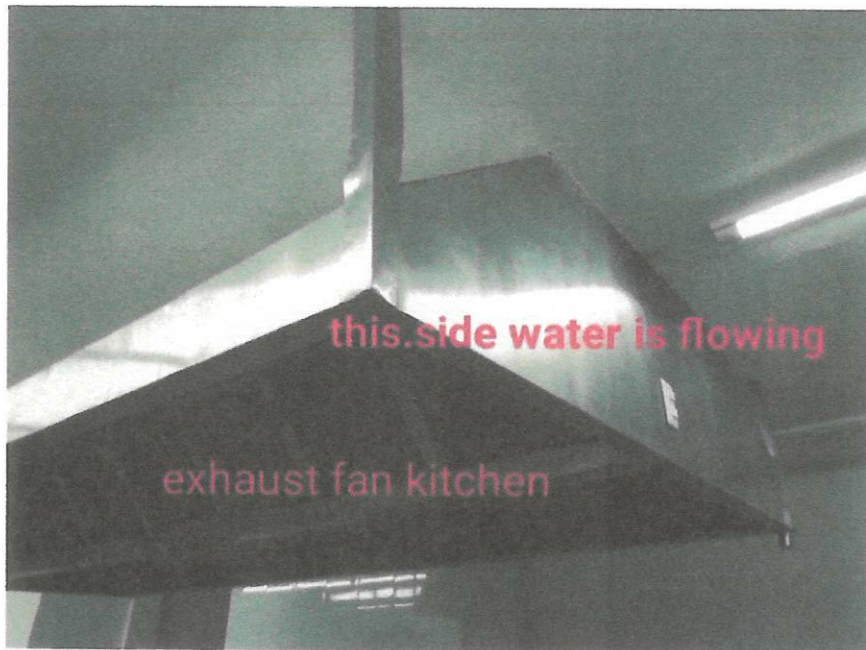
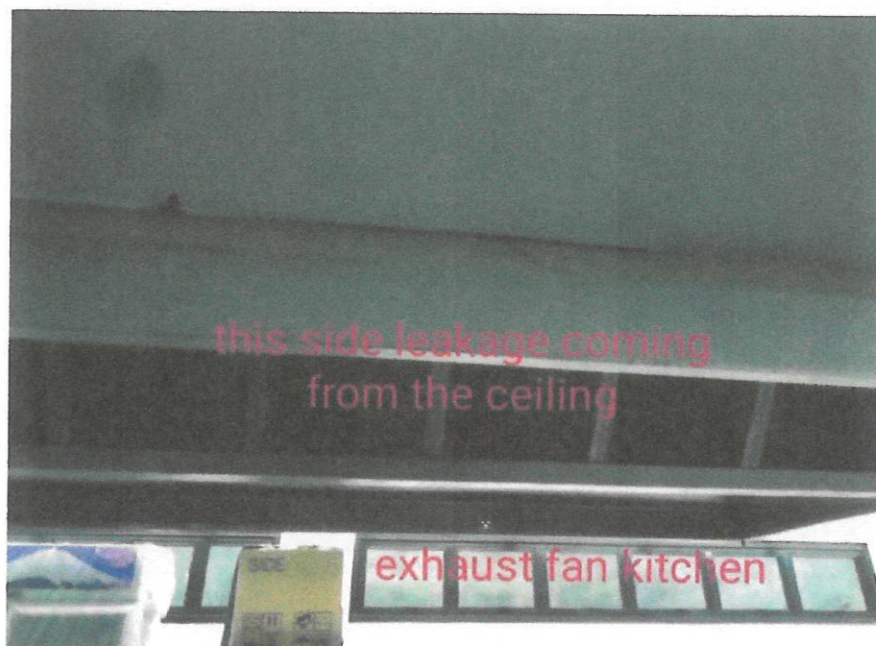
The observations were mostly water leaking or dripping in the conference room ceiling, walls, stairs, hallway (near room 119, and 109), glass wall panels, fire place, kitchen exhaust as shown in the photos attached.
Project Engr. Dado Partolan was verbally informed immediately.

1. Conference hall at the basement, a lot of water is flowing down from the ceiling and corner wall submerged on the floor.
2. Windows beside the stairs going down to the basement there is also leakage during typhoon Maring water was collected on the stairs.
3. Back door end of Hallway adjacent to Room 119 and 109 during typhoon i observed water coming from the door base/below and leaking from the glass wall.
4. Fire place, a huge amount of water was seen flowing coming from the ceiling .
5. Kitchen, leakage is coming from on the portion where the exhaust chimney is placed.
6. All portions with exhaust chimney has leakage.

Sir/ mam as per observations sealant that was applied is not enough which caused the leakages.

We write to inform you of the need by the contractor to do corrective actions on various observations noted during the October 11-12, 2021 Typhoon 'Maring' that affected the newly rehabilitation Mt. Data Hotel.
