TV Struck By Lightning Repaired

This Hisense 50” Smart TV had been a victim of a lightning strike. A friend of mine was asked by a customer of his to take it to landfill as he was cleaning the

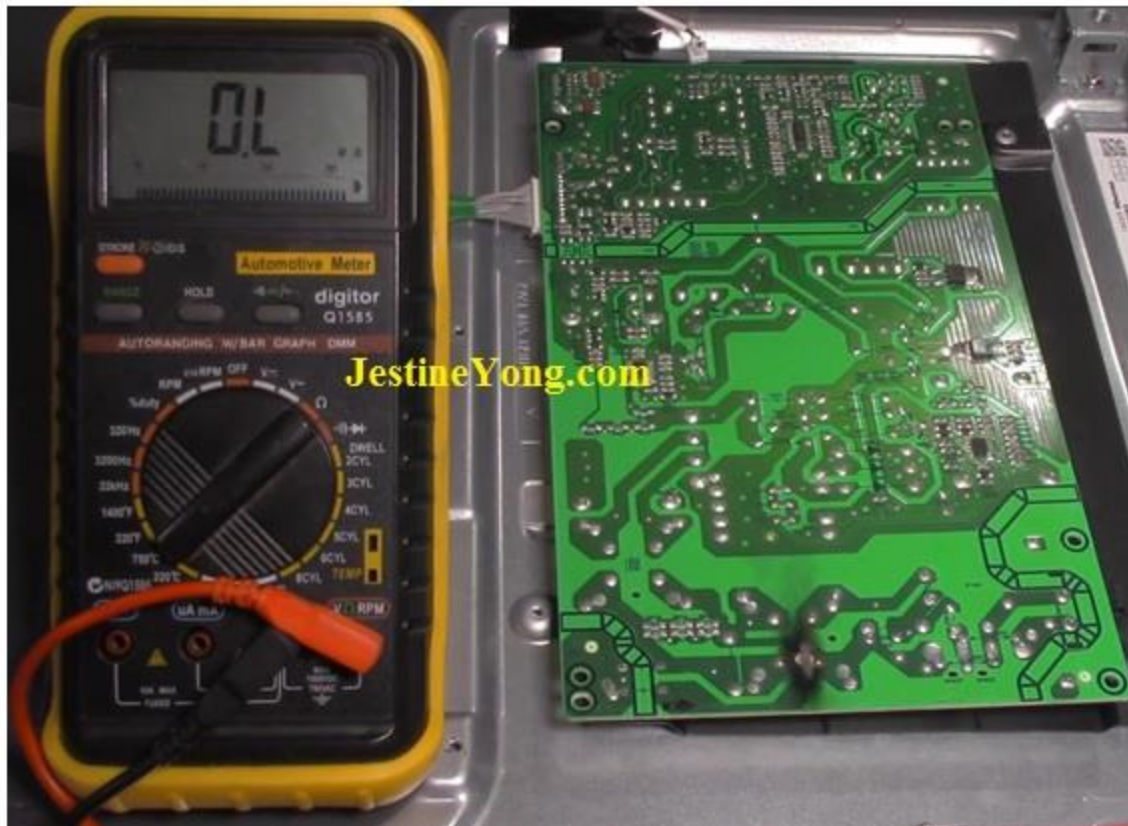
This TV had no standby light. Although I couldn't find a service manual, the voltages were written on the power board and testing proved that no voltages were being supplied to the mainboard. Considering this TV had a disagreement with a lightning bolt, I decided to check the protection circuit. Surely, with thousands, possibly millions of volts surging through the TV, I would naturally expect a blown fuse, varistor, thermistor, maybe some diodes and MOSFETS to be a little worse for wear.

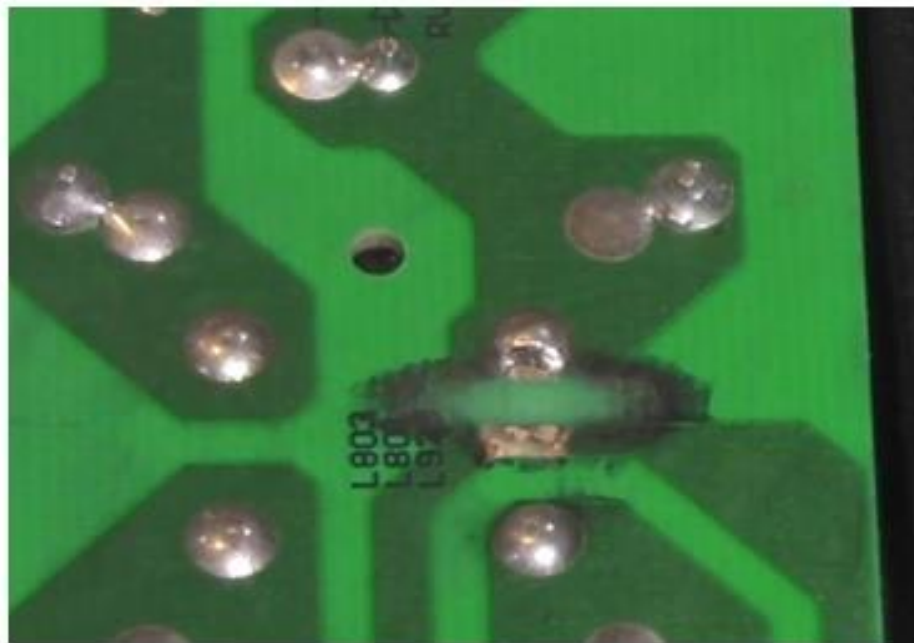
However, after checking these components, I was surprised that not even the fuse was blown! Further inspection showed a burnt track on the back of the board.

It is possible that this area became the weakest link during the high voltage surge & acted as a 'spark gap'.

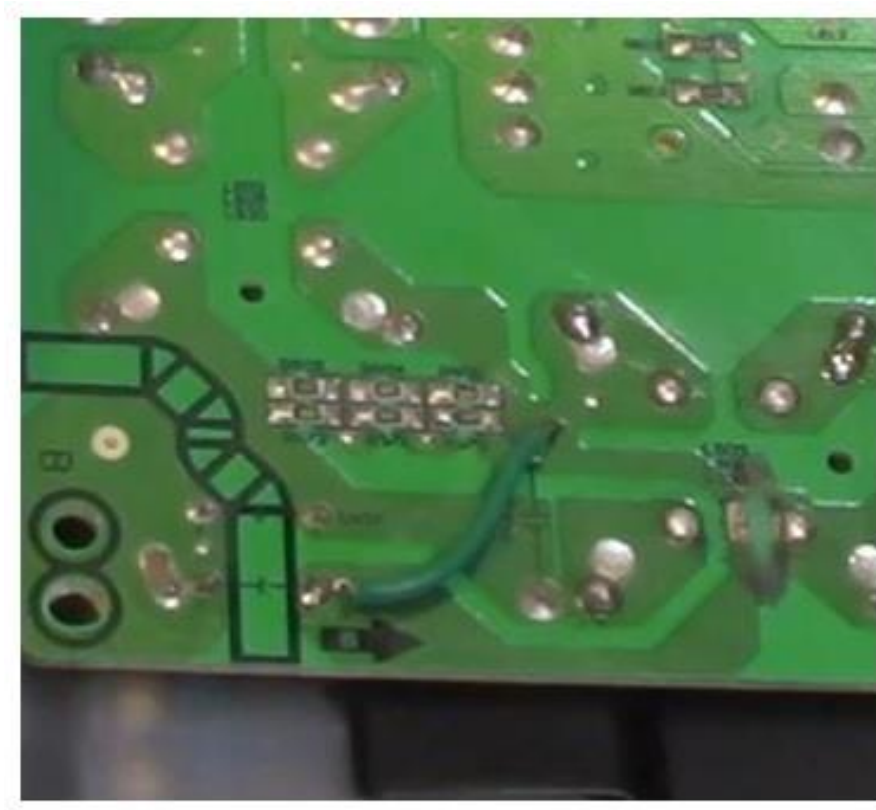
After cleaning up the burnt area, I made several incorrect conclusions. I naturally assumed that the inductor on the other side would be burnt out. Secondly, I thought that perhaps after bypassing this damaged track the TV might actually work!

Wrong on both counts!

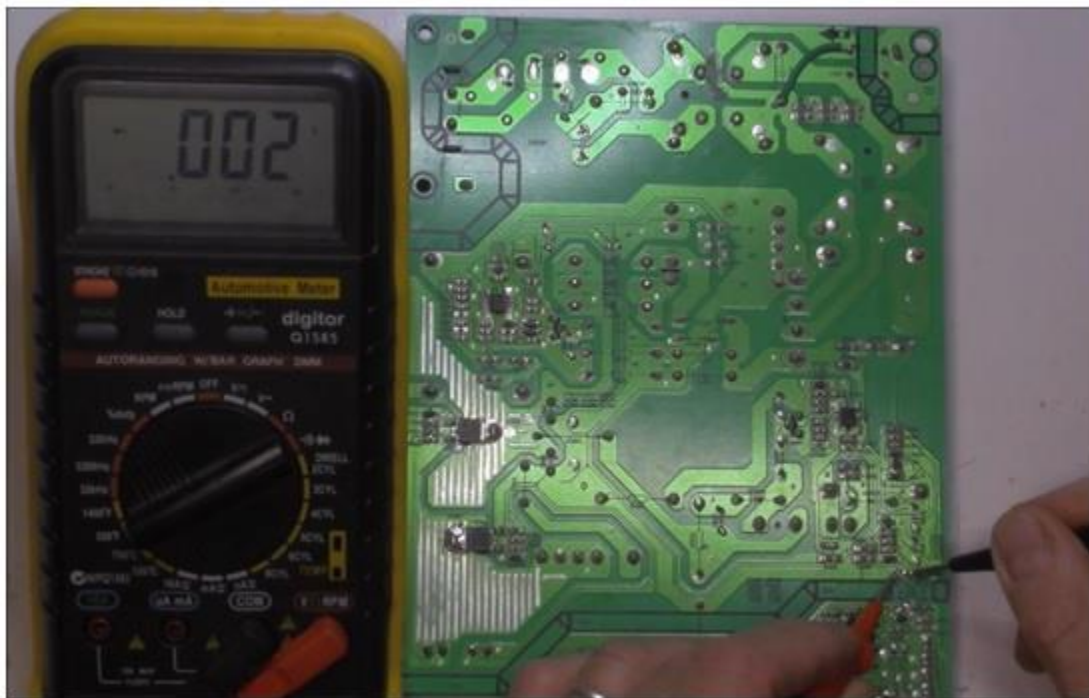
After this repair and test, I now had 340 volts at my main filter capacitors – that was good news!

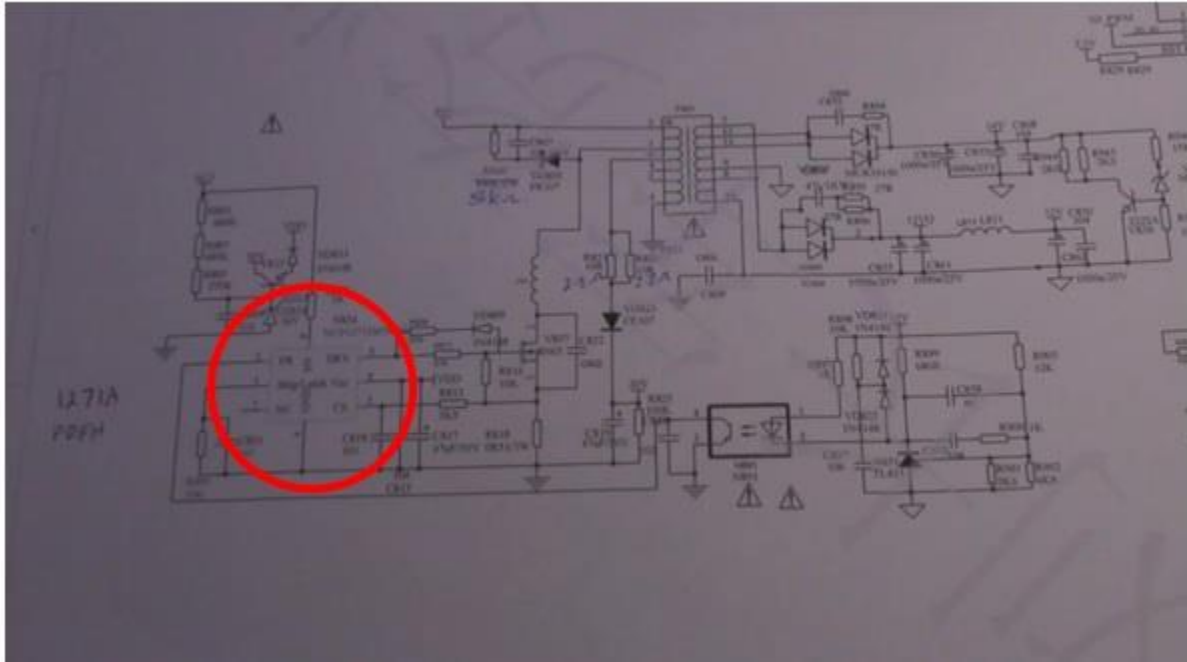
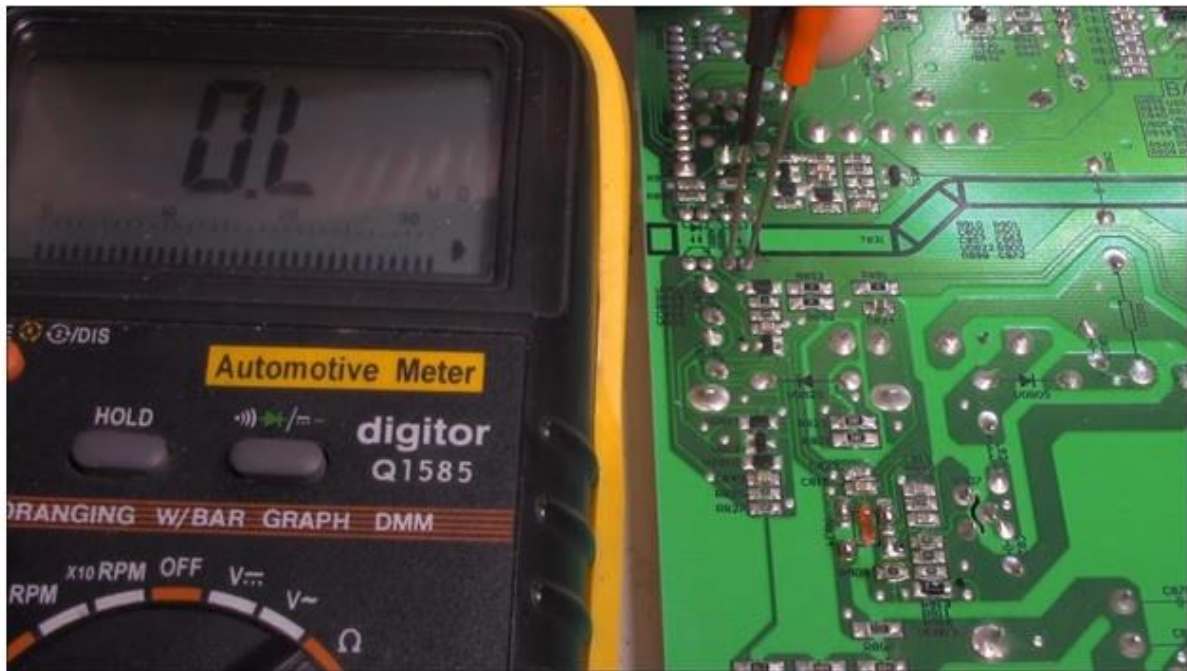
Further inspection showed one of the two optocouplers to be shorted on the Infrared side and open on the photo transistor side. However, even with the optocoupler removed, there was still a short on the board. At first, I suspected a

SMD capacitor to be faulty, but after further testing, it was found to be within specifications. Lifting one leg of the capacitor still resulted in a short in this circuit. After carefully examining the schematic, I decided to remove the IC, a NCP1271 Standby PWM Controller, to see if this had an internal short.

Success! The short had disappeared! This was evidence that the IC had shorted and damaged the optocoupler.

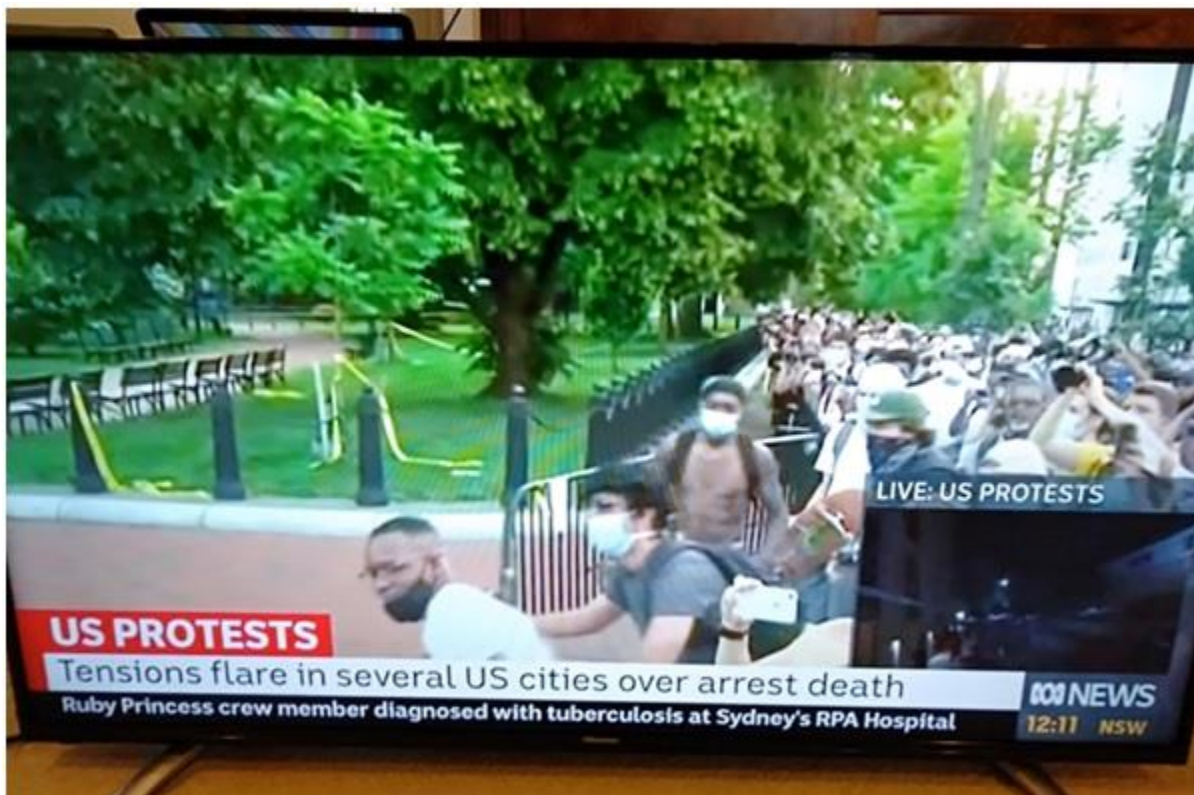
Now I could see a standby light when the power button was turned on.
