BH Update - Mar 17th

BH Report

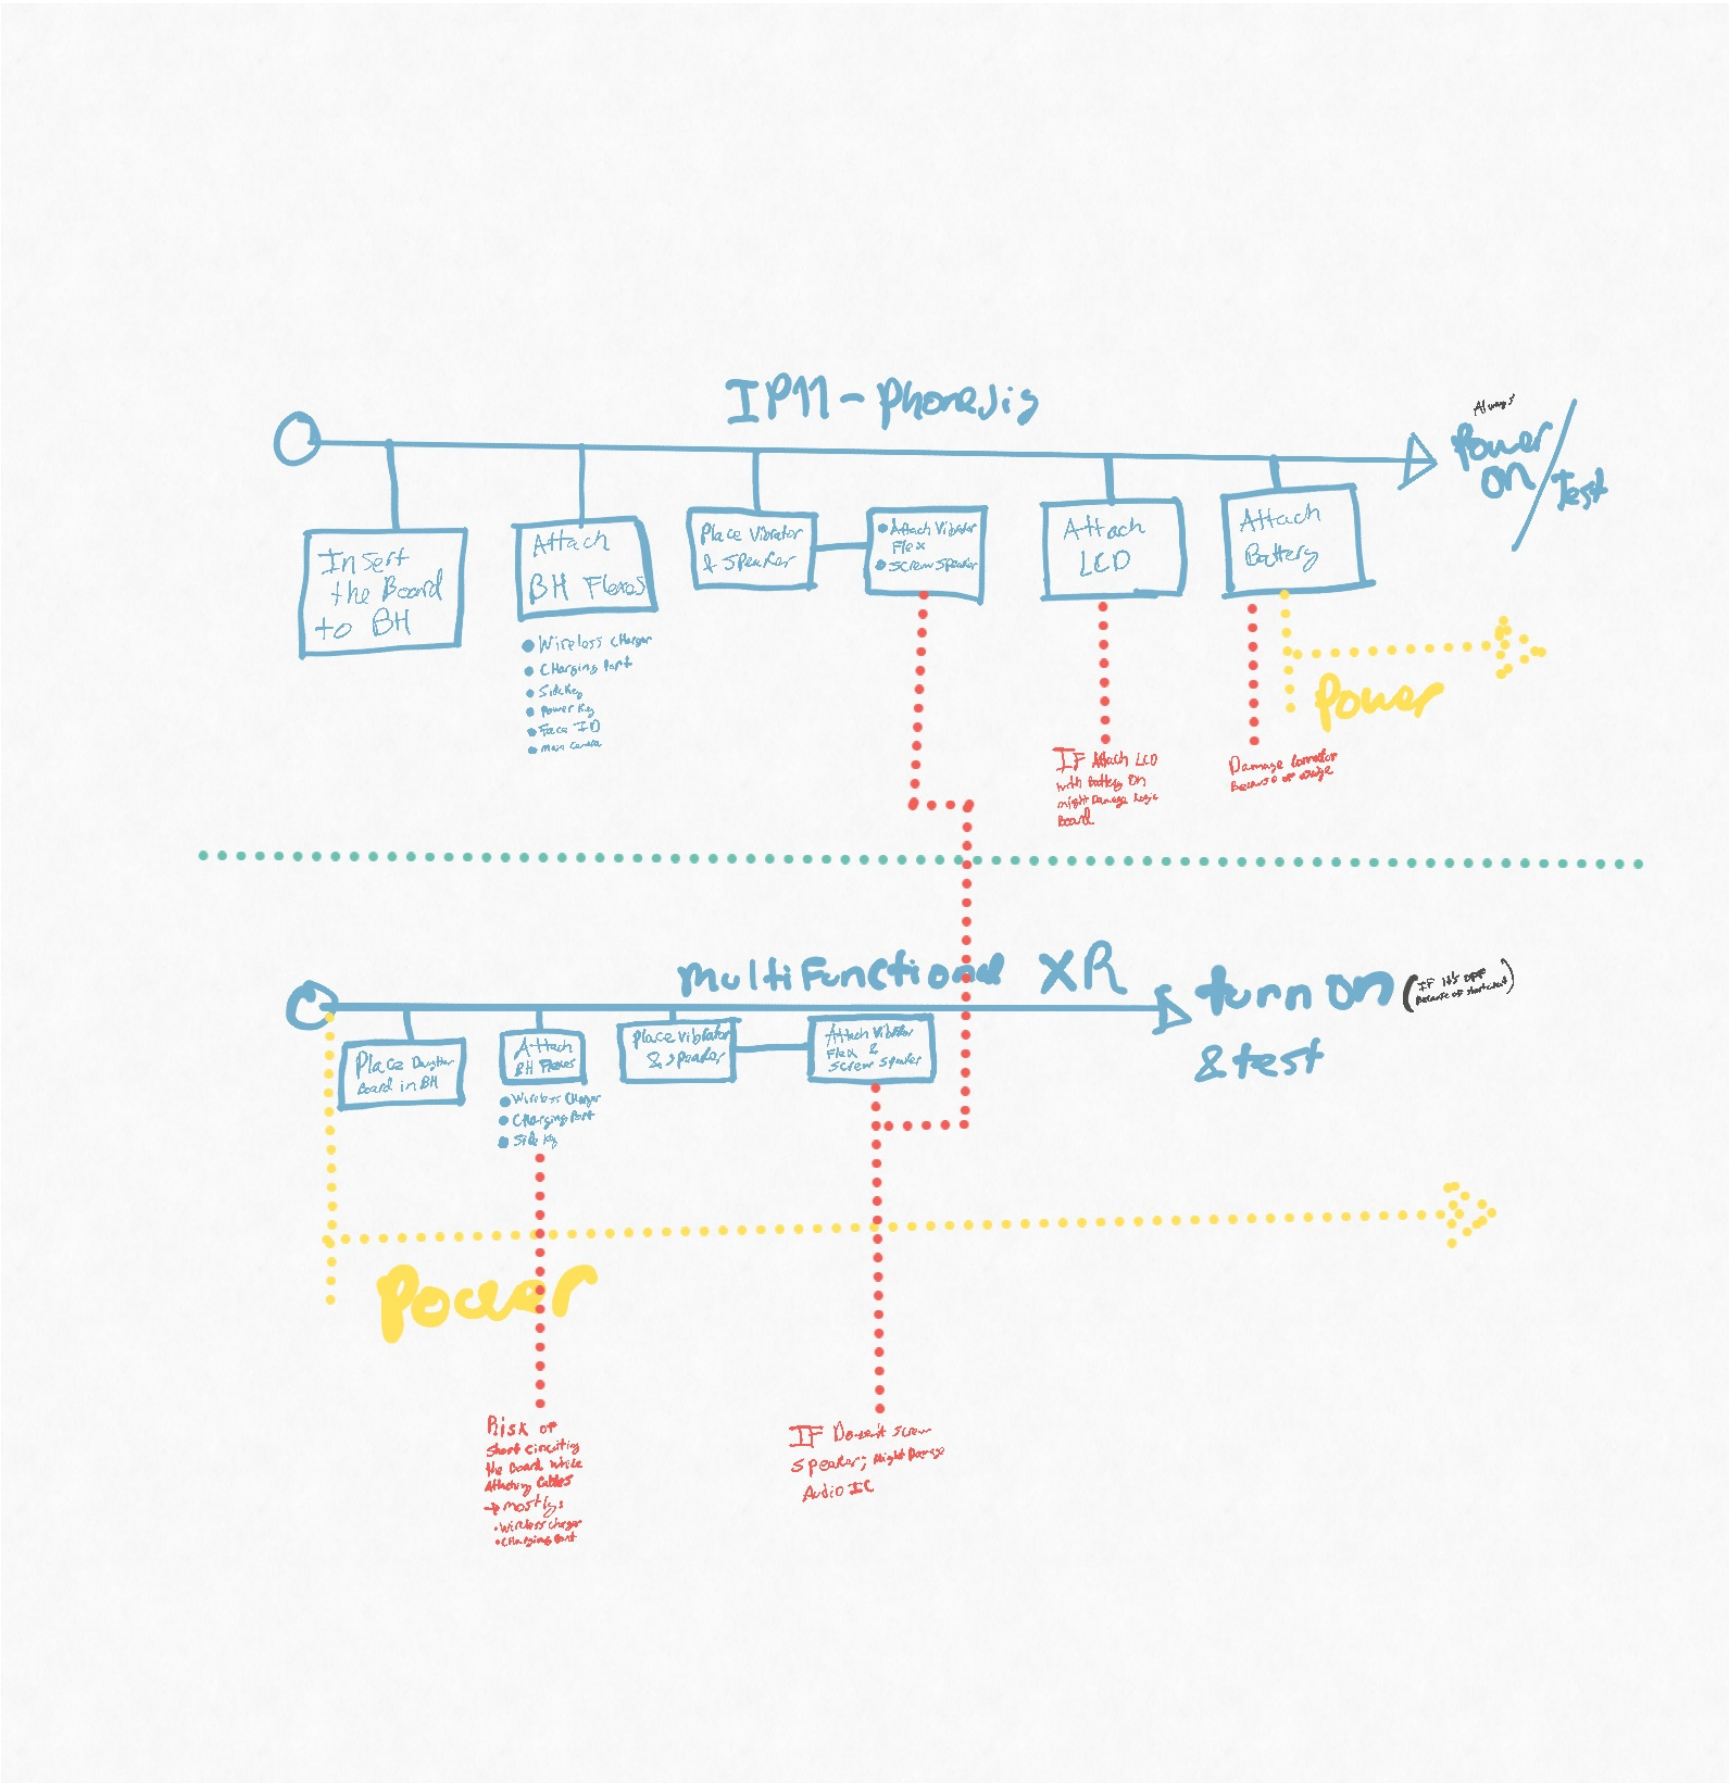
As requested I draw the flowchart of the process and the potential risks while assembling the back-housing. We gonna look over this tomorrow at 8:30am

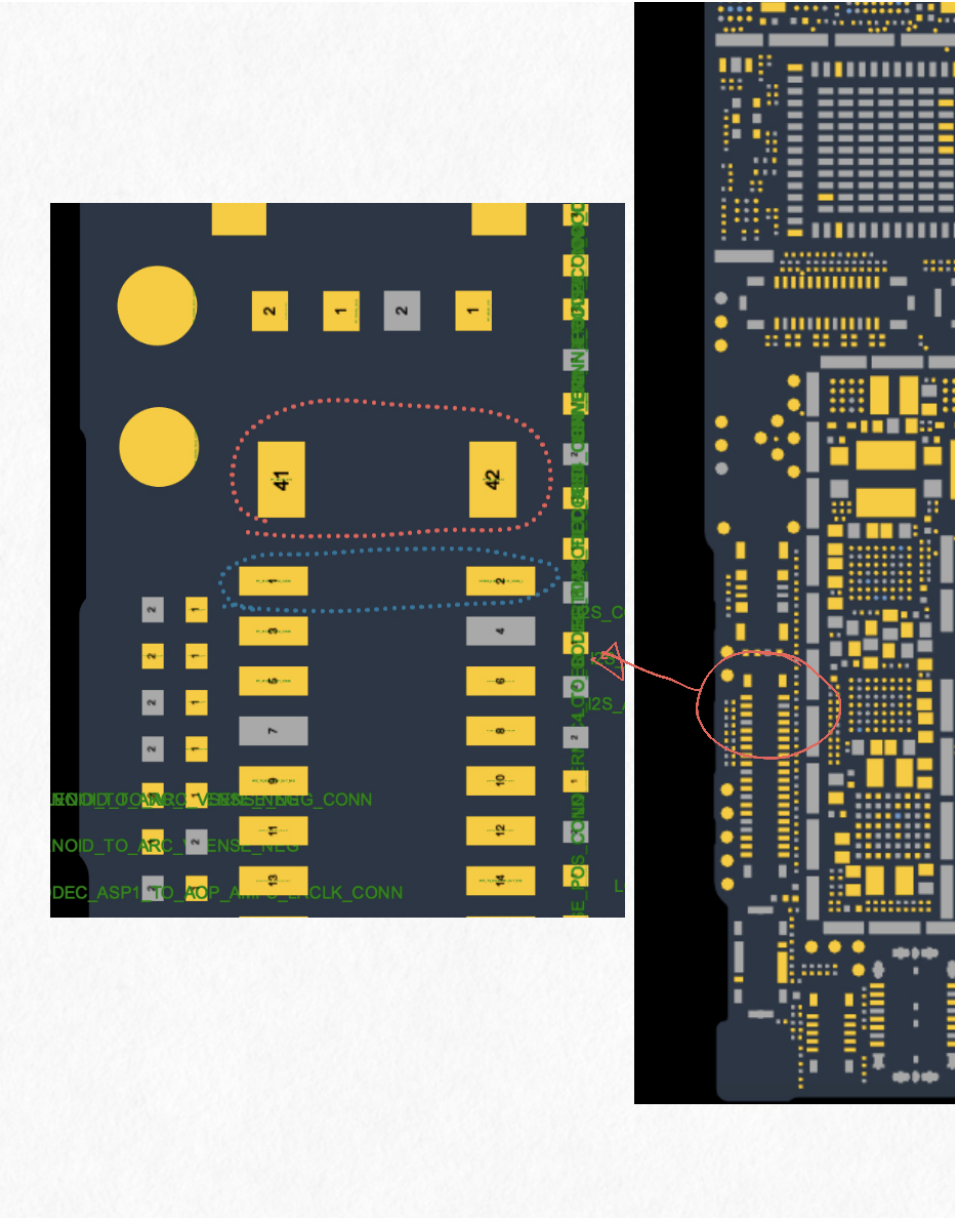
We went to the schematics to see what are the pins that could be making the short-circuit, we conclude its a power pin (VBUS) and a data pin, any of them when it goes low for the XR
